**AVIATION INVESTIGATION REPORT  
A08P0241**

**AERODYNAMIC STALL - COLLISION WITH TERRAIN**

**PACIFIC COASTAL AIRLINES  
GRUMMAN G-21A GOOSE C-GPCD  
ALICE LAKE, BRITISH COLUMBIA  
03 AUGUST 2008**

Report Number A08P0241

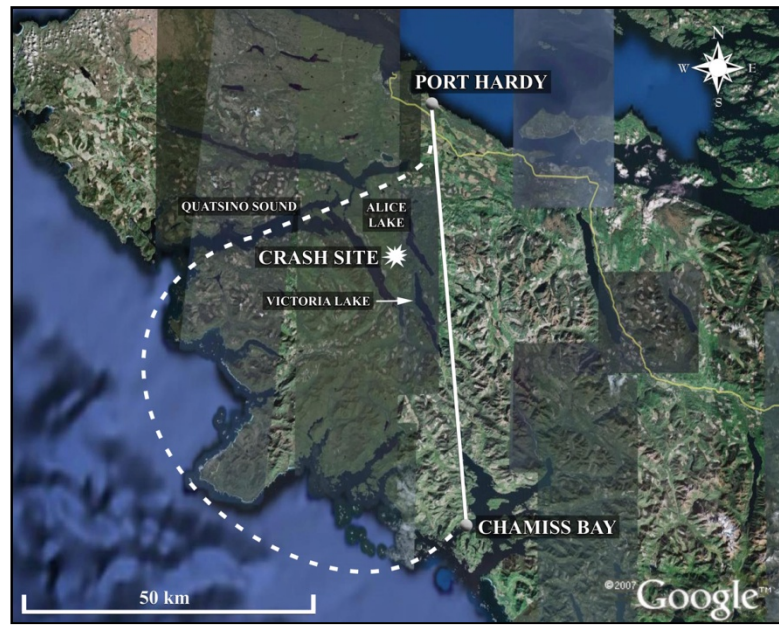
**Figure 1.** Routes and accident site

A direct route from Port Hardy to Chamiss Bay requires flying over a ridge of mountains with heights above 2000 feet asl and takes approximately 30 minutes to complete (see the solid line in Figure 1). In inclement weather, a number of passes are available to facilitate crossing the higher terrain near Alice Lake. Alternately, pilots can proceed south from Port Hardy towards Quatsino Sound, then west down the sound to the Pacific Ocean, then south along the coast to Chamiss Bay (see the dashed line in Figure 1). With the exception of the area immediately south of the Port Hardy Airport, the terrain along this route is much lower; in fact, it is near sea level. However, this route takes 30 minutes longer. In good weather conditions, pilots fly the direct route. In poor weather conditions, pilots typically use one of the passes or take the alternate route along the coast.

The aircraft took off from Port Hardy at 0708 and flew south on the direct track to Chamiss Bay. The flight was conducted clear of cloud and below the overcast ceiling. Several minutes later, the aircraft passed to the west of Alice Lake and east of a northwest-southeast ridge. Spot heights in the surrounding area are in excess of 2000 feet. As the aircraft approached the higher terrain, it began to climb gradually, and then more abruptly, to cross the cloud-covered ridge. Shortly thereafter, the aircraft's nose rose abruptly, the aircraft shuddered, the left wing dropped, and the aircraft descended steeply. The aircraft's wings then levelled and the nose began to rise. Before the aircraft's sink rate could be arrested, it struck the tree tops and fell to the ground beneath a dense canopy of foliage.
