**AVIATION INVESTIGATION REPORT
A08Q0054**

**LOSS OF VISUAL REFERENCES –
COLLISION WITH FROZEN LAKE SURFACE**

**BELL 206B III JET RANGER (HELICOPTER) C-GBKX
RÉSERVOIR GOUIN, QUEBEC
19 MARCH 2008**

Report Number A08Q0054

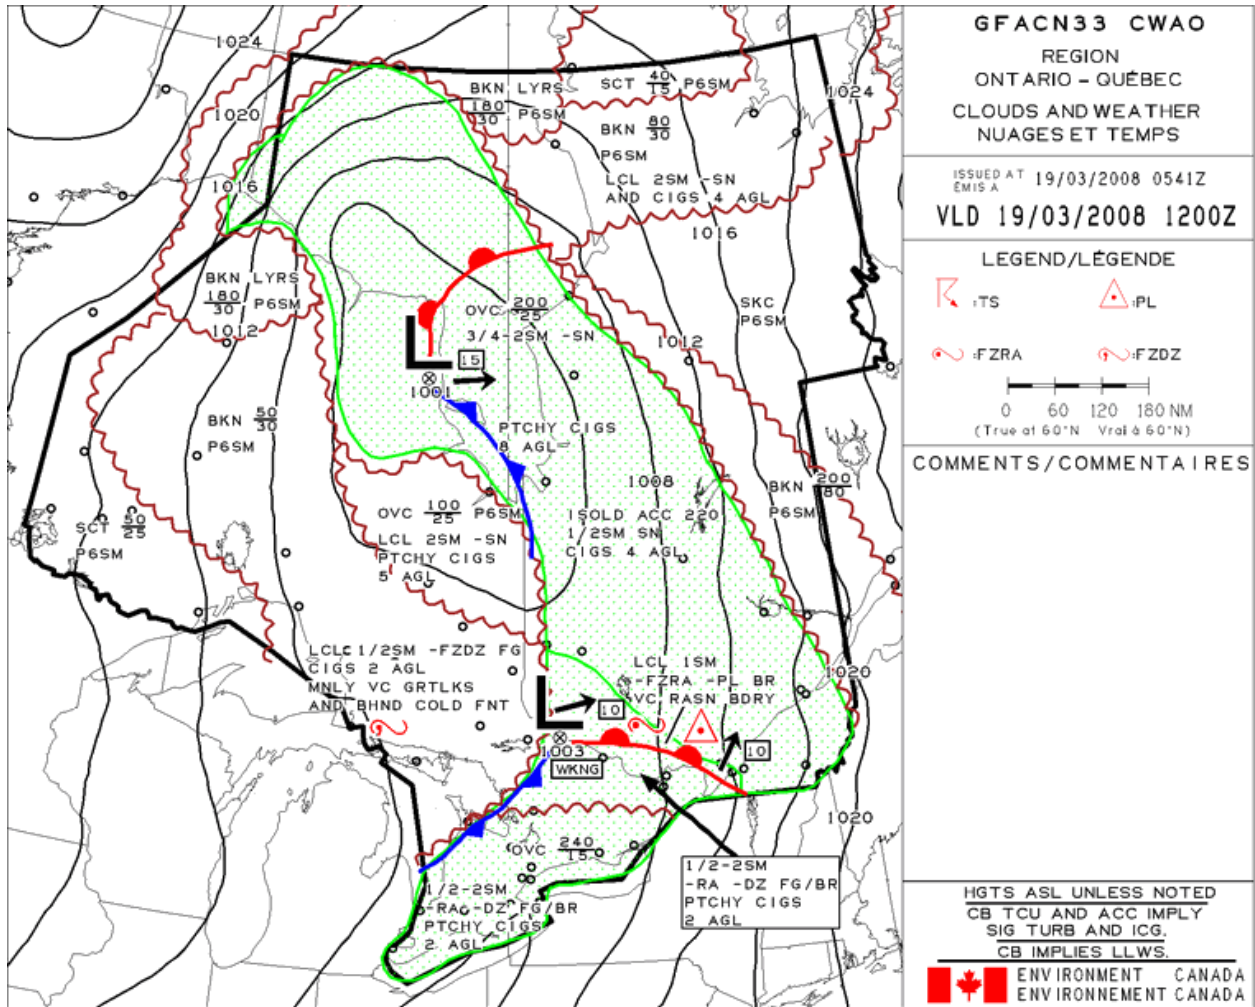
Appendix A – Graphic Area Forecast (GFA)

The Graphic Area Forecast (GFA) weather charts showed a low-pressure system moving eastwardly across Quebec that would have affected the weather in the Réservoir Gouin area by early morning on 19 March 2008 (see Appendix A – Graphic Area Forecast (GFA)). The forecast predicted:

Overcast ceilings between 2500 feet to 20 000 feet, visibility ¾ to 2 statute miles (sm) in light snow showers and patchy ceilings at 800 feet agl.
Isolated altocumulus castellanus cloud at 22 000 feet, ½ sm visibility in snow showers with patchy ceilings 400 feet agl. Locally 1 sm visibility in light snow pellets in vicinity of the rain-snow boundary.

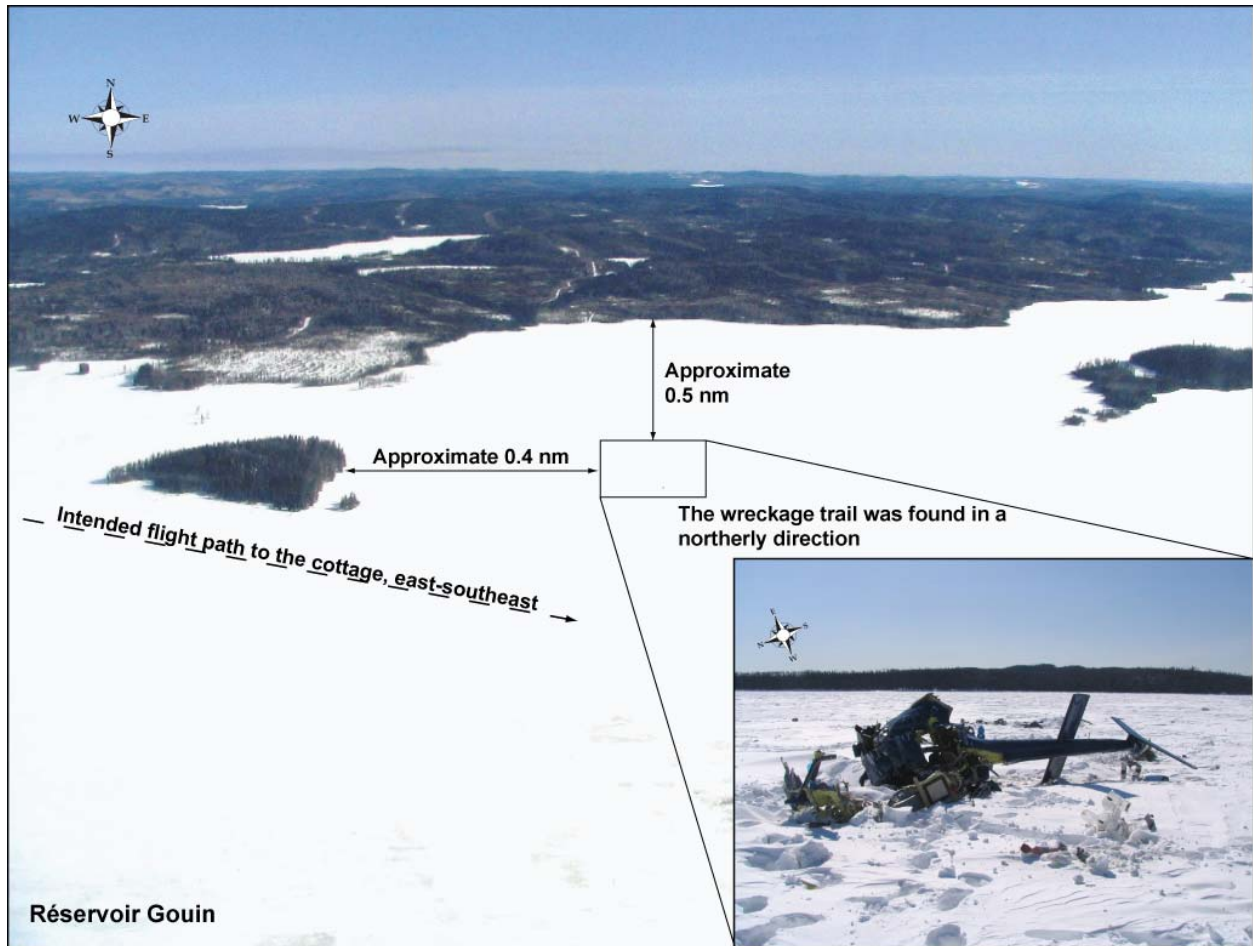
Appendix B – Site Diagram

Réservoir Gouin is a large, irregular-shaped body of water extending 55 nm east-west and 40 nm north-south. It is situated in Class G uncontrolled domestic airspace. The irregular-shaped shoreline made up of multiple inlets, fingers, and islands makes it particularly difficult to navigate especially in poor weather. The weather at the time of the occurrence was fluctuating between VMC and IMC. The environment was conducive to whiteout conditions where the degree of contrast was low due to the overcast, obscure sky, flat light, reduced visibility in snow showers and the snow-covered reservoir. Upon taking off in an easterly direction, the pilot had a finger of trees as a reference below the helicopter and the expanse of the white snow-covered reservoir surface in front of him (see Appendix B – Site Diagram).
