AVIATION INVESTIGATION REPORT

A08Q0171

RUNWAY EXCURSION

BOEING 747-428 F-GITC

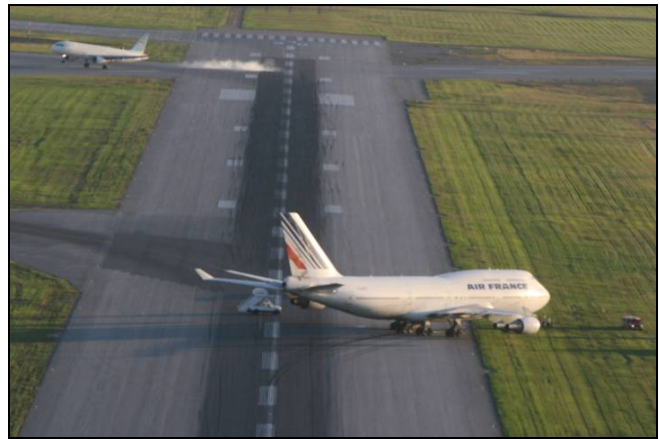
At approximately 45 knots, as the thrust reversers were stowed and the autobrake disengaged, the aircraft veered to the right. A combination of forward nose wheel tiller and full left rudder inputs were used in an attempt to stop the turn. However, the rate of turn increased rapidly. Maximum brake pressure was then applied and the aircraft came to a complete stop at 2148 on a heading of 277°M, with the nose wheels 26 feet off the right side of the runway surface (see Photo 1).

Photo 1. Aircraft on the right side of the runway.

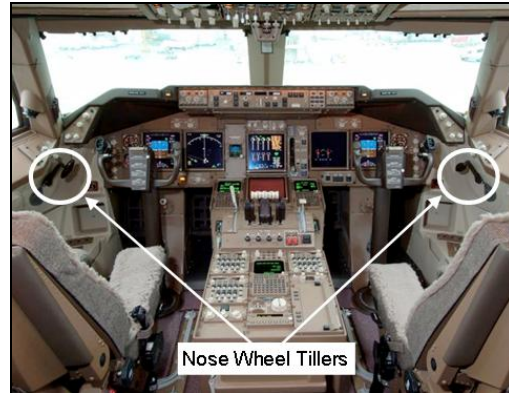
A hydraulically powered nose wheel steering is controlled by a tiller for each pilot to provide the primary low-speed steering of the aircraft on the ground (see Photo 2). A tiller movement of 150° clockwise will turn the nose wheels to the maximum steering angle of 70° to the right.⁸ A pointer on the tiller indicates the position relative to the neutral/centred position. A caution label is also located near the pointer, advising personnel not to hold or turn the tiller while towing the airplane (see Photo 3).⁹

Photo 2. Location of the tillers

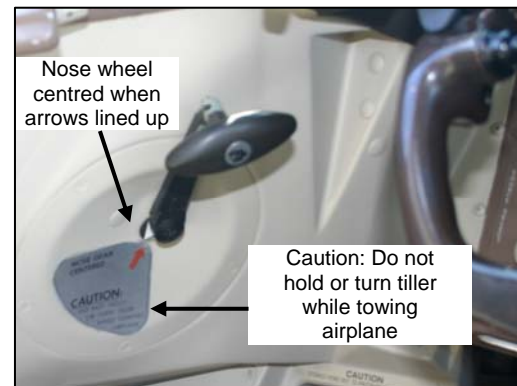
Photo 3. Close-up of left-hand tiller

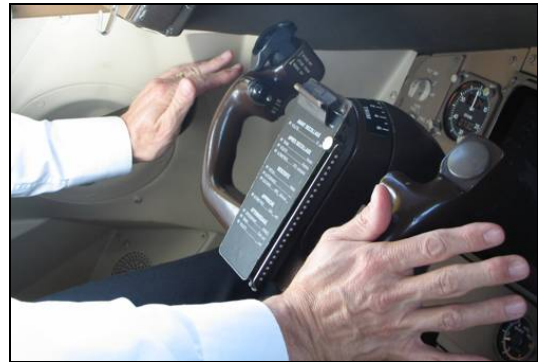
Photo 4. Tiller and control column forward

The forward displacement of the pilot's arm when pushing the control column to a near full forward position is equivalent to a forward movement of 50 to 60° of the tiller (see Photo 4), resulting in a 25 to 30° nose wheel deflection to the right.

Although the initial nose wheel tiller input can not be explained, the arm's angular position corresponds to an equivalent angular position it had when it was on the control column one second earlier. It is possible that the PF inadvertently pushed the tiller forward thinking it was the control column.

Air France distributed an internal memo to all B744 crews describing the event and reviewing the recommended use of the tiller.

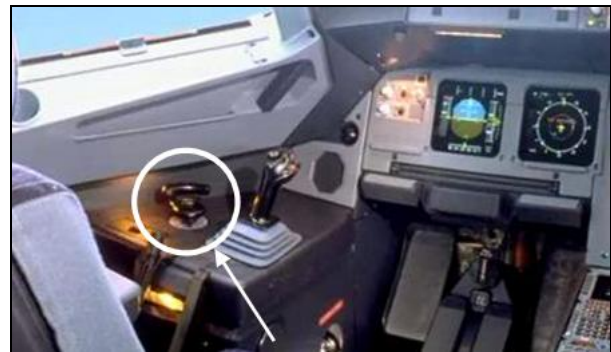
The aircraft previously flown by the captain, an A320, was equipped with nose wheel tillers located at knee height for both pilots (see Photo 5). The tillers operate on a horizontal plane with a left-right movement to turn the aircraft on the ground. The usual handling of either tiller is to lower the arm, grasp the top of the handle, and move the tiller by moving the wrist. The position of the nose wheel tiller on the A320 aircraft is lower and further outboard in relation to the tiller on the B744.

Photo 5. A320 Nose wheel tiller

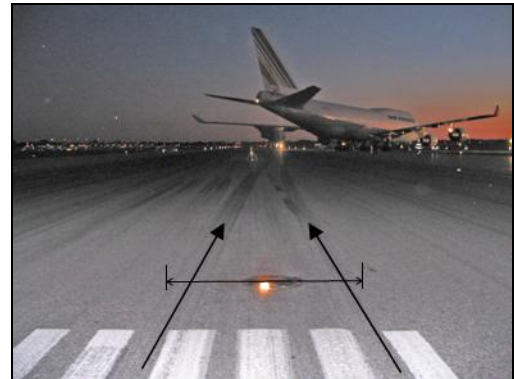
The nose wheel skid marks commence in a straight line on the runway centreline and remain on the centreline markings and centreline lighting over a distance of approximately 600 feet. The skid marks then move towards the right edge of the runway, resulting in a total skid distance of approximately 1160 feet (see Photo 6). The nose wheels came to rest 26 feet past the right edge of the runway.

Photo 6. Nose wheel skid marks

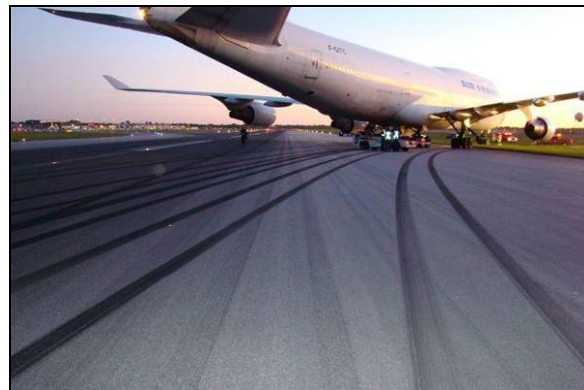
The main landing gear tire skid marks commence approximately 800 feet after the nose wheels began to skid, and continued for approximately 210 feet. The right main landing gear tires stopped 9 feet from the edge of the runway (see Photo 7).

Photo 7. Main gear tire marks (heavy braking)

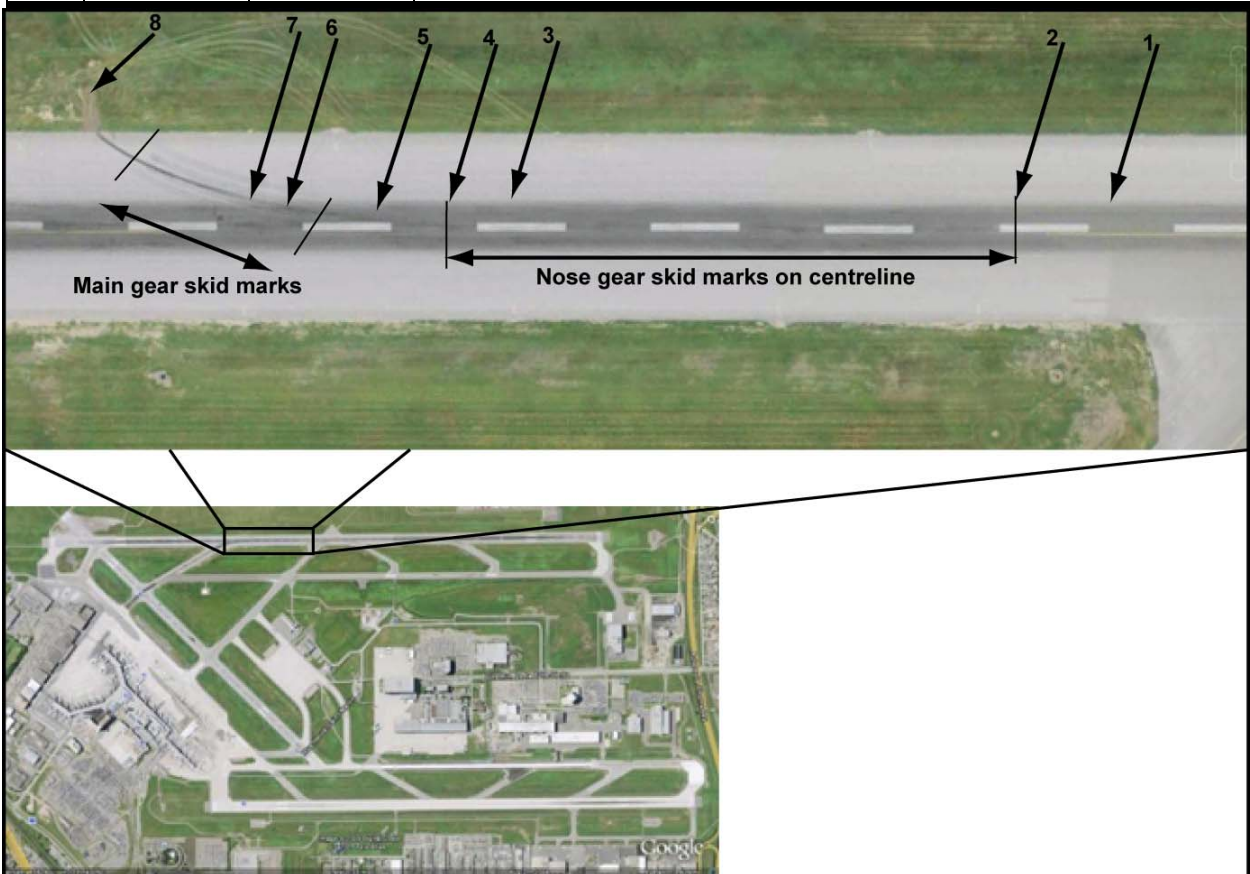
#	Time	Speed (k)	Event
1	21:45:12	66	Control column reaches neutral from forward deflection, lateral g to the right followed by a short left rudder correction
2	21:45:13	63	Nose wheel skid marks on the runway centreline begin as a result of an approximate 25° nosewheel deflection
3	21:45:19	47	Reversers stowed
4	21:45:20	45	Autobrakes disengaged, nose wheel skid marks leave runway centreline, aircraft heading increases
5	21:45:21	44	Rudder reaches full left position and tiller deflection is increased
6	21:45:23	43	Max. brakes are applied
7	21:45:24	40	Main gear skid marks appear on the runway
8	21:45:30	0	Aircraft stops

Figure 1. Landing rollout events
