AVIATION INVESTIGATION REPORT
A08Q0231

CONTROLLED FLIGHT INTO WATER

ROBINSON R44 RAVEN I (HELICOPTER) C-GSVX
LAC SIMON, QUEBEC
03 DECEMBER 2008

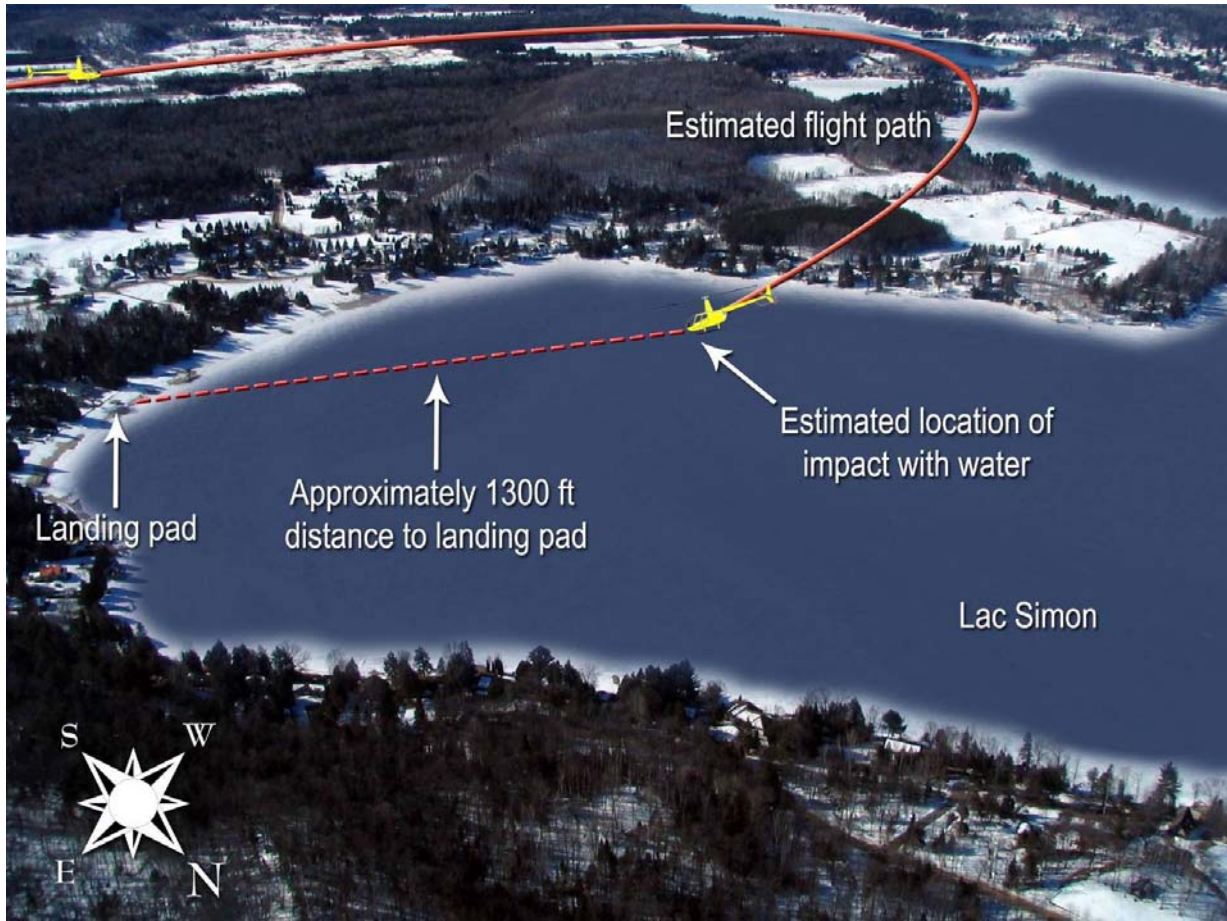
Appendix A - Estimated Robinson R44 Flight Path before Impact with Water

Upon arriving at Lac Simon at approximately 1800,¹ the pilot circled the cottage once, then flew by from the southwest side of the bay at approximately 150 feet above ground level (agl) and turned right over the open water for the final approach to the lit landing pad (see Appendix A – Estimated Robinson R44 Flight Path before Impact with Water). The landing pad was equipped with four low-intensity, solar-powered, light-emitting diode (LED) lights; three of the four lights were functional. A small bonfire was visible between the cottage and the landing pad. The helicopter's landing lights were on. Because it was off-season for cottagers, few lights from surrounding dwellings were lit. Only a few street lights were illuminated on the street that contours the bay. After executing a right-hand turn onto final approach, the helicopter descended below the normal final approach glide path to the landing pad and collided with the surface of the water. The helicopter was at an estimated speed of less than 20 knots at the time of impact and flipped on its left side.

While the weather conditions were appropriate for VFR flight at night, the dark lighting conditions of the surrounding area and the approach over the dark surface of the lake provided ideal conditions for the black hole illusion. It is likely that as a result of this illusion, the pilot believed the helicopter was higher than it was during the approach to land. The pilot unknowingly flew the helicopter lower than the intended approach path, causing the helicopter to collide with the surface of the water well before reaching the desired landing area.
