**AVIATION INVESTIGATION REPORT  
A08W0001**

**RUNWAY OVERRUN**

**NORTHWESTERN AIR LEASE LIMITED  
BRITISH AEROSPACE JETSTREAM 3212 C-FNAE  
FORT SMITH, NORTHWEST TERRITORIES  
04 JANUARY 2008**

Report Number A08W0001

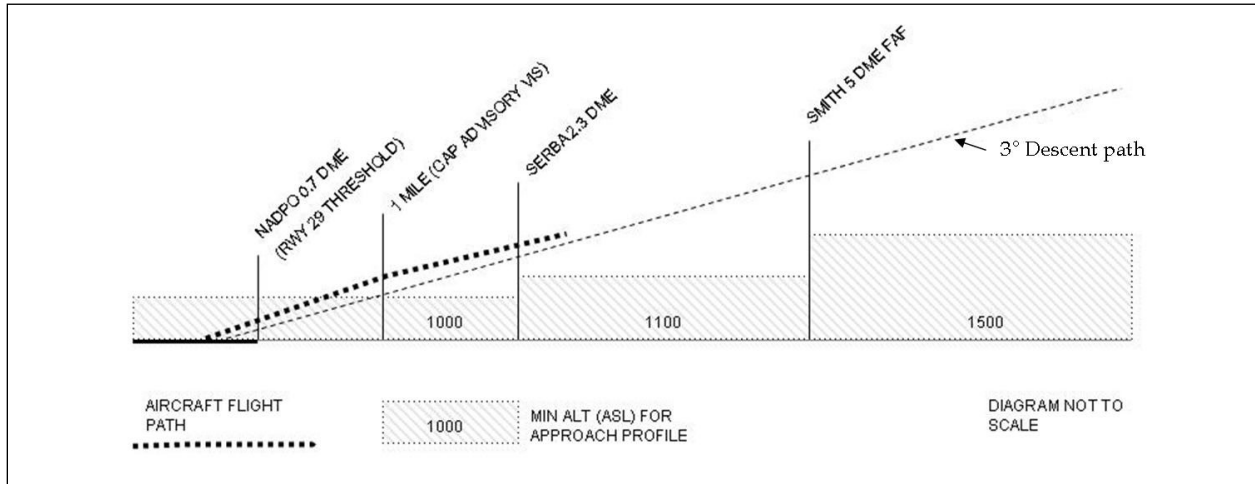
Figure 1. Approach profile

At the 2.3 DME SERBA fix, the aircraft was 200 to 300 feet above the minimum crossing altitude of 1100 feet asl. In accordance with standard operating procedures (SOPs), the crew had added approximately 10 knots to the  $V_{ref}$  of 112 knots<sup>5</sup> due to the existence of light ice observed on the engine inlets during the descent.

The reported ground visibility was below the CAP<sup>6</sup> advisory visibility. However, the runway clearway and runway identification strobe lights became visible between 1 and 1.5 DME, and the captain transitioned to visual manoeuvring and called for flaps to be increased from 20 degrees to 35 degrees. At that time, the aircraft was between 1200 and 1300 feet asl, which was 200 to 300 feet above the minimum descent altitude for the approach, and between 0.3 and 0.8 nautical miles from the missed approach point. When the VASIS became visible at approximately 1000 feet from the threshold, it displayed 4 white lights, indicating that the aircraft was above the optimum glide path for a normal touchdown. At that point the aircraft was at 500 feet agl. Engine power was reduced, and the descent steepened in an attempt to regain the optimum glide path on the VASIS. The airspeed increased to between 132 and 137 knots.

When the VASIS became visible, the first officer informed the captain that the aircraft was high on the approach. The approach was continued to the landing and a go-around was not proposed by either pilot.

When the VASIS became visible, the aircraft was above the optimum glide path for a touchdown in the first 1000 feet of the runway. In the attempt to regain the glide path, the pilot allowed the airspeed to increase to at least 20 knots above  $V_{ref}$ . By the time the aircraft decelerated to a speed allowing a firm touch-down, a considerable portion of the runway was over-flown. The remaining 3400 feet would have been sufficient for the aircraft to stop on a bare, dry runway after a touchdown at, or near,  $V_{ref}$ ; however, at a higher touchdown speed on a runway with a CRFI of 0.18 or 0.34, stopping in this distance could not be assured. Conservative CRFI charted landing distances are designed to cue flight crews to consider aircraft performance options for landing. Reference to CRFI charts prior to the approach would likely have prompted the crew of PLR 599 to consider rejecting the landing when the airspeed and height profile exceeded normal parameters.

1. The descent profile on final approach was above the optimal approach path for a landing in the runway touchdown zone. The aircraft landed about 3400 feet from the end of the runway, which afforded insufficient distance to stop on the slippery runway surface.

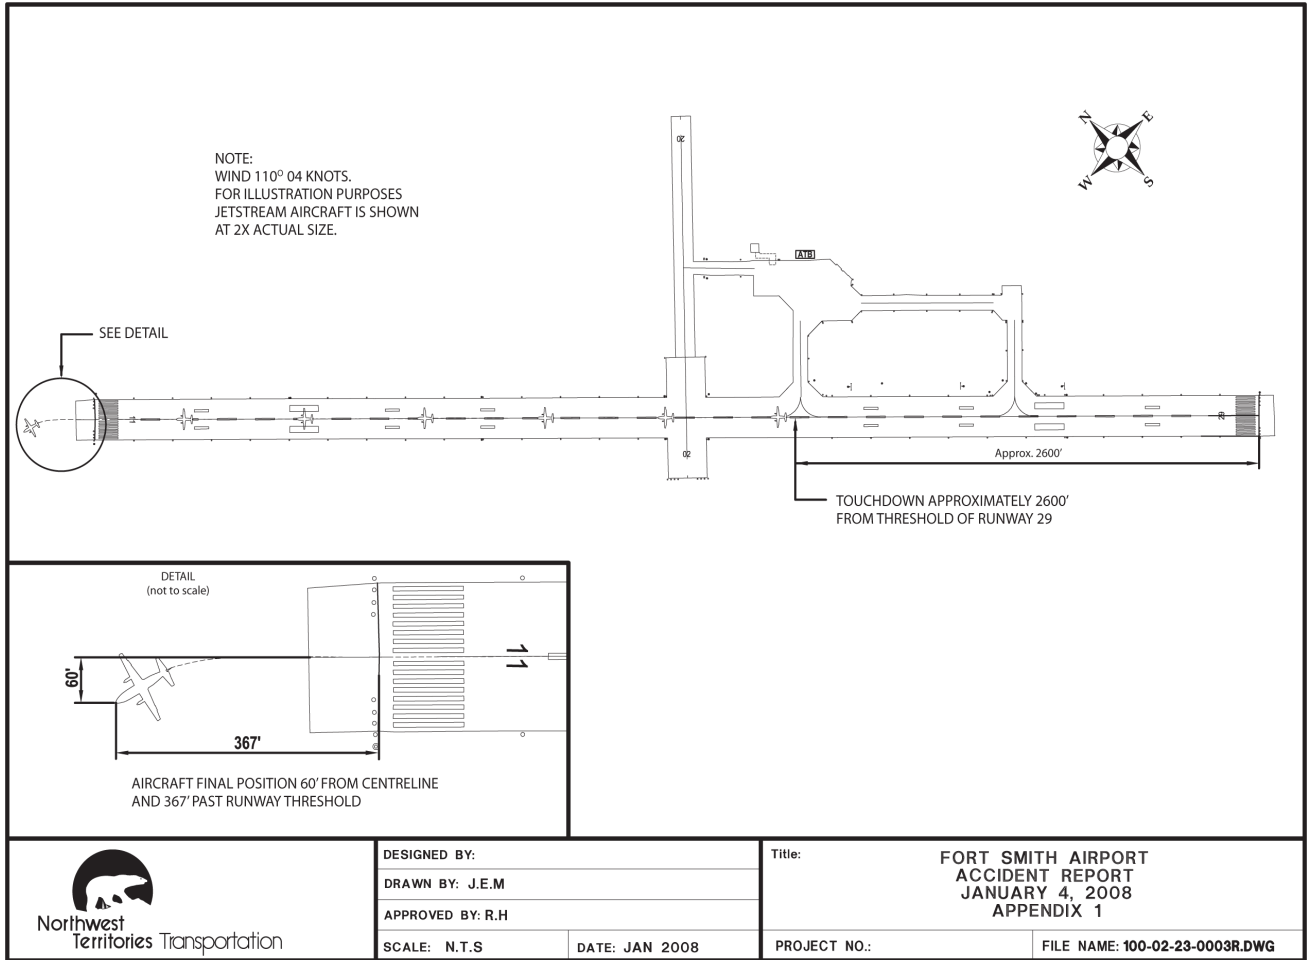
# Appendix A - Site Diagram

The aircraft touched down on the centreline of the runway at about 2600 feet from the threshold (see Appendix A - Site Diagram). About 3400 feet of runway remained in which to stop. The touchdown airspeed was at about 120 knots, or 8 knots above the airspeed recommended in the aircraft flight manual (AFM). The power levers were brought to flight idle and after the aircraft slowed to 90 knots, reverse thrust was selected in accordance with flight manual procedures.

Maximum braking with anti-skid was then applied. Braking action was reported to be poor during the landing roll. As the aircraft overran the paved surface, the PF steered the aircraft to the left to avoid the approach lights for Runway 11. During this turn, the right propeller contacted the snow, curling the tips of all four blades. There was no other damage to the aircraft. Steam emanating from the right engine due to snow ingestion was cleared by conducting a venting run on the engine. The passengers were briefed on the situation by the captain and were evacuated by vehicles within 15 minutes.
