AVIATION INVESTIGATION REPORT

A09Q0111

CONTROLLED FLIGHT INTO TERRAIN

BELL 206L (HELICOPTER) C-GNLK

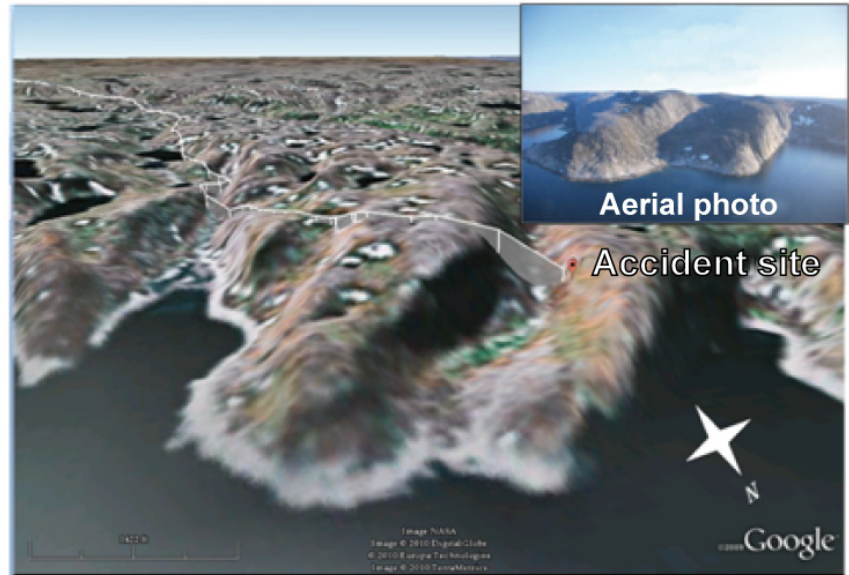
Figure 1. Trajectory recorded by the global positioning system (GPS)

The accident occurred a little under 1 nm from the Hudson Strait in a coastal valley lying 36 nm southeast of Kangiqsujuaq. The valley is about 2300 feet wide and runs inland toward the west between two rocky escarpments. The elevation of the ridgeline on the south side is 1050 feet asl, and that of the north ridgeline is about 820 feet asl. The aircraft was on a northerly heading when it struck the north wall of the valley at about 700 feet asl.

At the time of impact, the aircraft was in a nose-up attitude of about 30°. The collision trajectory was at an angle of about 45° to the right in relation to the valley. The aircraft was destroyed by impact forces. The main components were projected to the right of the point of impact. Several fires fed by the aircraft's fuel broke out after the collision. The accident was not survivable.

The accident occurred just under 1 nm from the coast while the aircraft was traversing a valley. The GPS data indicate an increase in speed and a loss of altitude after the northbound aircraft flew over the summit of the south wall of the valley. It is possible that the pilot was not aware of his geographical position. If that was the case, he did not know he was about to traverse a valley. The need to maintain visual references therefore led the pilot to follow the downward slope in conditions of reduced visibility. Taking into account his speed, the pilot was unable to avoid the north wall of the valley.

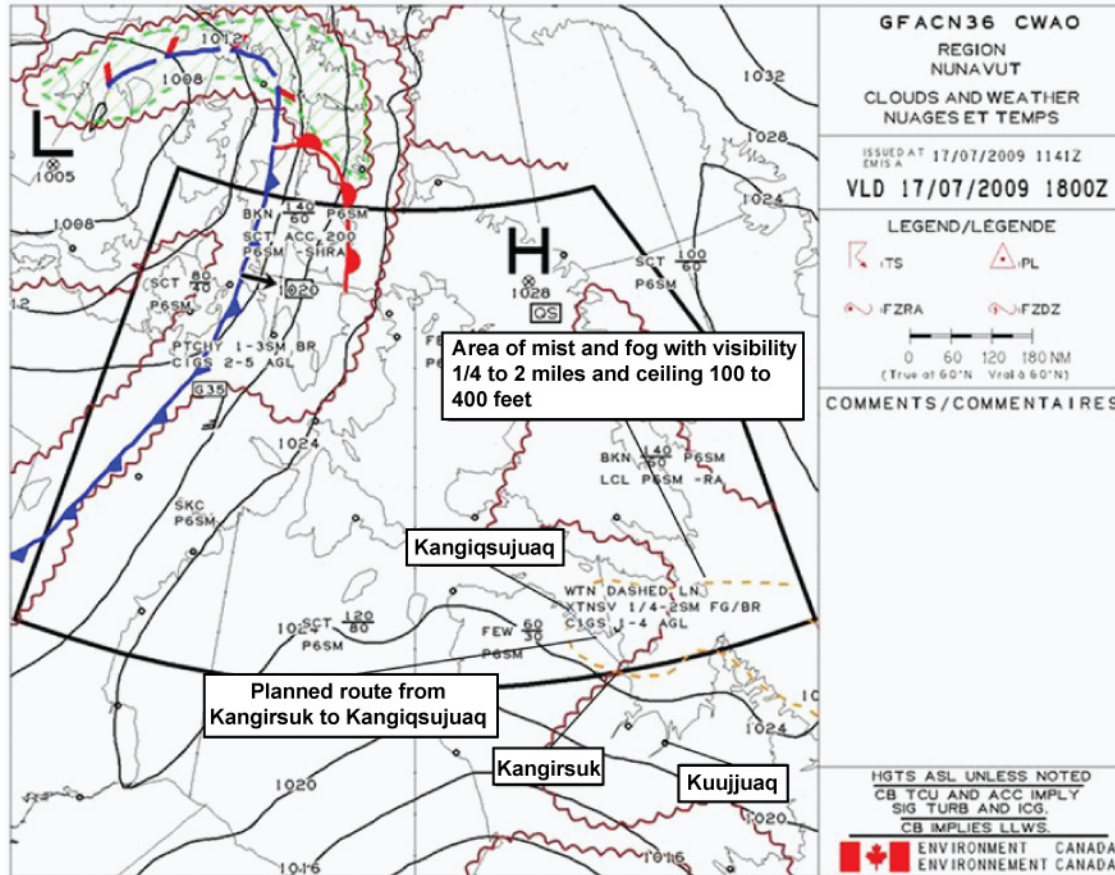
Appendix A – Graphic Area Forecast (GFA)

The GFAs issued at 0141, 0741, and 1341 (see 0741 GFA at Appendix A) indicate a few clouds based at 3000 asl with tops at 6000 feet asl ¹¹ with visibility over 6 sm. ¹² The forecast for the incident area called for a fog bank ¹³ reducing visibility to between 1/4 and 2 sm in mist and fog with ceiling of 100 to 400 feet agl. ¹⁴

For an undetermined reason, the pilot did not call the FIC at Québec to request a printout of the GFA. Because the pilot could have obtained weather information from the Internet, it cannot be stated without a doubt that he did not check the GFA before going to the airport. However, if he had done so, especially being an airline pilot, he would have easily seen that the GFA for the region called for visibilities of ¼ sm to 2 sm in mist/fog and ceilings of 100 to 200 feet between Kangirsuk and Kangiqsujaq in the coastal area and over the Hudson Strait. Also, by analyzing the GFA he would have seen that the mist was clearing over the land to the west of the shoreline. Given his qualifications, the route he elected to fly and the diversion route he chose, it is unlikely that the pilot checked the GFA on the Internet. Furthermore, it appears that the weather information obtained from the CHL Goose Bay base did not enable the pilot to conceptualize the information provided in the GFA for the region.

Second, the pilot could have diverted west and proceeded farther inland. There is reason to believe that if the pilot had checked the GFA before taking off from Kuujjuaq, he would have chosen that option (see Appendix A). The rolling terrain was suitable for low-level flight, and the area of mist/fog was clearing to the west. A thorough analysis of the full weather picture and the planned route would have enabled the pilot to choose that option.
