AVIATION INVESTIGATION REPORT A10O0089

RISK OF COLLISION

**NAV CANADA - TORONTO AREA CONTROL CENTRE
TORONTO / BILLY BISHOP TORONTO CITY AIRPORT
TORONTO, ONTARIO, 6 NM SE
11 MAY 2010**

Report Number A10O0089

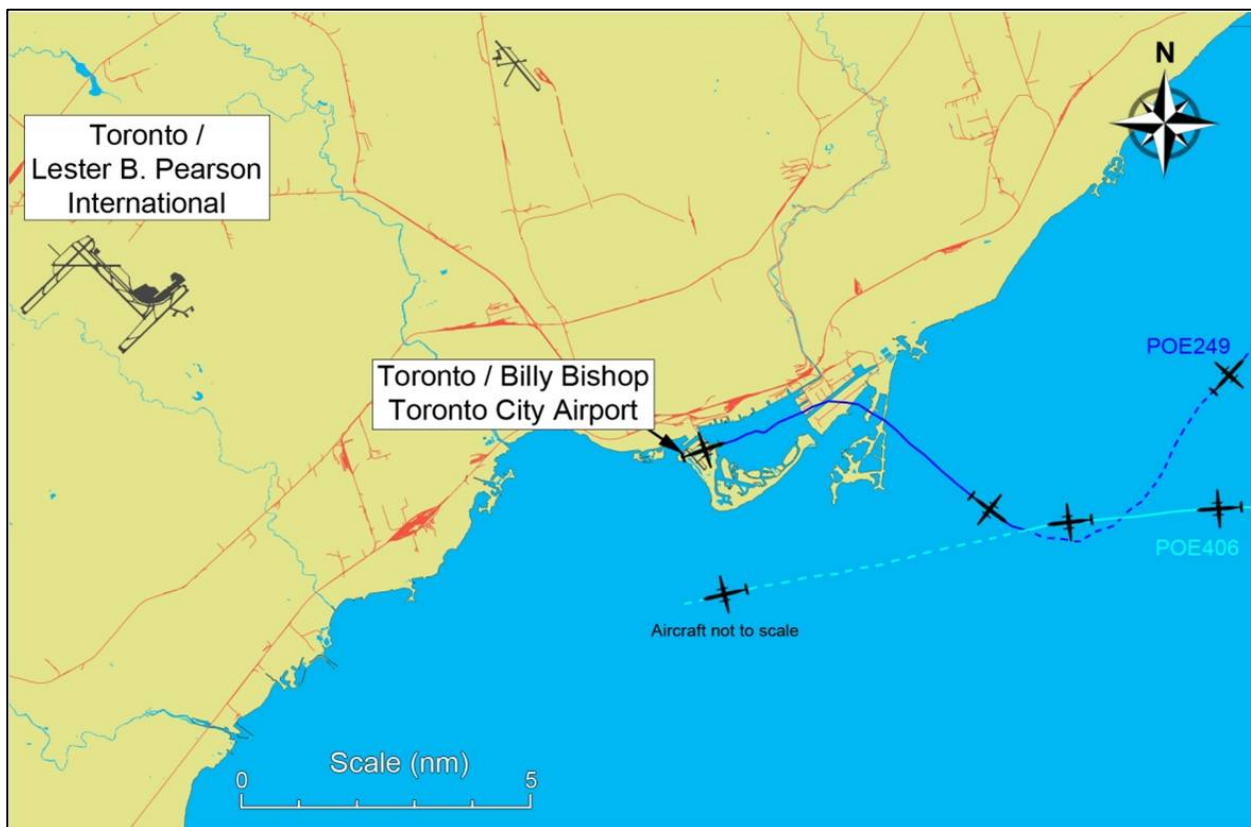
Figure 1. Flight Paths

For 10 seconds, another aircraft transmitted on the frequency. During this time, both POE249 and POE406 received and responded to their respective traffic collision avoidance system (TCAS) resolution advisories. Seconds later, POE249 and POE406 crossed paths 300 feet vertically apart, 6 nm east southeast of Billy Bishop Airport (see Figure 1).
