# **AVIATION INVESTIGATION REPORT**

## **A10O0101**

**POWER LOSS AND COLLISION WITH BUILDING**

**CIRRUS SR20 C-GYPJ**

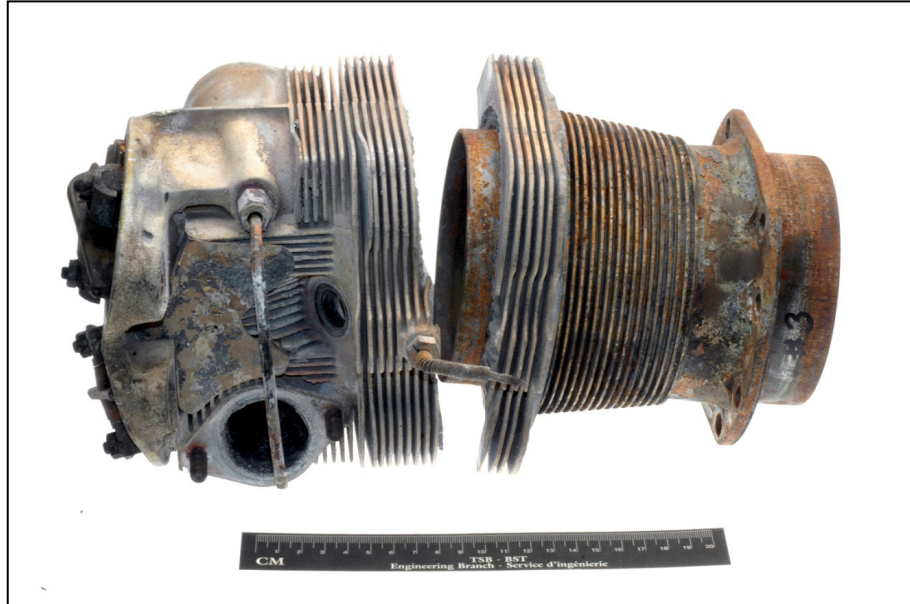
Examination of the engine showed that the number 3 cylinder head had separated from the barrel (see Figure 1). The cylinder head remained held in place by the induction and exhaust systems. No other abnormalities were found with the engine that would have prevented it from producing power.

**Figure 1.** Number 3 cylinder after removal from the engine

cylinder head showed it had failed near the second and third threads and there were visible signs of fatigue on the fracture surface; externally this would be at the roots of cooling fins 4, 5 and 6.<sup>3</sup>

A high cycle fatigue crack originated from the notch<sup>4</sup> created by the sharp edge of the steel barrel thread crest on the aluminum thread flank of cylinder 3. Once the crack dimension had grown to a critical size, the remaining load-bearing section could no longer withstand the load and the head separated in a single-cycle overstress. Although no specific defects were observed in the region of the cylinder where fatigue initiated, this region had post-fracture rubbing damage masking the original features.

The fatigue crack in the number 3 cylinder head developed at the notch created by the steel threads of the barrel. Given its location, there are no practical means of non-destructive testing that would identify a crack. A crack in a cylinder head could go undetected and the engine would continue to operate normally until the crack reached a critical dimension, at which point the cylinder head would fail in overload without warning. This would result in a reduction of power, a rough running engine or a complete engine failure.

1. The number 3 cylinder head failed in fatigue and separated from the cylinder during takeoff, resulting in reduced power from the engine.
2. While manoeuvring, the aircraft stalled and entered a spin at an altitude from which recovery was impossible.
