**AVIATION INVESTIGATION REPORT  
A10P0242**

**LOSS OF ENGINE POWER AND LANDING ROLLOVER**

**TRANSWEST HELICOPTERS LTD.  
BELL 214B-1 (HELICOPTER), C-GTWV  
LILLOOET, BRITISH COLUMBIA, 20 NM NW  
29 JULY 2010**

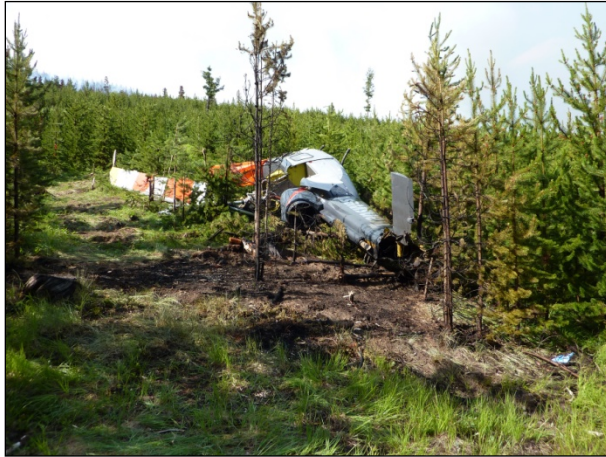
**Photo 1.** Helicopter wreckage

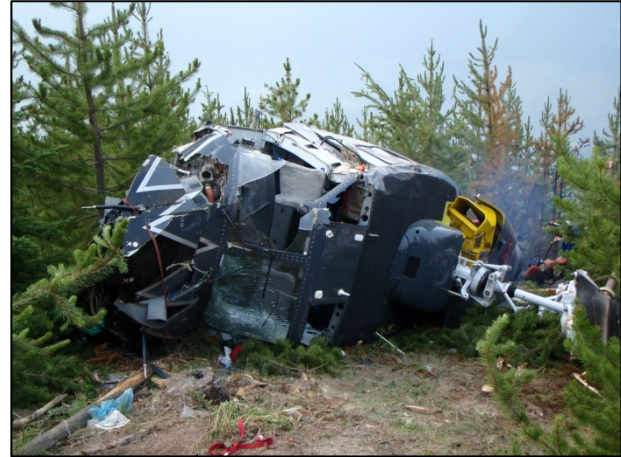
**Photo 2.** Cockpit and cabin damage

The forces induced by the yaw at impact contributed to the nature of the injuries. Both pilots were wearing helmets. During the impact and subsequent rollover, the right side of the helmet of the PIC in the left-hand seat hit the forward door frame; the PIC sustained acceleration-deceleration injuries to the head and neck as a result.

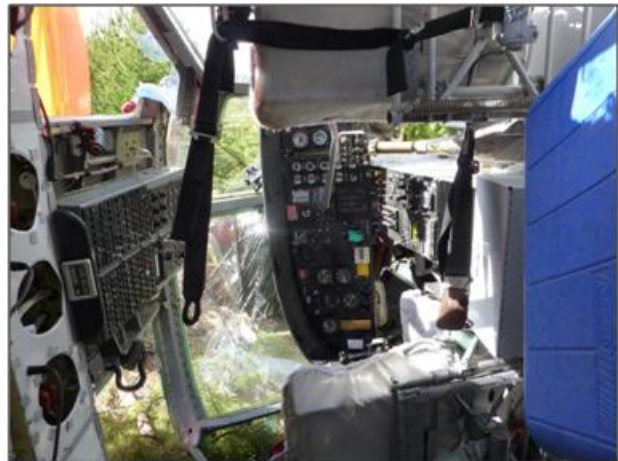
**Photo 3.** Helicopter cabin on its side

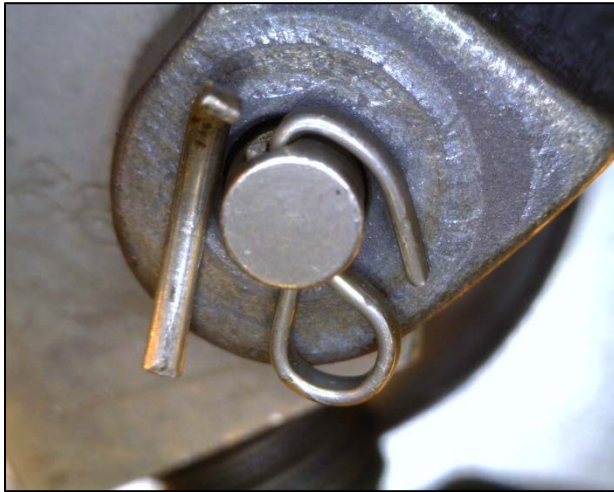
- A cotter pin<sup>9</sup> leg from the linkage-position adjustment group (Photo 4), that had broken off before the occurrence due to fatigue, caused by rubbing. The cotter pin is located next to the ratio servo flapper-valve. The fatigue fracture was caused by the contact and mutual movement of the cotter pin and the speed-adjustment lever. Unlike references to other cotter-pin installations in the linkage housing section of the FCU, Figure 5-13 and instruction 5-14.b of the *Hamilton Sundstrand Component Maintenance Manual (CMM) F3120* do not refer to a washer at that location, and none was installed. The absence of a washer is inconsistent with standard practice for this type of application. A washer is normally installed to reduce the risk of fatigue failure due to rubbing.<sup>10</sup>

**Photo 4.** Fractured cotter pin

The investigation determined that the cotter pin from the N2 linkage-position adjustment group broke as a result of a fatigue fracture caused by contact with and mutual movement of the speed adjustment lever. According to Figure 5-13 and instruction 5-14.b of component maintenance manual F3120, installation of a washer at the cotter-pin location of the N2 linkage-position adjustment group was not required. This lack of requirement is inconsistent with standard practice for similar applications, where relative or mutual movement of parts can cause wear, generate debris, and ultimately result in fractures. As a result, there was increased risk of fatigue failure during flight operations.

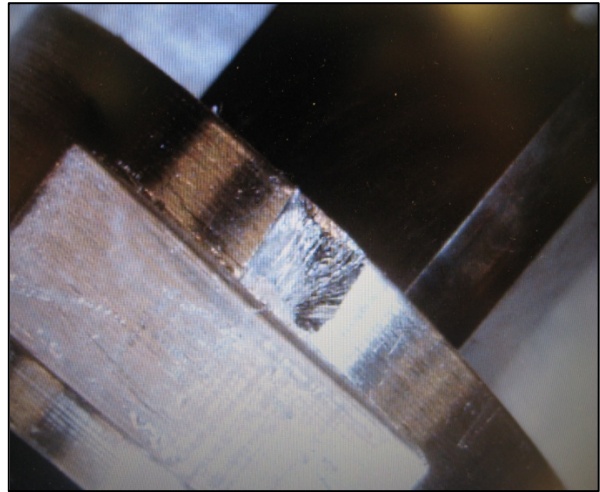
- A fragment fractured from the flange of the N1 servo-valve sleeve (Photo 5). The initial crack in the flange pre-dated the occurrence, and the separation of the fragment likely also happened before the occurrence. In 1985, Hamilton Sundstrand issued a service bulletin (SB) intended to provide servo-valve sleeve-retention slots with improved durability.<sup>11</sup> Only the N2 servo-valve had been modified in accordance with this SB. The modification had not

**Photo 5.** Chipped N1 servo-valve flange

The FCU's N1 servo-valve sleeve had a fractured retention slot/flange. This type of servo valve is also used on other aircraft types. Therefore, if SB JFC31 No. 3012 is not applied to other aircraft types that utilize similar fuel-control servo-valve sleeves, those aircraft may be at risk for similar fractures.

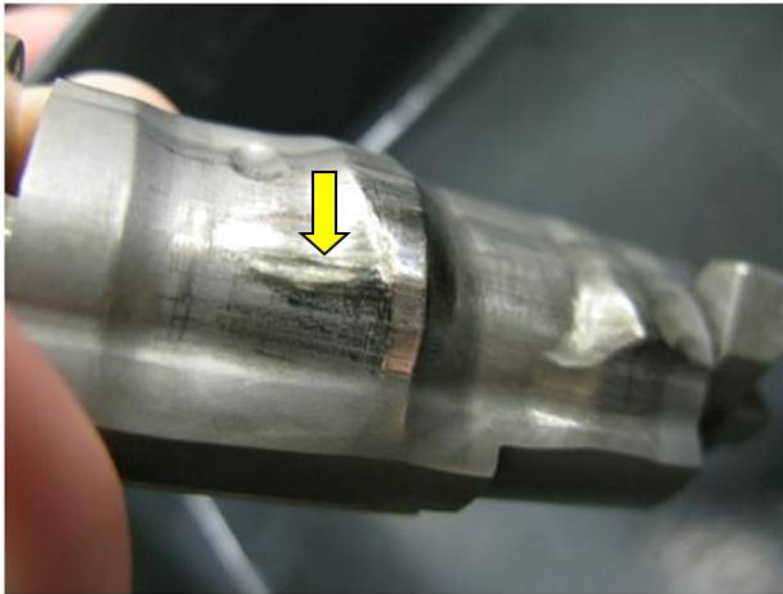
According to Hamilton Sundstrand, wear to the contours of the 3D cam <sup>12</sup> beyond the limits specified in the CMM may result in fuel-scheduling anomalies. During the disassembly of the occurrence FCU at the manufacturer's facility, a wear groove reported as unusual was observed on the 3D cam (Photo 6). However, no previous fuel-scheduling anomalies had been reported or recorded in the journey log of the occurrence helicopter. As a result, the 3D cam was sent to the TSB Laboratory, where it could be evaluated for its possible contribution to the power loss experienced during the occurrence. Testing conducted by the TSB Laboratory determined that the wear was within the limits specified by the manufacturer. This type of wear was indicative of solid-to-solid wear interaction between the 3D cam and the cam follower surfaces, and indicated that small metal particles were being removed from the contact surfaces of the cam and the followers.

**Photo 6.** Wear on 3D cam
