**AVIATION INVESTIGATION REPORT
A11H0003**

RUNWAY EXCURSION

**TRANS STATES AIRLINES LLC
EMBRAER EMB-145LR, N840HK
OTTAWA/MACDONALD-CARTIER INTERNATIONAL
AIRPORT, OTTAWA, ONTARIO
04 SEPTEMBER 2011**

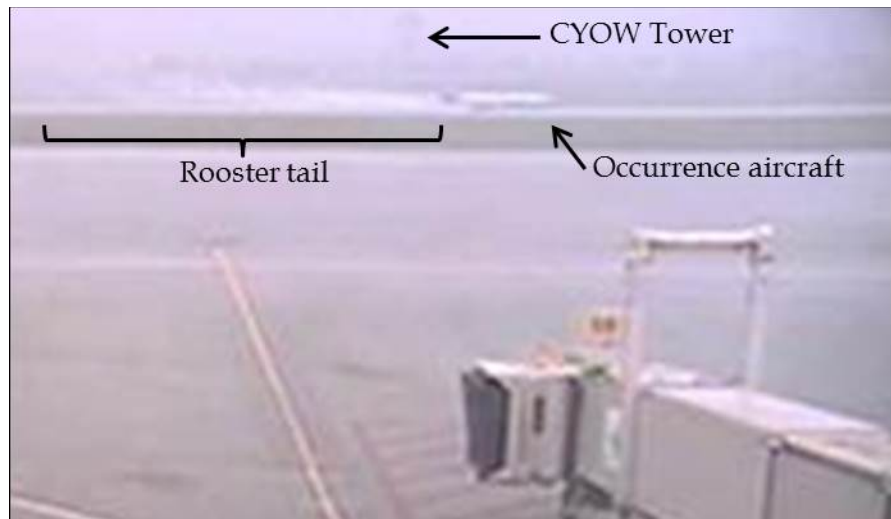
Photo 1. Surveillance video image of occurrence aircraft landing

Sufficient water was present on the runway surface to cause the aircraft tires to send a spray of water, commonly known as a rooster tail, to a height of over 22 feet, trailing over 300 feet behind the aircraft (Photo 1).

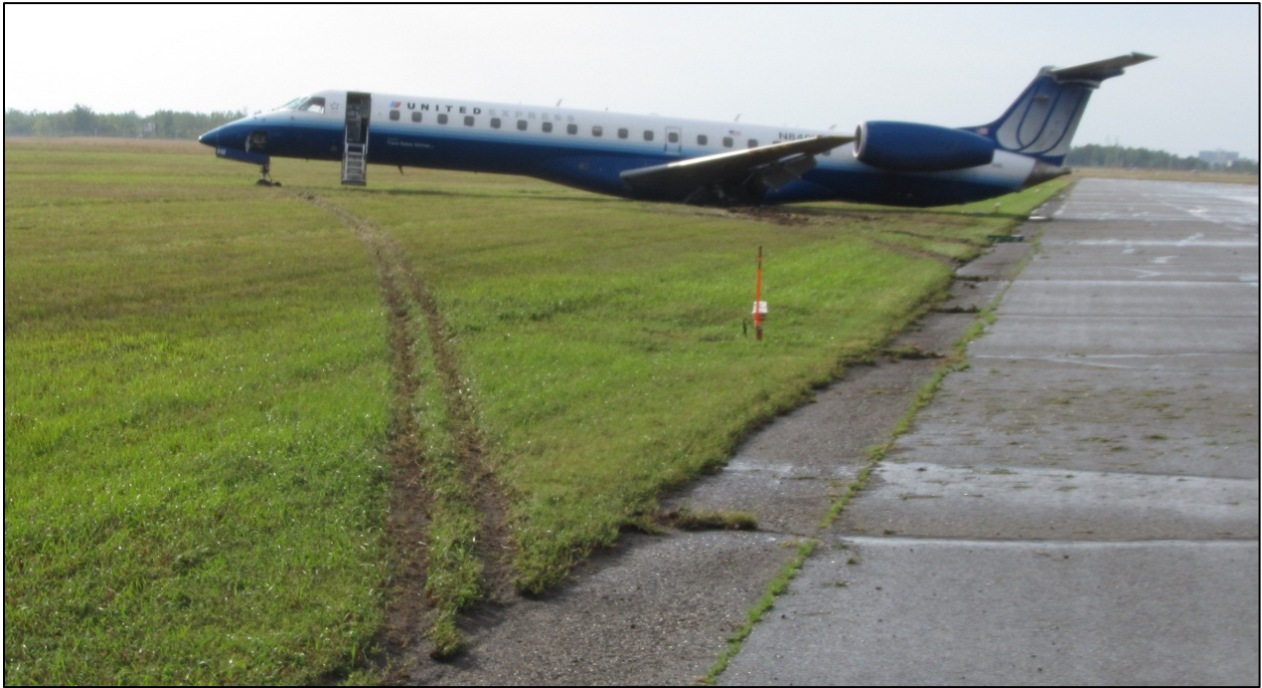
The aircraft was substantially damaged when the main landing gear collapsed. The lower surface of the left wing was damaged, causing a fuel leak (Photo 2).

Photo 2. Occurrence aircraft off Runway 32

All 3 landing gear assemblies, as well as various hydraulic, electrical and flight control systems, sustained damage. The right main landing gear bay, right wing leading and trailing edges, right inboard and outboard flaps and flap actuators, and the wing-to-fuselage fairings sustained damage. The lower surface of the left wing was penetrated, allowing fuel to be released.

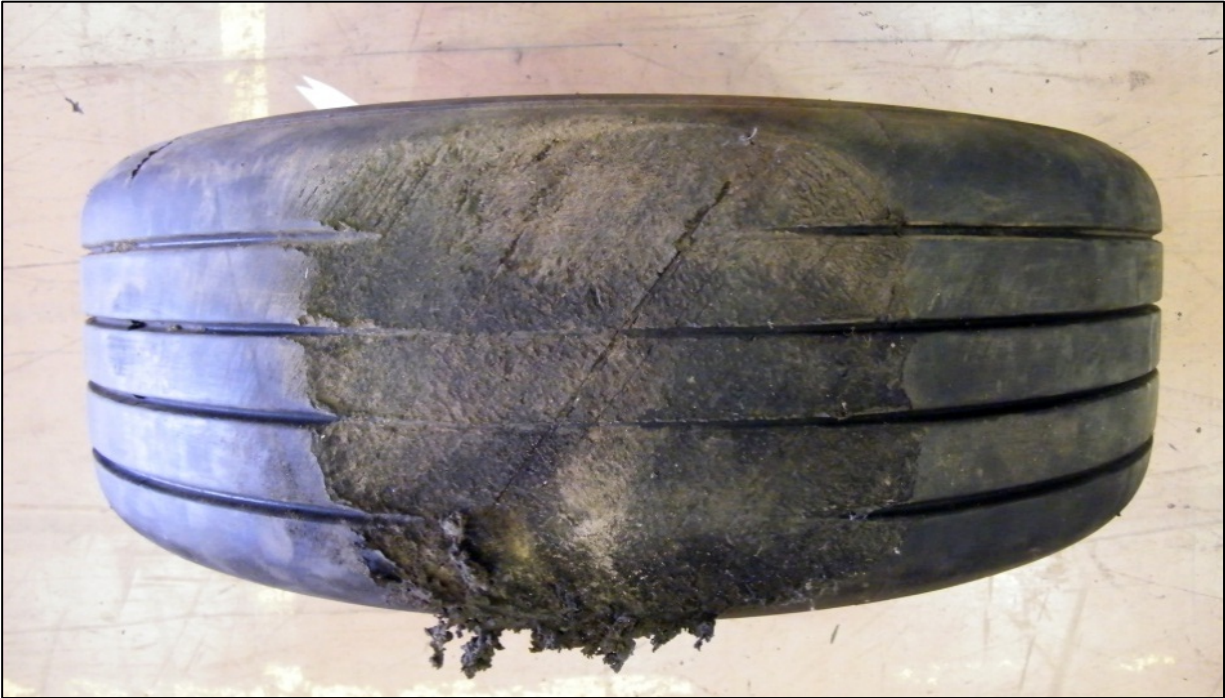
Photo 3. Damage seen on main landing gear tire no. 2 was evident on all 4 main landing gear tires.

Signs of reverted rubber hydroplaning (section 1.18.1) were observed on all 4 main tires (Photo 3). Skid marks running approximately 55° to the aircraft axis were visible atop the reverted rubber regions. Steam-cleaned marks from all 4 main wheel tires were observed in various locations along the runway (Photo 4).

Reverted rubber hydroplaning, which normally follows dynamic hydroplaning, occurs when a locked tire skids along the runway surface, generating sufficient heat to revert (melt) the tire rubber to its original uncured state. Only this type of hydroplaning produces a clear mark on the tire tread in the form of a burn, a patch of reverted rubber.

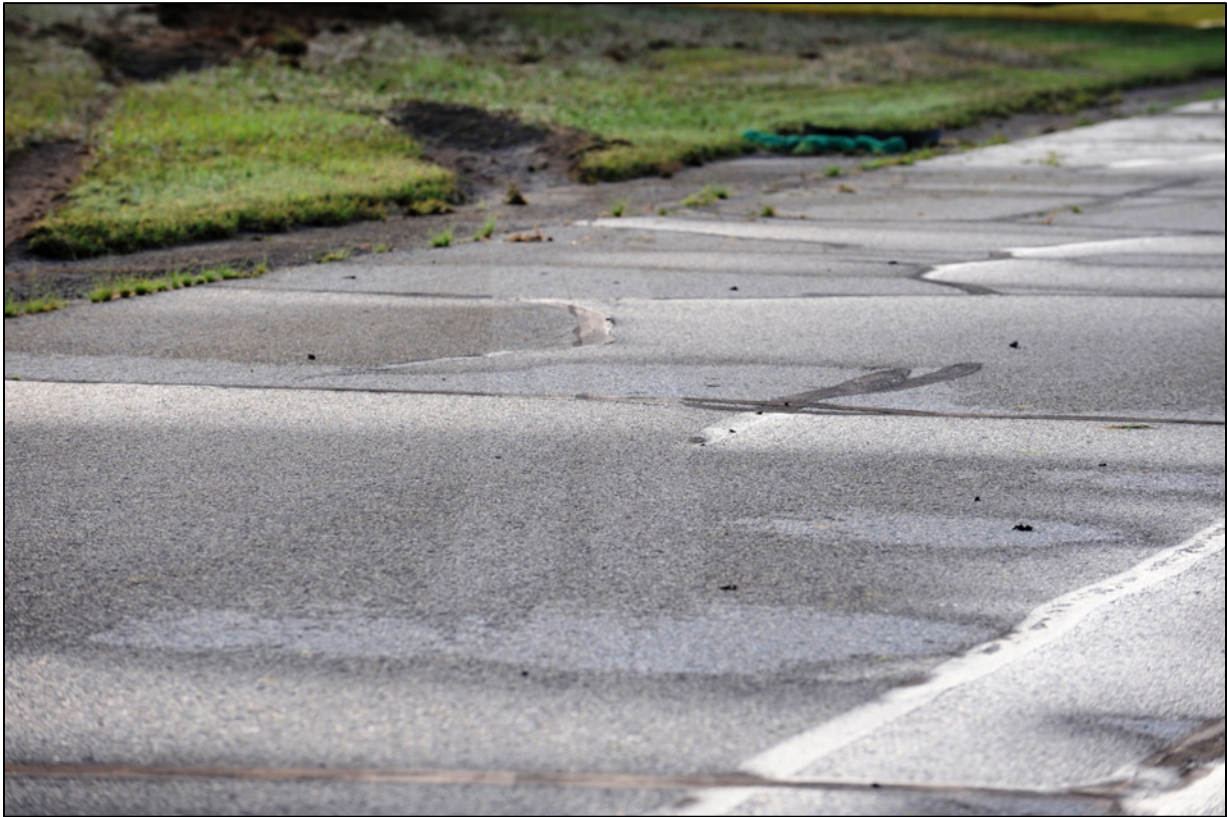
Photo 4. White steam-cleaned marks

After the captain applied the brakes, the aircraft began to skid. Brake application was maintained throughout the landing roll and up until the aircraft stopped. Steam-cleaned marks were noted at various locations along the runway, and all 4 of the aircraft's main landing gear tires exhibited patches of reverted rubber. The tires had angular cuts across these patches, which are consistent with all 4 wheels being locked when the aircraft departed the runway surface. This sign indicates that the aircraft experienced hydroplaning almost immediately after landing and periodically throughout the landing roll. The presence of water on the runway caused the aircraft to hydroplane, which led to a loss of directional control and braking ability. This condition would have been exacerbated at some time during the landing roll because the EPB was applied.

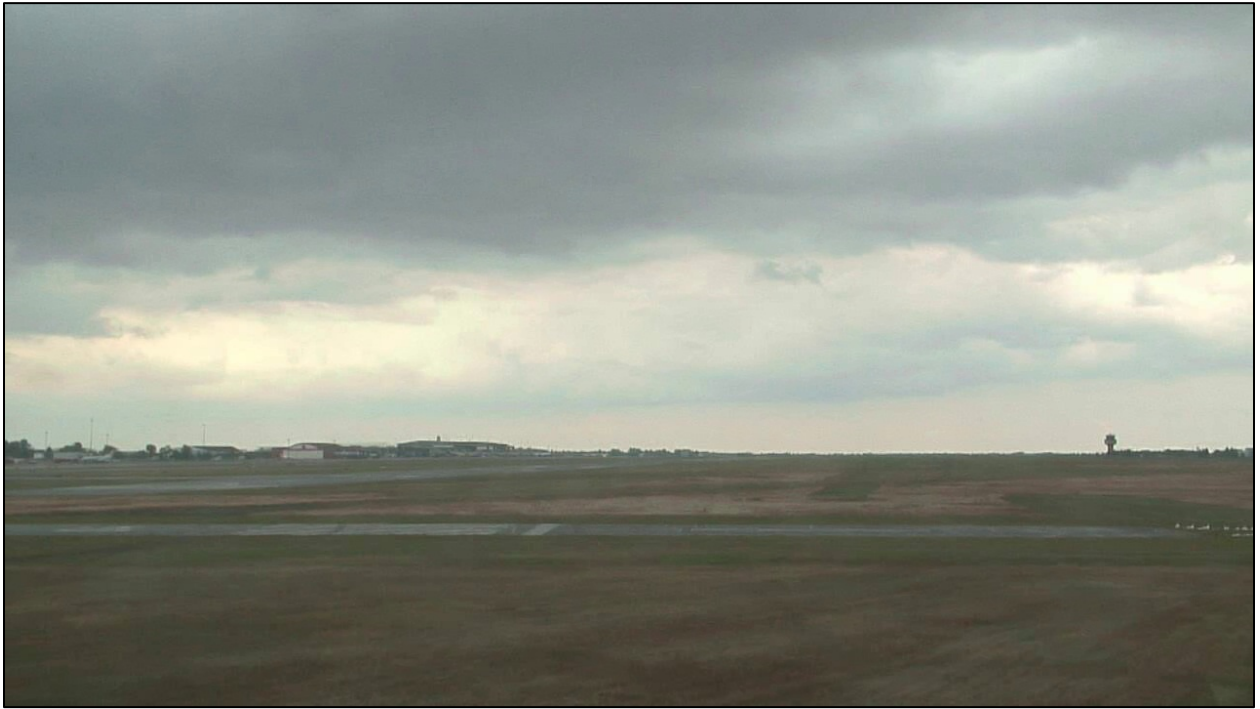
Photo 5. View from the departure end of Runway 32, 10 minutes before landing

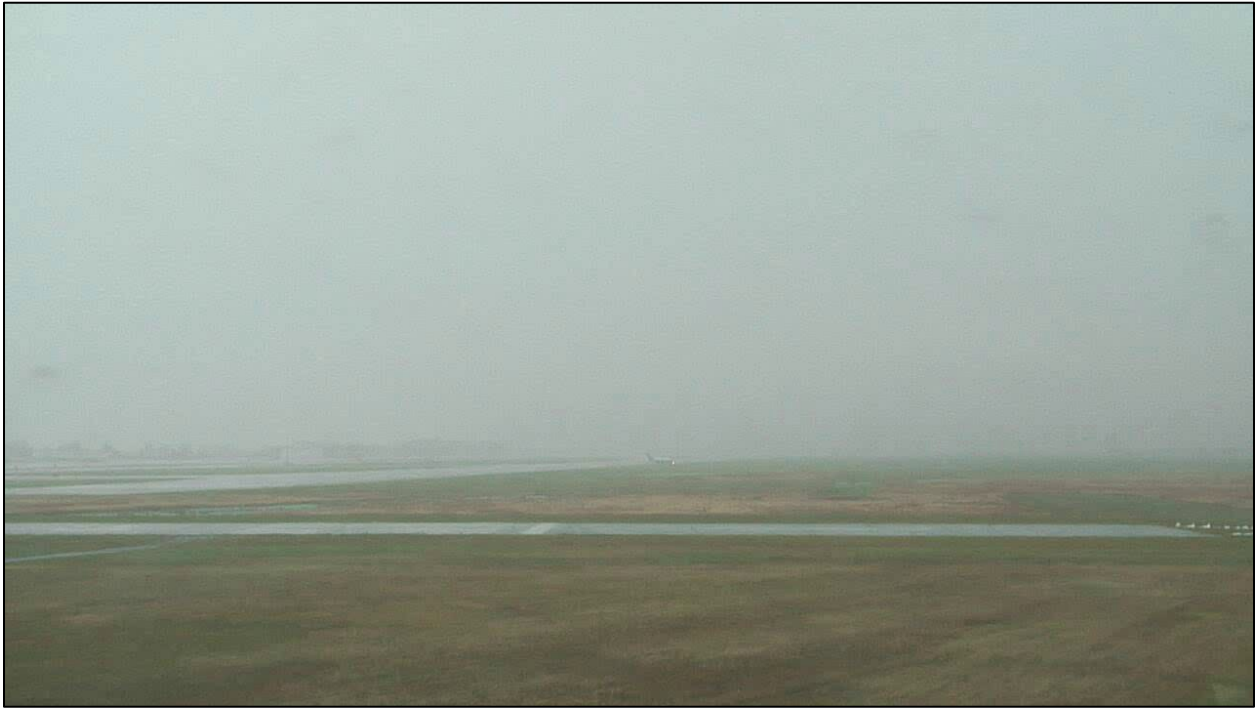
Photo 6. View from the departure end of Runway 32 as the aircraft exits the runway

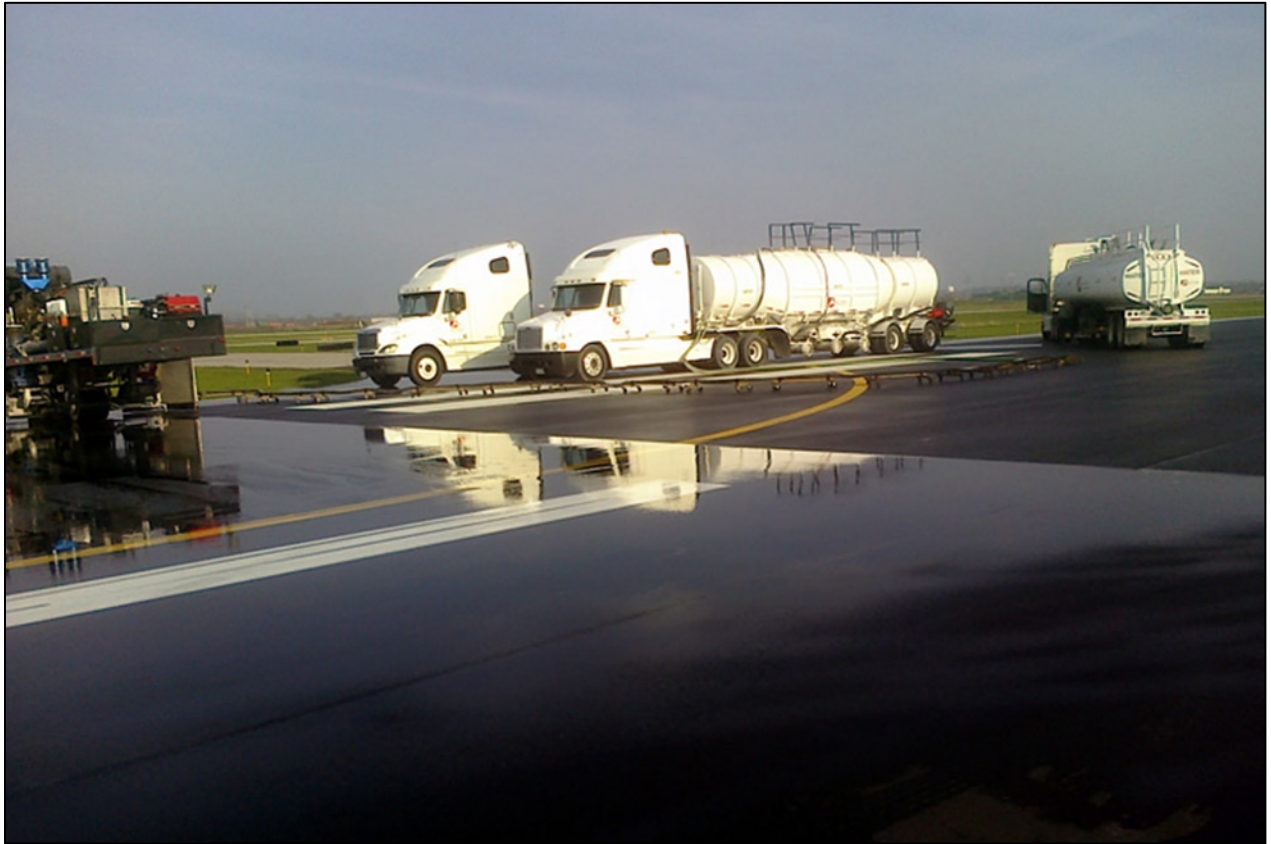
Appendix C – Grooved runway

Photo 7. A grooved runway (the section where the trucks are parked) versus a non-grooved runway, shown after being flushed with water during the grooving process (photo used with permission from the St. Louis Downtown Airport [KCPS])
