**AVIATION INVESTIGATION REPORT
A11O0031**

ERRONEOUS AIR DATA INDICATIONS

**SUNWING AIRLINES INC.
BOEING 737-8Q8, C-FTAH
TORONTO-LESTER B. PEARSON INTERNATIONAL AIRPORT
TORONTO, ONTARIO
13 MARCH 2011**

Report Number A11O0031

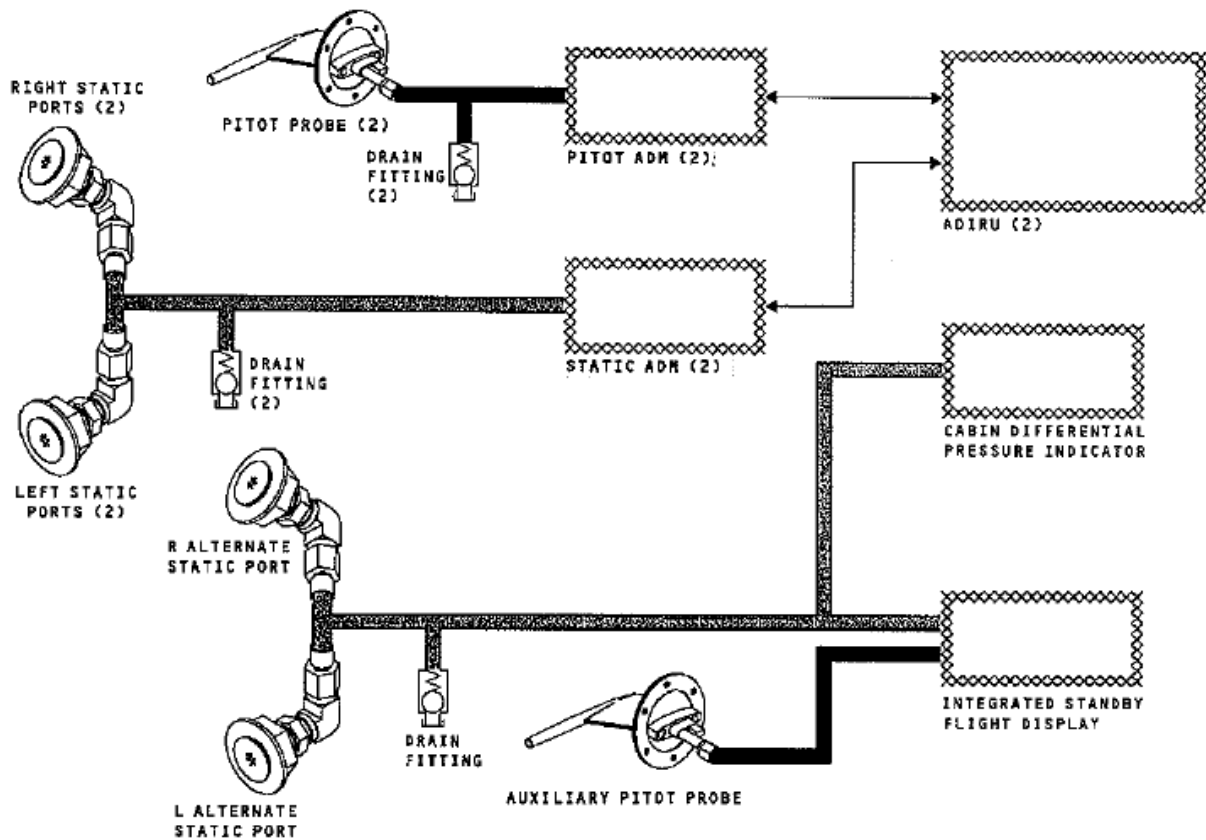
Appendix D – Boeing 737-800 Pitot-Static System Schematic ³⁷

1. A failure in the right pitot-static system caused the output of erroneous airspeed data from the right air data and inertial reference unit. This resulted in erroneous airspeed indications, stall warnings, and for unknown reasons, misleading flight director commands being displayed on the aircraft instruments during take-off and initial climb.
