**AVIATION INVESTIGATION REPORT
A11O0205**

**IN-FLIGHT SEPARATION OF MAIN ROTOR BLADE AND
COLLISION WITH TERRAIN**

**SUNRISE HELICOPTERS INC.
BELL 206L, C-GDQH
KAPUSKASING, ONTARIO, 15 NM S
02 NOVEMBER 2011**

Report Number A11O0205

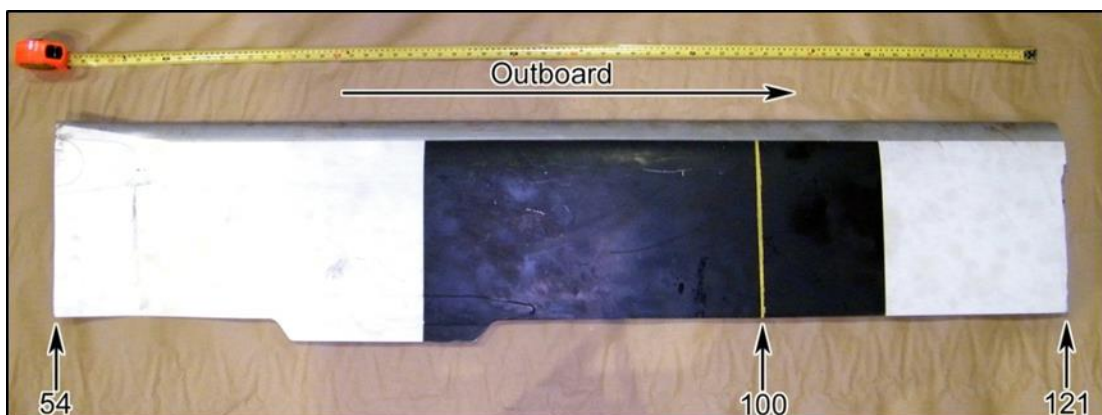
Photo 1. Upper side of fractured blade

The top surface of the inboard section of the occurrence blade was marked chord-wise with a yellow painted line at blade station 100 (Photo 1). The outboard section of the occurrence blade was not recovered, therefore it could not be determined if it was marked at blade station 145. The mating blade was marked at the appropriate blade stations, as per the ASB.

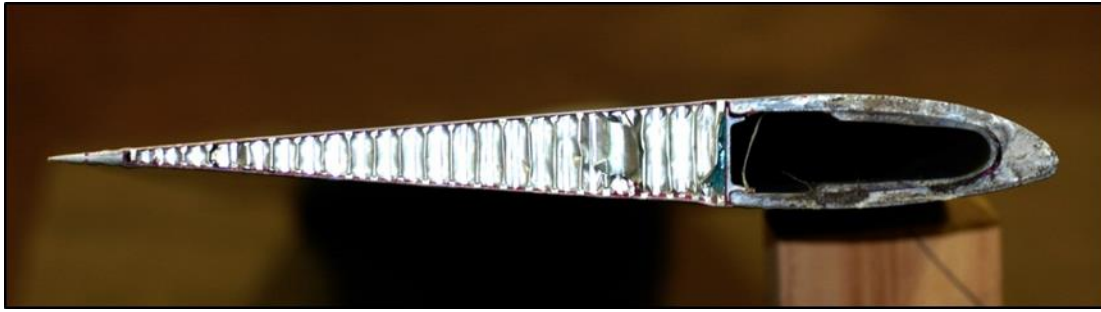
Photo 2. Cross-section of fractured blade (blade station 121)

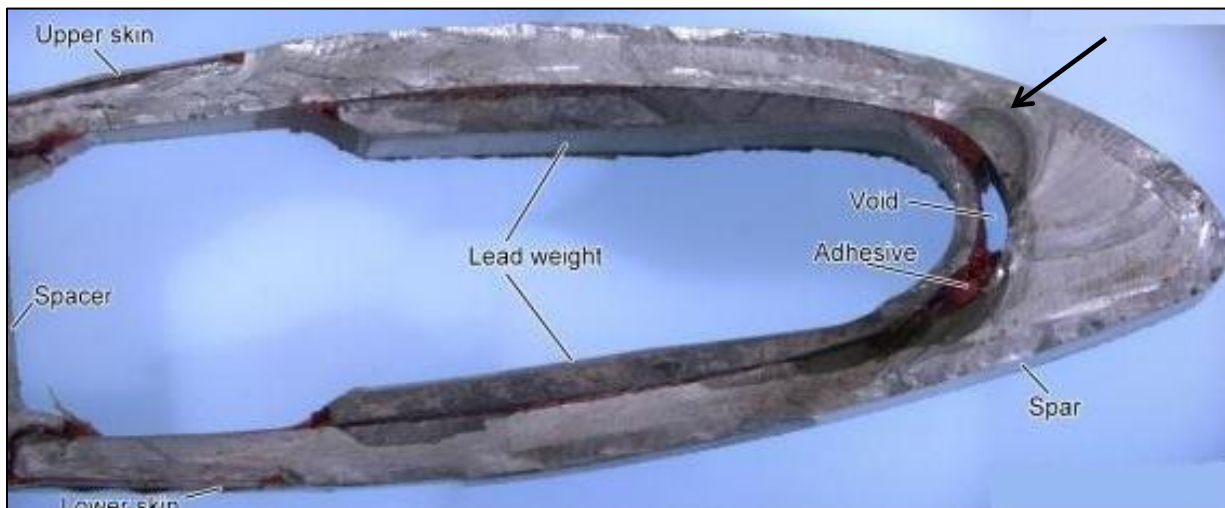
The lead weight was bonded to the aluminum spar with adhesive (reddish material in Photo 3). There was a large void in the adhesive at station 121 (location of fracture). The span-wise length of the void in the inboard direction from the fracture surface was about 13 inches. The total length of this void is unknown since the outboard portion of the blade was not recovered. The cross section of the void measured approximately 9.5 millimeters (mm) x 1.5 mm (0.374 x 0.0591 inches).

The blade spar fracture initiated on the inner surface of the spar, at the location of the void in the adhesive used to bond the lead weight to the spar at station 121. The fracture initiation location was a visible fingernail-shaped region, which is typical of fatigue cracking, and was clearly identifiable, even in the condition in which the blade was received. The fingernail-shaped region (Photo 3 - large black arrow) in the fracture initiation area had a different appearance than the rest of the fracture surface. This region appeared dark, which suggested a corrosion deposit on the surface. In addition, the fingernail-shaped region had a relatively flat and smooth surface, which is typical of stable crack growth. The fracture surface in this area was oxidized with corrosion scale.

Photo 3. Cross-section of fractured spar

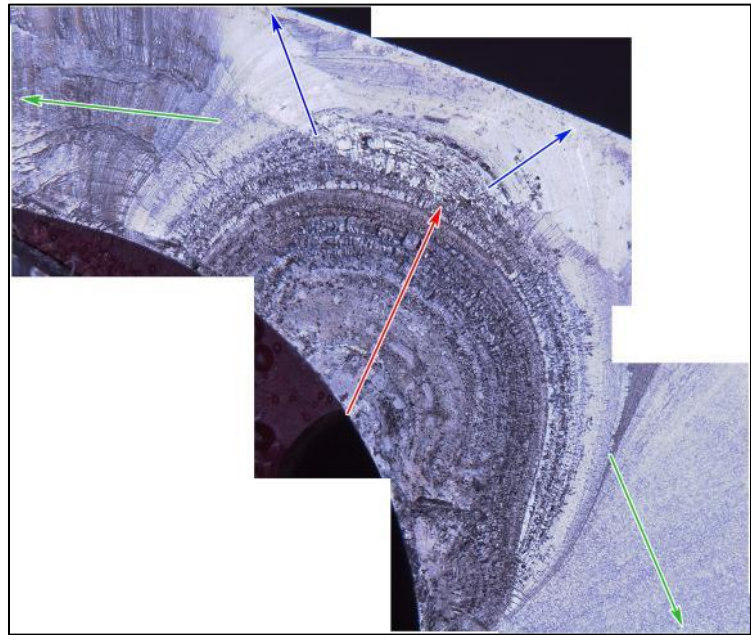
The fatigue crack located at blade station 121 had grown upwards, under the blade surface. The direction of the crack growth in this area (see red arrow in Photo 4) was consistent with the out-of-plane bending of the blade (helicopter start/stop cycles). The fatigue crack grew to such a size that in-flight high-frequency loads began to significantly contribute to its progression. When the crack was approximately 6 mm from its origin site, a chord-wise acceleration of its growth occurred (see blue arrows in Photo 4).

Eventually, the crack propagation direction changed so that one portion of the crack started to advance towards the leading edge, and the other portion, to the trailing edge of the blade (see green arrows in Photo 4). The general direction of the crack propagation at this stage was consistent with cyclic, predominantly in-plane bending of the blade (high-frequency loading). The crack growth became unstable and it accelerated, eventually leading to blade separation. It was impossible to accurately determine the number of cycles required for the initial fatigue area (red arrow) to grow to its observed size because striations in this region had been obliterated by rubbing and corrosion damage.

Photo 4. Fatigue crack progression

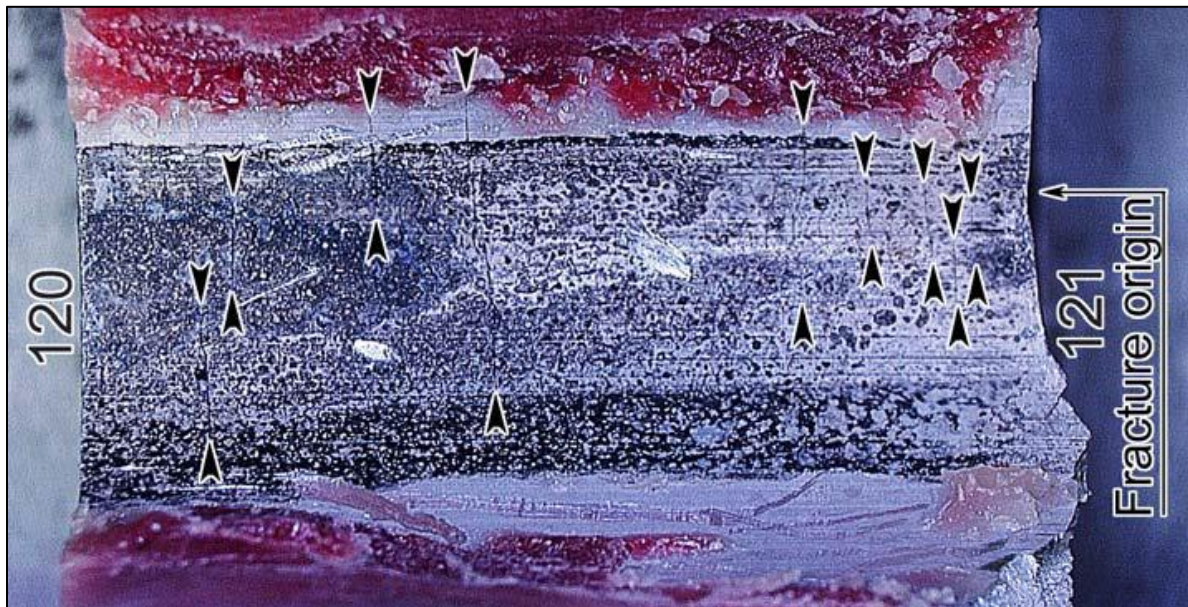
There were numerous secondary fatigue cracks originating from the inner surface of the blade spar, at the location of a large void in the adhesive used to bond the lead weight to the spar (Photo 5). These cracks grew upward under the surface of the blade and were observed between blade station 110 and the main fracture surface (blade station 121). The cracks revealed a pattern typical of progressive (fatigue) cracking (Photo 5). These secondary cracks were similar to the initial, fingernail-shaped portion of the main fracture, but smaller.

Photo 5. Spar inner surface with lead weight and adhesive removed (arrowheads showing secondary cracks)

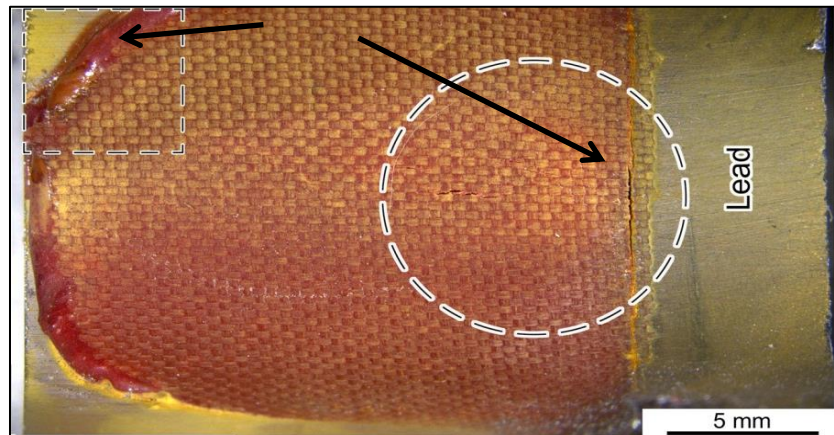
The lead weight was not completely sealed at its edges due to micro-cracks in the adhesive material adjacent to the lead weight (Photo 6 - large black arrows within dashed areas). Therefore, moisture penetrated through the gap between the lead weight and the spar. This allowed corrosion of the inner surface of the spar where there was a void in the adhesive, as well as corrosion of fracture surfaces while the fatigue cracks were growing. The appearance of the corrosion scale was consistent with a long-term exposure of aluminum to moisture.

Corrosion can accelerate fatigue by providing sites suitable for crack nucleation (corrosion pits) and by increasing the crack propagation rate. The corrosion scale on the fracture surface diminished with distance from the fracture origin. The corrosion may have contributed to the initial crack growth, but unlikely played any role in the crack propagation in the chord-wise direction during the faster, unstable growth.

Photo 6. Inboard end of the lead weight and adhesive

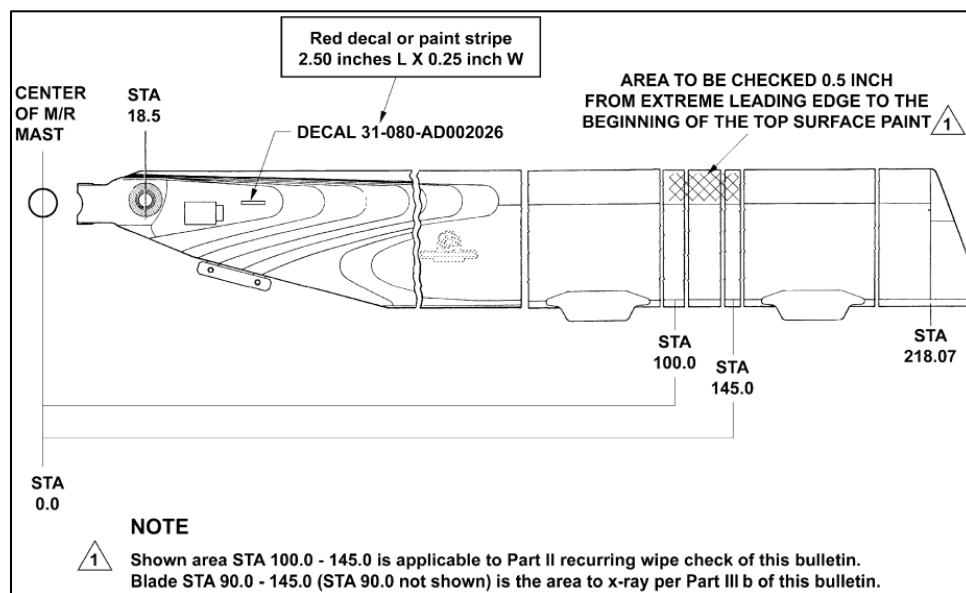
Figure 1. Main rotor blade area to be checked (Source: ASB 206L-09-159)

- Check affected area (Figure 1) for evidence of cracks as follows:
 - Prepare a blue food coloring solution that will be used to perform the check by thoroughly mixing 100 millilitres (ml) of isopropyl alcohol, 100 ml of clean tap water or distilled water and 20 drops of blue food coloring in a clean container.

- Apply the blue food coloring solution in the area to be checked using a cheesecloth saturated with the solution or apply with a spray bottle.
 - After 10 to 20 seconds, wipe off the solution with a cheesecloth in a span-wise direction.

- Carefully check affected area for evidence of a crack. If a crack is present, the blue food coloring solution will remain in the crack as the excess of solution is wiped off or the cheesecloth will catch on the rough edges of the crack.

- If a crack is found, remove the blade from service before further flight and contact Bell Helicopter Product Support Engineering.³
