**AVIATION INVESTIGATION REPORT
A11P0106**

AERODYNAMIC STALL AND COLLISION WITH TERRAIN

**PACIFIC FLYING CLUB
CESSNA 152, C-GZDR
HARRISON LAKE, BRITISH COLUMBIA, 10 NM W
05 JULY 2011**

Report Number A11P0106

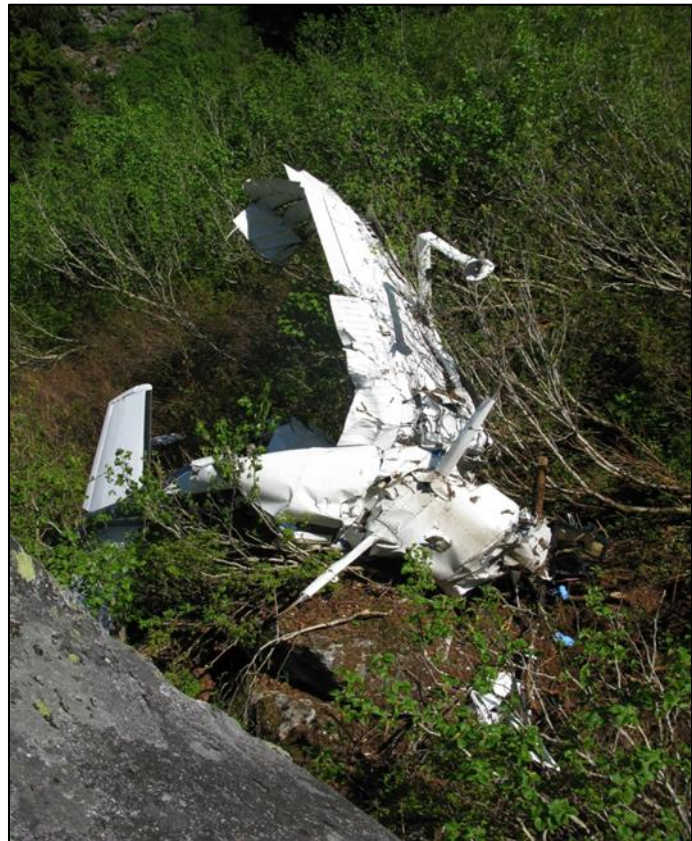
Photo 1. Wreckage of C-GZDR

knots) or less. The first ground contact had been with the right wing tip on a large boulder. The propeller and the right landing gear then struck the ground before the fuselage struck another large rock. The aircraft came to rest only 28 feet from the first contact point. The propeller slashed cleanly through a 5-inch diameter tree trunk, leaving a cut that indicated the propeller angle and engine power at the time of impact. Tree-strike damage and the deformation of the propeller indicated that the engine was producing significant power at the time of impact.

Both wings were extensively damaged; the wing center and cabin ceiling had been torn off with the wings still attached. The fuselage was broken behind the rear bulkhead, and the tail section was folded over the wreckage. The tail itself only suffered minor damage. The wing fuel tanks were torn open, spilling the remaining fuel, but there was no fire. While no fuel was found in the tanks, traces of fuel were found in the soil beneath the main wreckage. All major components remained loosely attached with cables and torn metal. Only some small parts were ejected, and were found no more than 35 feet down-slope from the main wreckage.

The cockpit instruments were badly damaged; however, 2 instruments – the engine tachometer and the attitude indicator – were examined.

The examination of the stall warning system on the wing revealed that the reed inside the horn was absent. Due to the extensive damage to the wing root area, the stall horn was exposed; the reed may have been dislodged during the accident or during the recovery of the wreckage. According to the aircraft manufacturer, the stall warning reed has been found dislodged after previous accidents. The investigation revealed that the stall warning horn was serviceable on previous flights on the day of the accident.

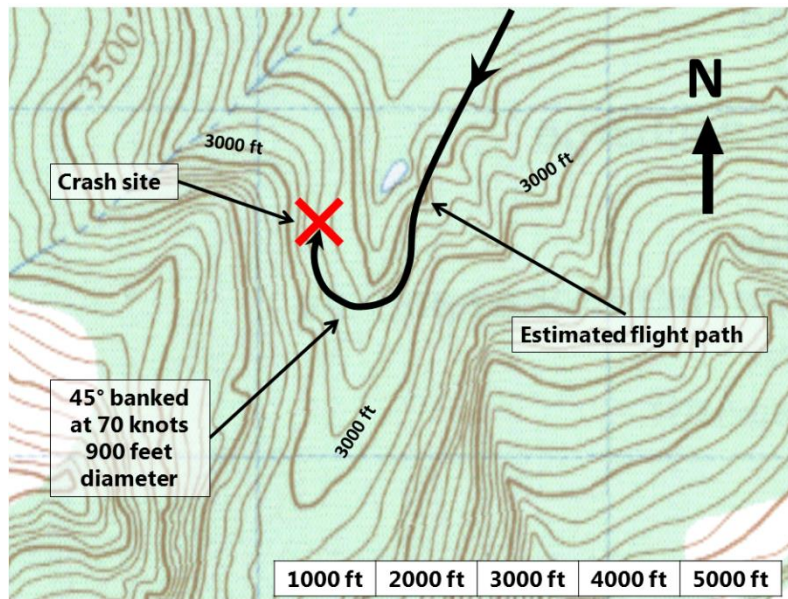
Figure 1. Estimated flight path and turn radius

The site of the occurrence is in a narrow canyon that branches off a larger valley. The floor of the valley rises steadily from Harrison Lake to the mouth of the canyon, where it then rises rapidly into the canyon. At the end of the canyon is a pass that is 3100 feet above sea level (asl) and leads to Stave Lake. Both sides of the canyon rise steeply, with slopes approaching 60°. Both sides of the pass were capped with snowfields starting at approximately 4000 feet asl and extending up to 6500 feet asl. The west side of the pass was in shadow below 4000 feet asl, while the east side of the pass was in bright sunshine. The investigation determined the likelihood that the aircraft turned in the canyon, resulting in a stall from a low altitude (Figure 1).

The canyon width above the occurrence site is approximately 1700 feet wide. At the altitude of the pass and at a typical manoeuvring speed of 70 knots indicated airspeed, the aircraft would have required approximately 900 feet of lateral spacing to reverse course using 45° of bank. There was only sufficient clearance to make that turn if the turn was initiated from close to either canyon wall. Starting the turn from the centre of the canyon requires an extreme bank angle, and there would be a risk of stall or collision with the canyon wall.

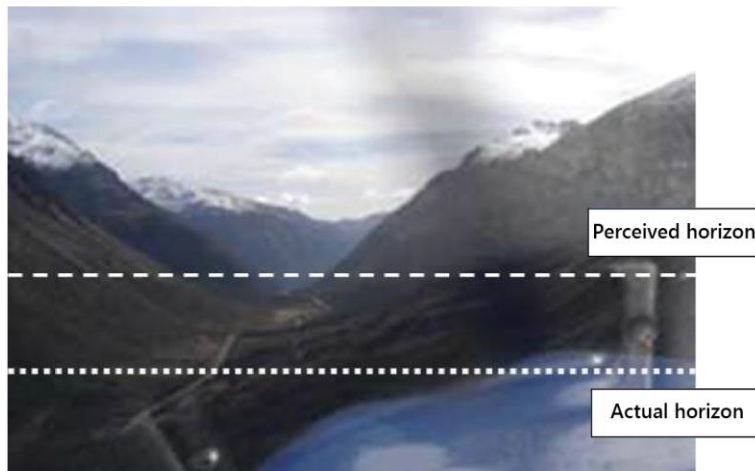
Photo 2. Actual and perceived horizon

Another illusion encountered while flying in the mountains is the inability to accurately define the actual horizon.²⁷ The mountains block the view of the actual horizon, and the pilot can perceive it to be higher than it is. This perception can cause the pilot to initiate a climb when trying to fly level. This slow climb can result in a loss of airspeed and an increasing angle of attack (Photo 2).

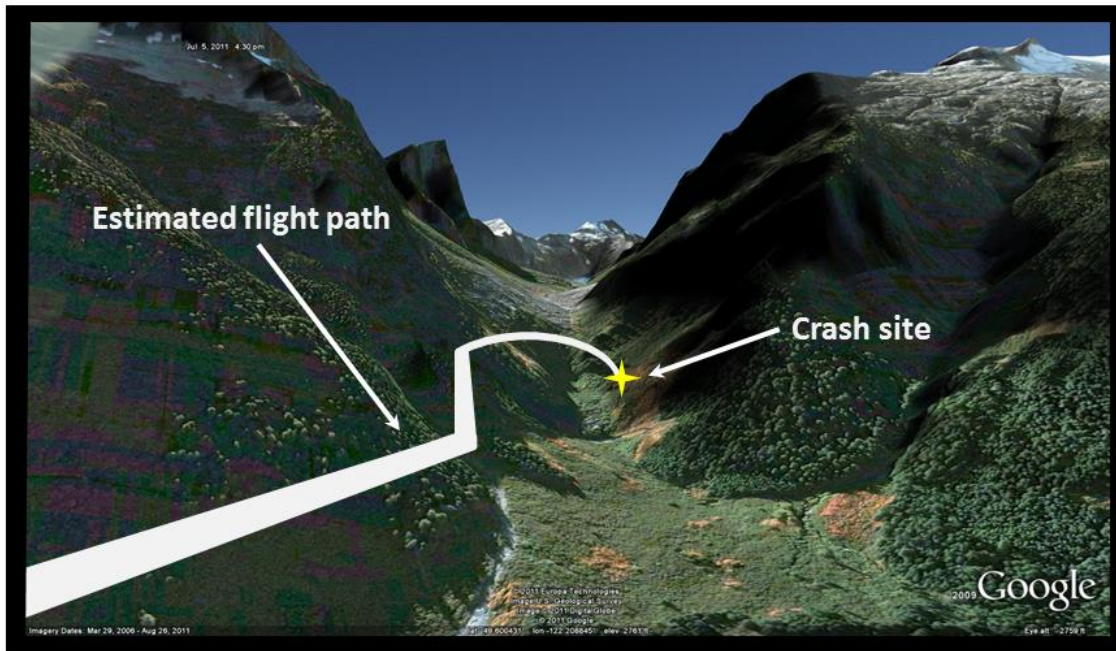
Figure 6. Estimated flight path with shadows at the time of the accident (Image: Google Earth)

The accident occurred close to a route commonly used by the instructor for mountain-flying training. It could not be determined why the aircraft entered this canyon; but, with insufficient performance to climb above the terrain at the highest point of the pass, it is likely that the pilots executed a turn in the canyon. Since the left-hand (east) side of the pass would have been exposed to the sun, it is more likely that they were flying on the left-hand side of the valley and attempted a right-hand turn. This attempt would have resulted in a turn toward a shadowed, steeply sloping surface. The lack of references associated with flying in the valley would have made it difficult for the pilots to visually determine their angle of bank relative to the horizon (Figure 6).

It is not known why the aircraft was at such a low level before the crash. However, conducting a turn at a low altitude would have increased the risk level of the manoeuvre, and was not in accordance with PFC policy regarding minimum flight altitudes. If the instructor delayed the decision to initiate the turn-around, it would have further reduced safety margins. With the flaps in the up position, the stall speed would have been 7 knots higher than if the flaps had been down fully. In addition, it is possible that once the turn was initiated, the aircraft encountered a downdraft on the shadow side of the valley, which could have caused the aircraft to sink. If the pilots were not cross-checking their instruments, it is also possible that the loss of horizon and visual illusions caused by the surrounding terrain may have caused the pilots to inadvertently stall the aircraft while conducting the turn.
