**AVIATION INVESTIGATION REPORT
A11Q0168**

**COLLISION WITH TERRAIN FOLLOWING NIGHT-TIME
TAKEOFF**

**ROBINSON R44 RAVEN II (HELICOPTER) C-GEBY
SAINT-FERDINAND, QUEBEC
27 AUGUST 2011**

Report Number A11Q0168

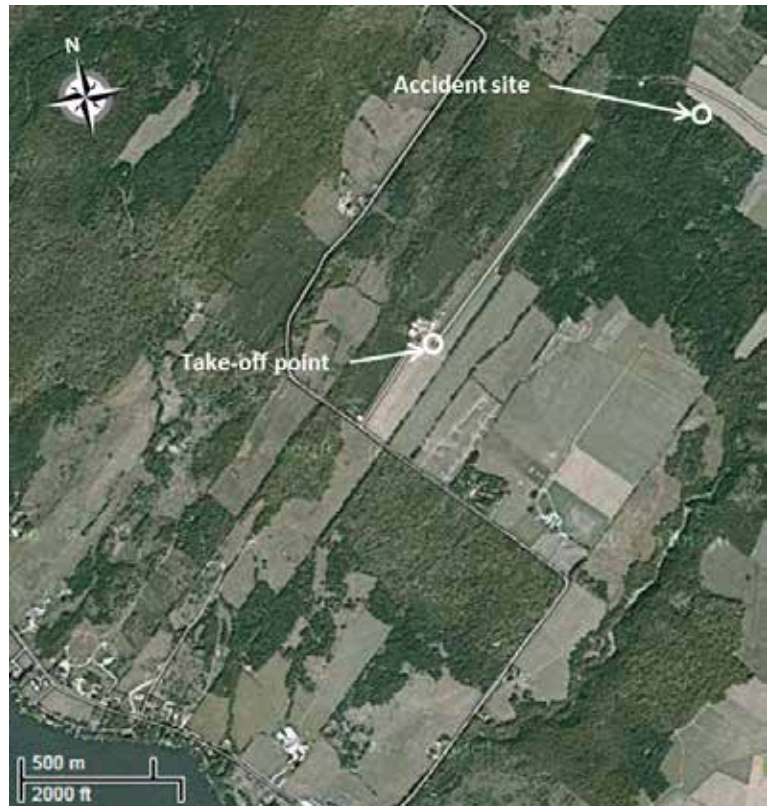
Around 2050, the pilot and 3 passengers returned to the helicopter for the night flight home, a distance of 37 nm that would have taken approximately 20 minutes to cover. The aircraft did not appear on the radar after take-off. No one saw the aircraft take off or crash. Only a sound of impact was heard, around 2100. At 2109, a distress signal from the aircraft's emergency locator transmitter (ELT) was detected by the Cospas-Sarsat satellite system. ⁴ At 2344, the aircraft was found by a Sûreté du Québec officer in a wooded area about 3940 feet northeast of the take-off point, just 1215 feet from the far end of Runway 05 () .

Figure 1. Aerial view of the Saint-Ferdinand area

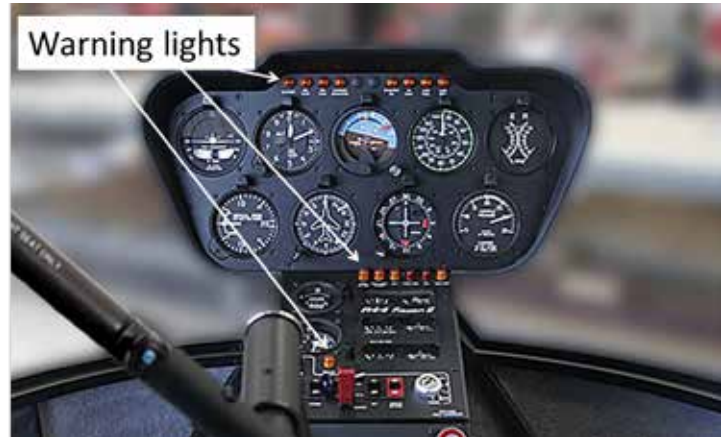
The R44 Raven II is equipped with 15 warning lights that warn the pilot of conditions requiring attention. Eight of these lights are located at the top of the instrument panel, and 7 are in the middle panel (Photo 1).¹⁹

Typically, a bulb filament will stretch if it is hot or illuminated at the time of impact. A filament can also fracture sharply when cold or not change at all. Except for the filament in the CLUTCH warning light, which stretched slightly, none of the filaments in the bulbs that resisted the impact showed evidence of fracture or stretching (Appendix D).

Photo 1. Typical instrument panel of an R44 Raven II

Despite the unclear condition of some of the warning lights, other factors indicate that they were probably off. For instance, it is unlikely that the LOW FUEL light came on, considering the amount of fuel loaded before departure from Saint-Nicolas and the actual flight time. As well, an inspection of the components of the FUEL FILTER, AUX FUEL PUMP, ALT, OIL PRESSURE, and GOVERNOR OFF lights revealed no anomaly that would have caused these lights to come on. The ENGINE FIRE light was very likely off, because there was no indication of a fire either before or after impact. Concerning the CLUTCH light, which may have been on at the time of impact, the *Pilot's Operating Handbook* states that it is normal for this light to sometimes come on briefly.

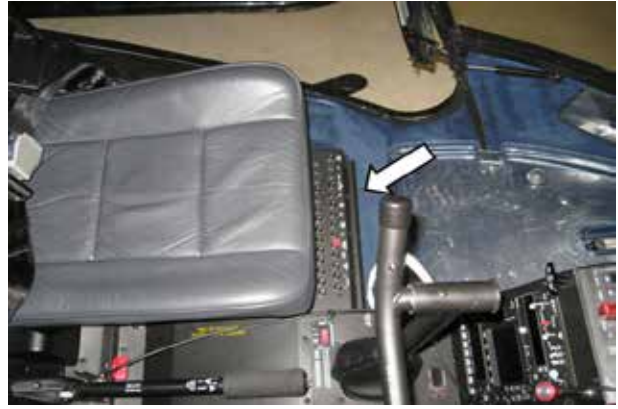
As previously mentioned, it is normal for the warning light to come on during flight. However, if it remains on for more than 7 or 8 seconds, the *Pilot's Operating Handbook* recommends pulling the clutch circuit breaker, reducing power, and landing immediately. The breaker panel, located on the floor in front of the left-hand seat, is difficult to see from the pilot's seat (Photo 2). For this reason, it is marked with a red ring to facilitate identification and manual activation. As well, the pilot is warned to be prepared to enter autorotation and to inspect the drive system. Following the accident, the breaker was found "IN", and was working properly.

Photo 2. Left breaker panel

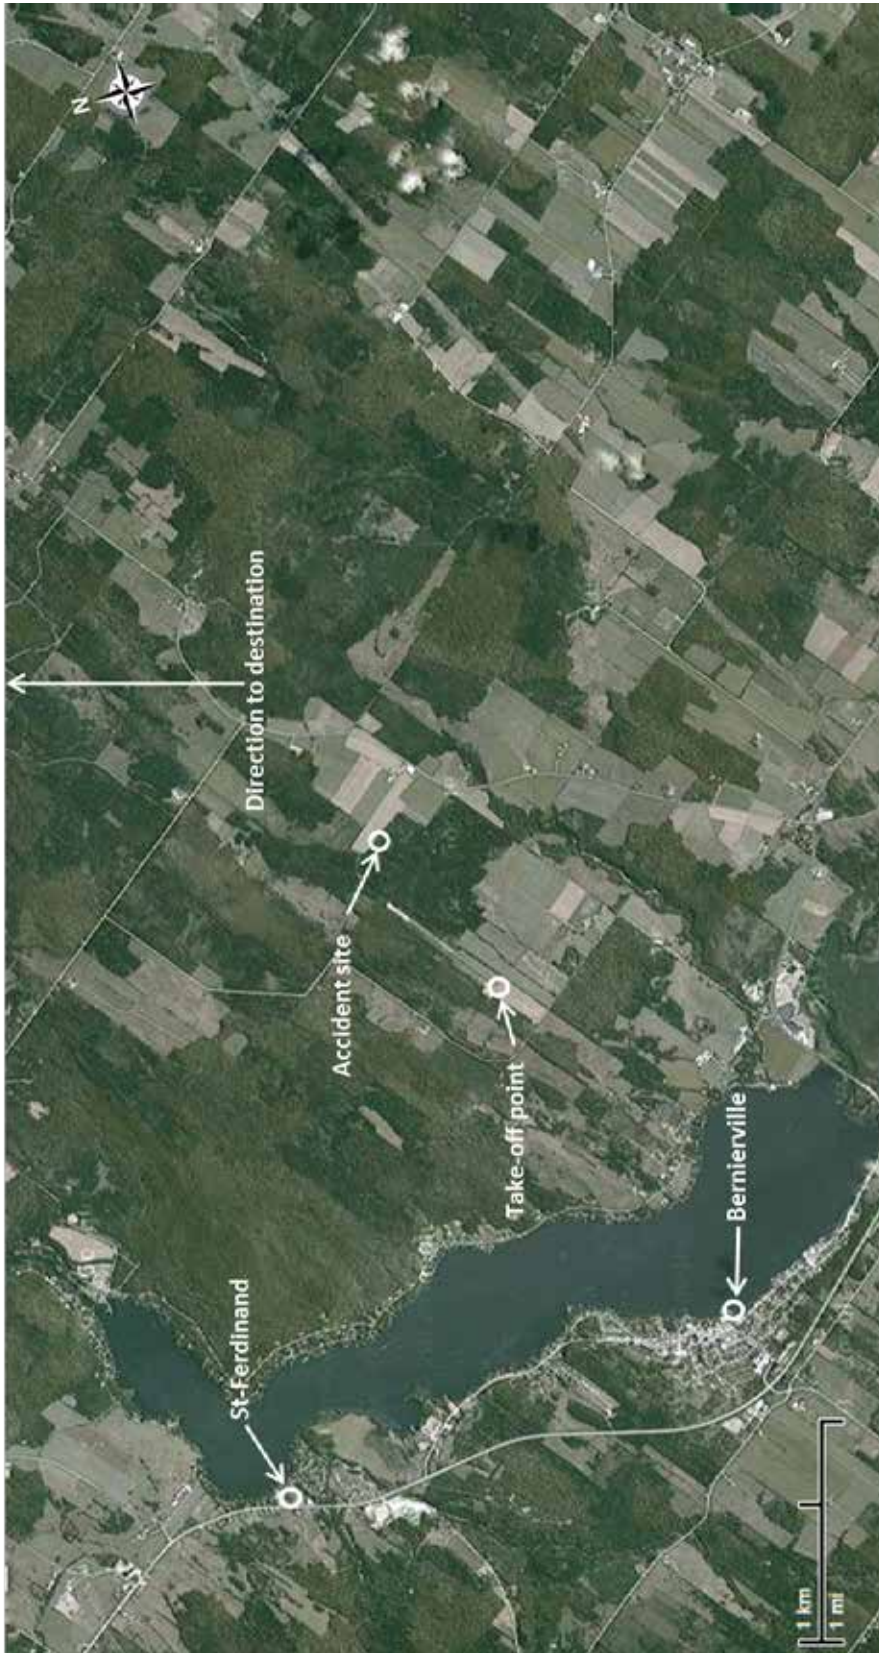
Appendix B — Aerodrome Environment

The elevation of the Saint-Ferdinand Aerodrome is 1050 feet asl. Runway 05/23 was an unlit ¹⁶ 3000-foot long by 75-foot wide grass/gravel runway. Beyond the end of Runway 05 is a wooded area; however, the end of Runway 23 abuts on an unobstructed field of almost 1400 feet that slopes toward a lake. The aerodrome has no aircraft rescue and firefighting (ARFF) services, nor are they required by regulation.

Apart from the village of Bernierville, situated approximately 1.7 nm southwest of the airport, and the village of Saint-Ferdinand, approximately 2 nm west, there are few visual references at night (Appendix B). Although there are a few hangars on the southwest side of the runway, none are lit. The roads next to the airport are not lit either, and there are few homes in the vicinity. Moreover, there are many trees in the area north-northeast of the airport (the direction of the planned destination).

- The departure in these directions offered few visual references.
- The rising terrain reduced obstacle clearance during the initial climb.
- The area was more wooded, offering less chance of a forced landing in the event of engine failure during the initial climb.
