**AVIATION INVESTIGATION REPORT  
A11W0152**

**CONTINUED VISUAL FLIGHT INTO INSTRUMENT  
METEOROLOGICAL CONDITIONS - COLLISION WITH  
TERRAIN**

**ROTORWORKS INC.  
BELL 206B (HELICOPTER), C-FHTT  
DRAYTON VALLEY INDUSTRIAL AIRPORT, ALBERTA,  
1 NM S,  
05 OCTOBER 2011**

Report Number A11W0152

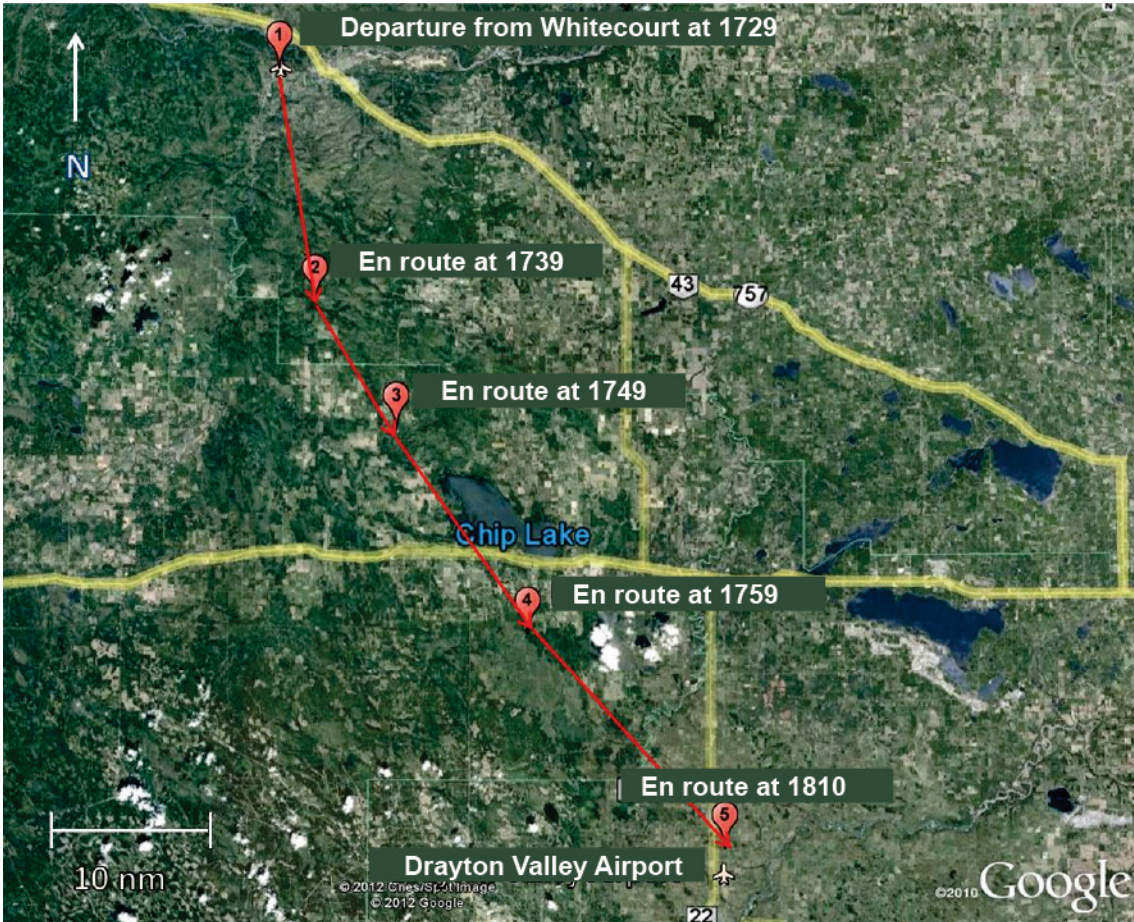
Figure 1. SPOT GPS track

On 05 October 2011, the pilot departed Whitecourt Airport at approximately 1729<sup>1</sup> (Figure 1). The flight was a visual flight rules (VFR) flight returning to Drayton Valley Industrial Airport (via the McLeod River Valley, Highway 16 and Highway 22), where the pilot resided. The pilot departed Whitecourt Airport with approximately 50 US gallons of fuel<sup>2</sup> on board. The planned duration of the flight was 1 hour. Assuming a normal fuel consumption of 25 US gallons per hour, C-FHHT left Whitecourt with approximately 2 hours of fuel on board. The pilot checked the weather for Edmonton and Edson, Alberta, and discussed it with the chief pilot/owner prior to departure. They agreed on the routing to be used with the reported weather and that,

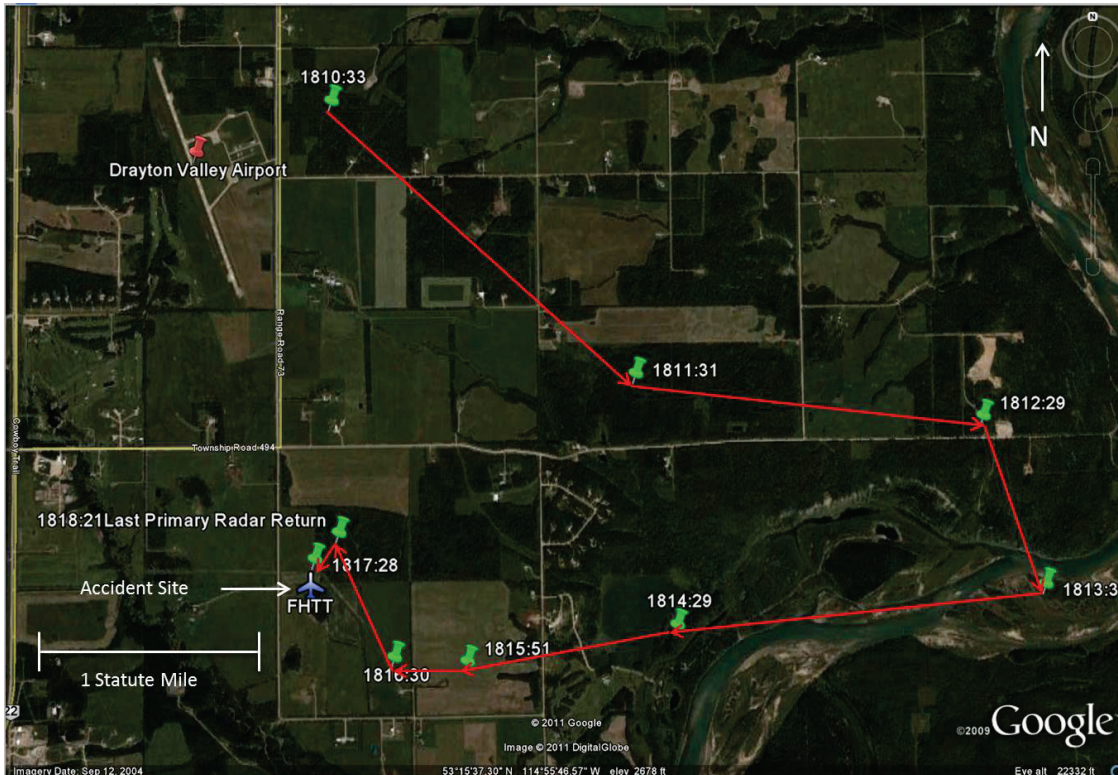
**Figure 2.** C-FHTT flight path (derived from NAV CANADA radar)

A final call was made at 1807 where the pilot reported slowing down to 20 mph and starting descent. Tracking data showed that the helicopter was located approximately 1 nm north of the airport. The pilot expressed some concern about icing due to the temperature.

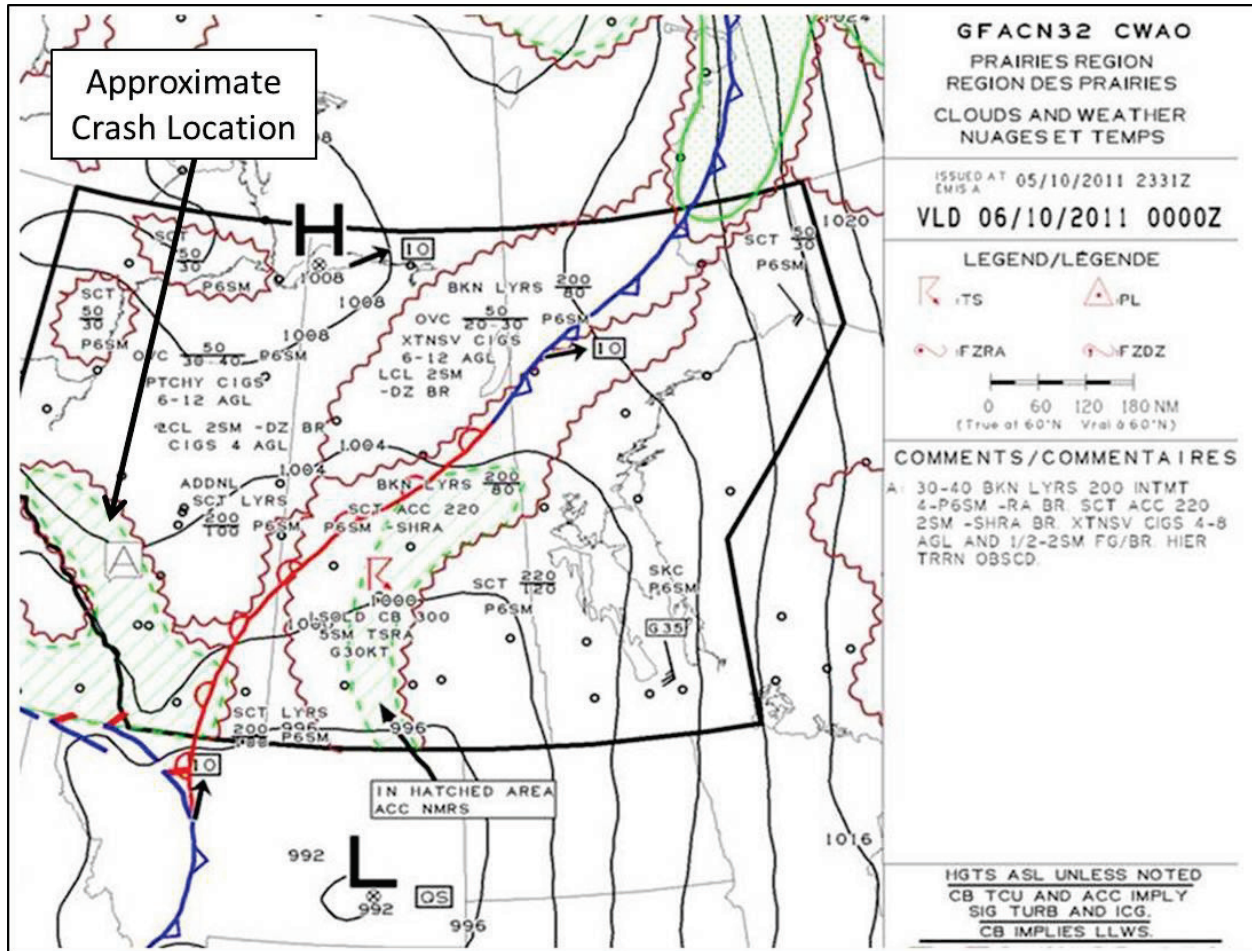
Figure 3. Graphic area forecast (accident location depicted)

Reported weather conditions upon departure from Whitecourt indicated that ceilings were 600 to 900 feet above ground level (agl) and visibility was 3 statute miles (sm). According to the graphic area forecast (Figure 3), the western part of Alberta, along the Rocky Mountains and along the route to Drayton Valley were forecast to experience broken ceiling from 3000 to 4000 feet asl with layers to 20 000 feet asl. In this area, intermittent visibilities of 4 to 6 sm in light rain and mist were forecast, with scattered altocumulus castellanus clouds to 22 000 feet asl. Also forecast were extensive ceilings of 400 to 800 feet agl and visibilities of ½ - 2 sm in fog and mist. Higher terrain would have been obscured. Patchy moderate mixed icing conditions were forecast between the freezing level (7500 to 10 000 feet asl) and 18 000 feet asl.
