**AVIATION INVESTIGATION REPORT
A12C0053**

MID-AIR COLLISION

**PIPER PA-28R-200 ARROW, C-GLAJ
AND
LAKE LA-4-200 BUCCANEER, C-GFCH
ST. BRIEUX, SASKATCHEWAN, 8 NM W
12 MAY 2012**

Report Number A12C0053

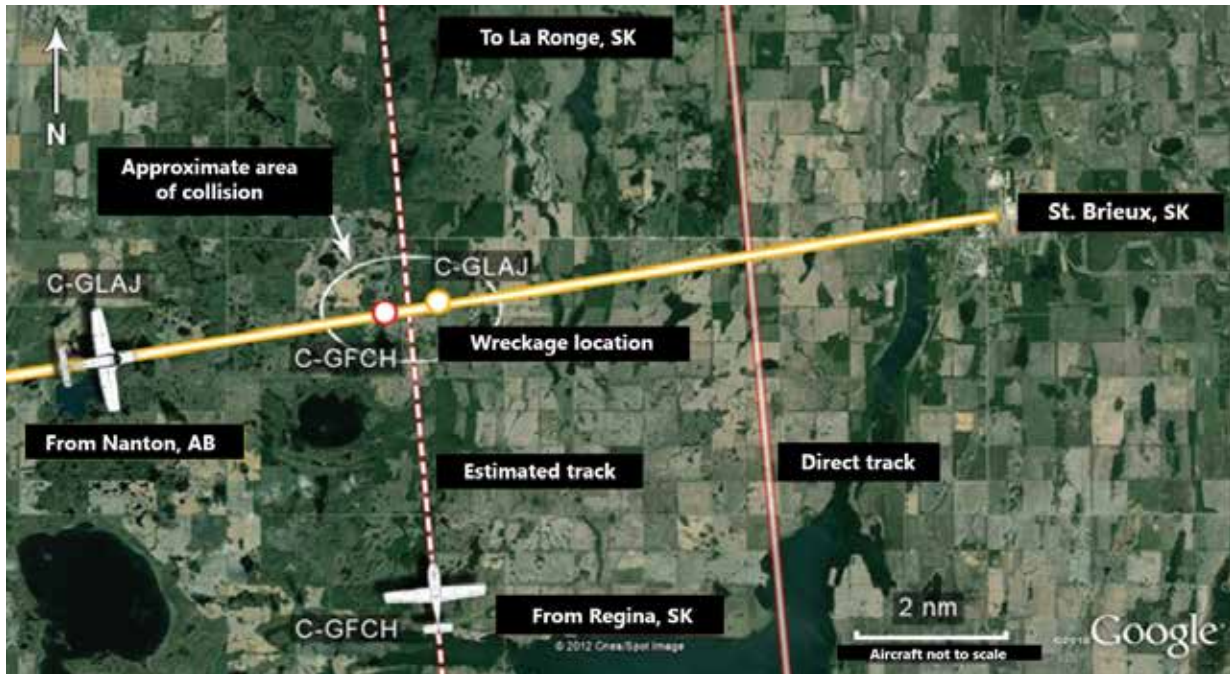
C-GLAJ was at an altitude of 9500 feet asl, which was the correct altitude for direction of flight. The aircraft was visible on air traffic control (ATC) radar for most of the flight. The pilot was not communicating with ATC, nor was such communication required in the airspace in which the flight was being operated. Shortly after passing Saskatoon, Saskatchewan, C-GLAJ began a slow descent. It was last observed by ATC radar at 0840 at position 52°37'13" N, 105°05'30" W, ² approximately 8 nautical miles (nm) west of St. Brieux at an altitude of approximately 4400 feet asl on a track of 064° true (T).

C-GFCH departed Regina International Airport at 0718. The pilot of C-GFCH had filed a flight itinerary with a family member. The itinerary indicated that the flight would proceed direct from Regina to La Ronge, Saskatchewan, and that it should arrive some time before 1030. The available information indicated that the aircraft was operating at an altitude of 4500 feet asl, which was the correct altitude for direction of flight. At approximately 0802, C-GFCH was visible on ATC radar, approximately 80 nm north of Regina, on a direct track of 352°T for La Ronge. The pilot was not required by regulation to communicate with ATC in the airspace in the vicinity of the accident site. Shortly after 0840, C-GFCH was observed to be rapidly descending in a nose-down attitude before disappearing below the tree line.

Figure 1. Routes of flight

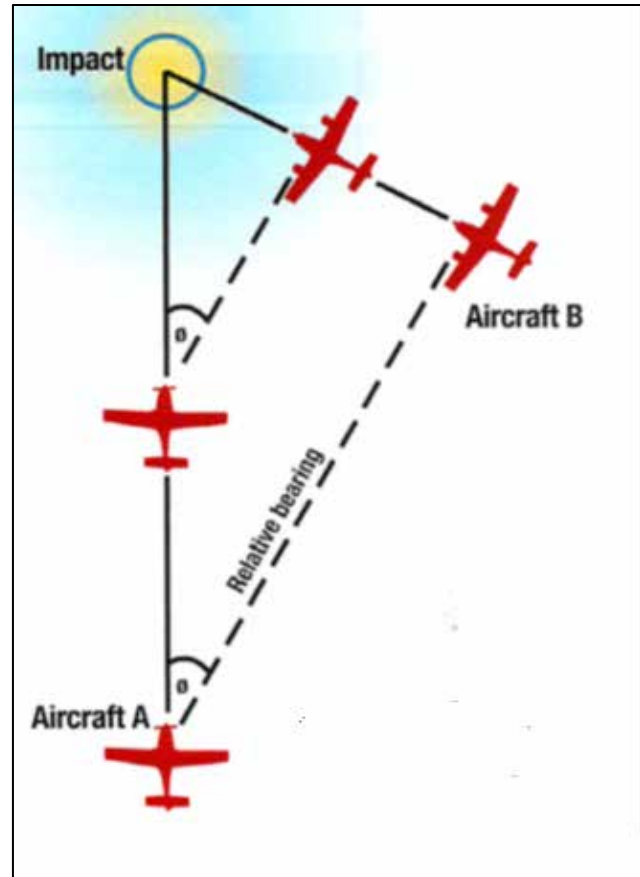
Aircraft on converging tracks, such as the 2 aircraft involved in this occurrence, can be difficult to see, because there is very little relative motion apparent to the observer. Figure 3 illustrates how the relative bearing between 2 converging aircraft remains constant as they converge. This results in the aircraft appearing stationary to each other, making each aircraft less conspicuous to the other. The closing speed of the aircraft was calculated as 194 knots.

Figure 3. Aircraft relative bearing

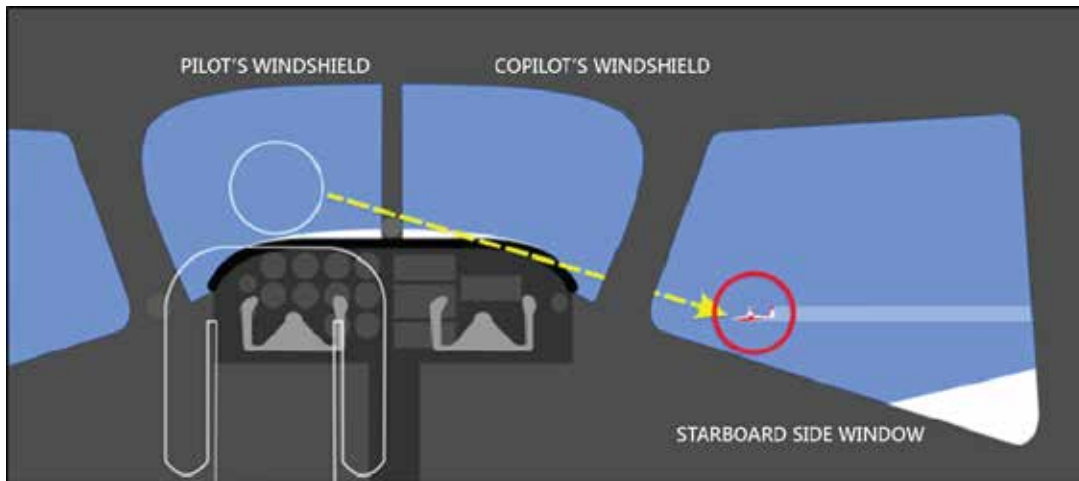
The relative position of each of the occurrence aircraft just before the collision would have made visual acquisition difficult. C-GLAJ was descending from a higher altitude than C-GFCH. As a result, C-GLAJ may have been obscured by the left wing of C-GFCH. Likewise, C-GFCH may have been obscured from C-GLAJ's pilot's view by the nose of C-GLAJ. The diagrams below indicate the positions of the aircraft relative to each other and the aircraft cockpit structures (figures 5 and 6).

Figure 5. View from cockpit of C-GLAJ indicating pilot's view partly obstructed by nose of aircraft (Note: Image not to scale)

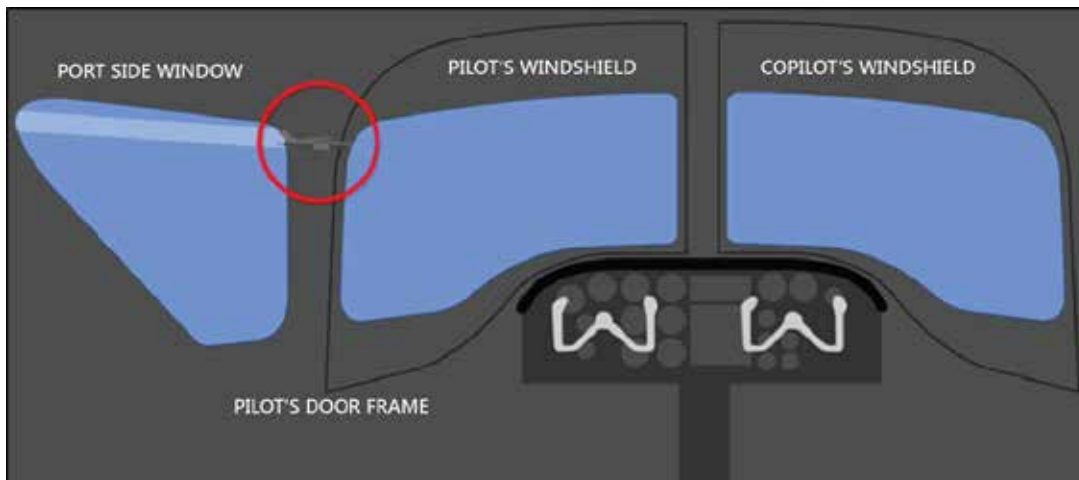
Figure 6. View from cockpit of C-GFCH indicating pilot's view partly obstructed by aircraft structure (Note: Image not to scale)

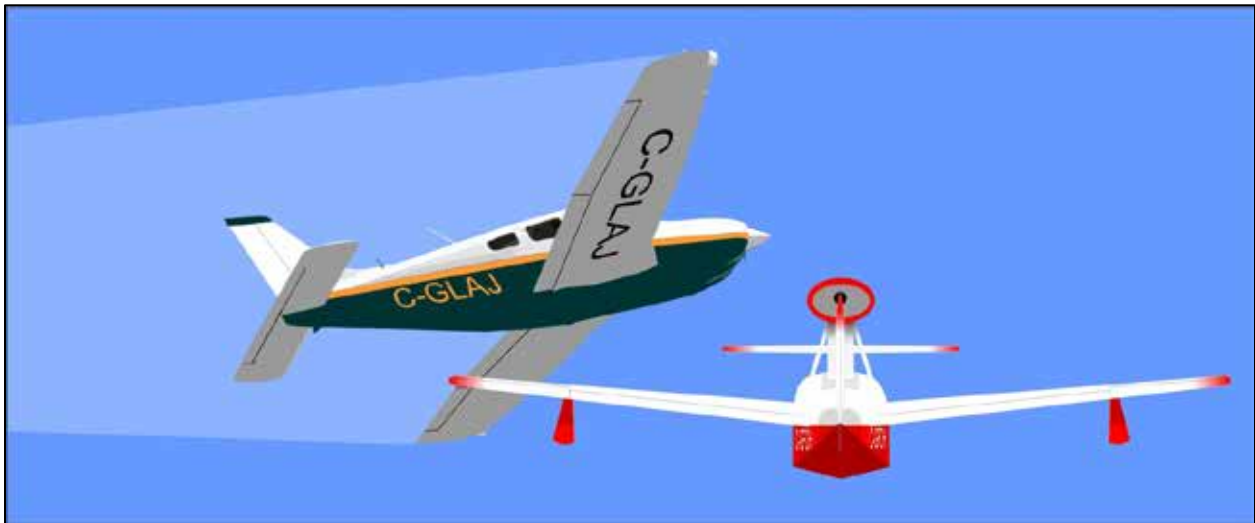
Inspection of the damage to both aircraft left wings and ailerons indicated that the pilot of C-GLAJ might have banked to the left, turning northward and away from C-GFCH. This type of evasive action would have resulted in C-GLAJ's left wing being down to the point where it only could have come in contact with the left wing of C-GFCH. A reconstruction of the likely aircraft positions at impact was prepared (Figure 7). The left outboard wing sections came to earth very close to each other and away from both main wreckage sites. This indicated that:

- They were shorn off in the air at the time of the collision;
- Either one or both of the aircraft had initiated some sort of turning avoidance manoeuvre; and
- Because of the structural damage, both aircraft would have been uncontrollable after the collision.

Figure 7. Relative positions of the aircraft at impact
