**AVIATION INVESTIGATION REPORT
A12O0005**

RUNWAY OVERRUN

**AIR BRAVO CORPORATION
PILATUS PC-12/45 C-FPCN
TIMMINS/VICTOR M. POWER AIRPORT, ONTARIO
15 JANUARY 2012**

Report Number A12O0005

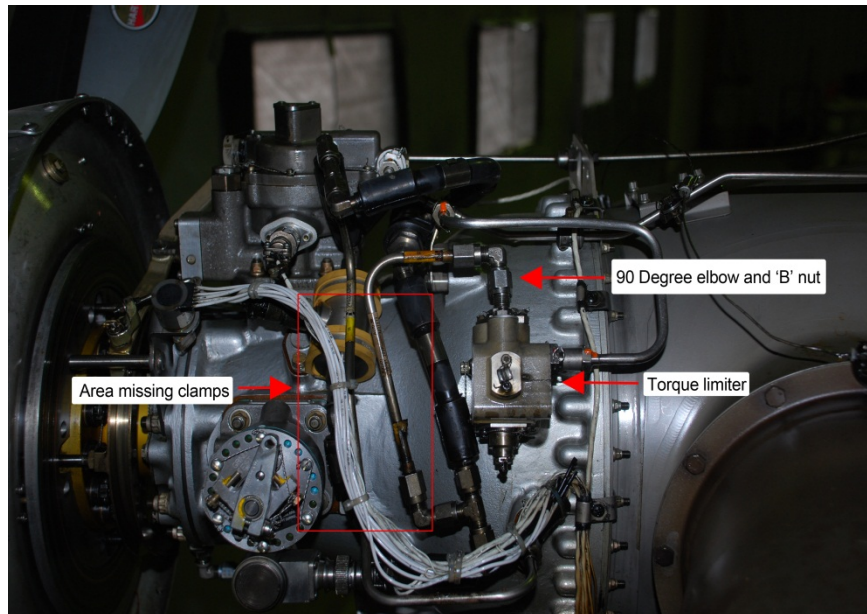
An inspection of the engine following the accident showed that the B nut on a 90° fitting attached to the oil outlet male union on top of the torque limiter was completely disconnected. Normally the engine contains 13.6 litres of oil. Less than a litre of oil was left in the engine. As well, 2 sets of clamps were missing from the associated plumbing (Photo 1). The magnetic chip detector was removed and found to be completely covered in ferrous material. The oil filter was removed and found to be covered in both ferrous and non-ferrous material.

Photo 1. B nut, indicating the area missing clamps

Both the B nut on the 90° elbow and the male union from the top of the torque limiter showed signs of galling on their cup-and-cone mating surfaces. Galling is an indicator that the fittings had been previously subjected to excessive torque. Once galling has occurred, proper torque values may be difficult to maintain due to a lack of proper contact area between the mating surfaces.

The initiating event in this occurrence was the loosening of a B nut on the 90° fitting attached to the oil outlet on top of the torque limiter. This allowed all useable engine oil to be pumped overboard in a short period of time. Several hypotheses were considered to determine how the B nut could have become loose, including the following:

- Galling on the mating surfaces prevented proper tightening of the B nut.
- The B nut was incorrectly installed during the engine installation.
- There was vibration in the oil lines due to the missing clamps, which caused rotational movement of the 90° fitting.

It could not be positively determined how the fitting became loose. It may have been any or a combination of all of these hypotheses but the end result was that a single point failure on the engine led to a complete and sudden loss of all the engine oil.

1. For undetermined reasons, the B nut fitting on the oil outlet of the torque limiter became loose, causing a complete loss of engine oil.
2. The flight crew did not effectively manage the final approach and landing speed, resulting in the aircraft touching down long and fast and overrunning the runway

A secondary locking device such as lock wire can prevent fittings like the B nut from backing off even if it is installed incorrectly. The application of torque seal can provide a visual clue that the fitting has become loose.

1. Lack of a secondary locking device or visual indication of fittings becoming loose increases the risk of critical components loosening in flight, jeopardizing the continued safe operation of the aircraft.

The operator carried out a safety management system investigation following the incident, which highlighted the same issues as this investigation. As a result of its internal investigation the company developed several new procedures for the maintenance and flight operations departments. Maintenance now requires any fitting on the engine without a means of attaching a secondary locking device to have the fitting torqued using standard values in the latest version of the AC 43.13. Once torqued, the fitting is to be inspected by another aircraft maintenance engineer for correct torque and torque seal is to be applied to the fittings. Flight operations have written a new scenario for simulator training to mirror the conditions of this occurrence and evaluate how flight crews deal with a similar one.
