**AVIATION INVESTIGATION REPORT  
A12P0136**

**COLLISION WITH TERRAIN**

**PIPER PA-30 TWIN COMANCHE C-GLGJ  
KELOWNA, BRITISH COLUMBIA, 18 NM W  
13 AUGUST 2012**

Report Number A12P0136

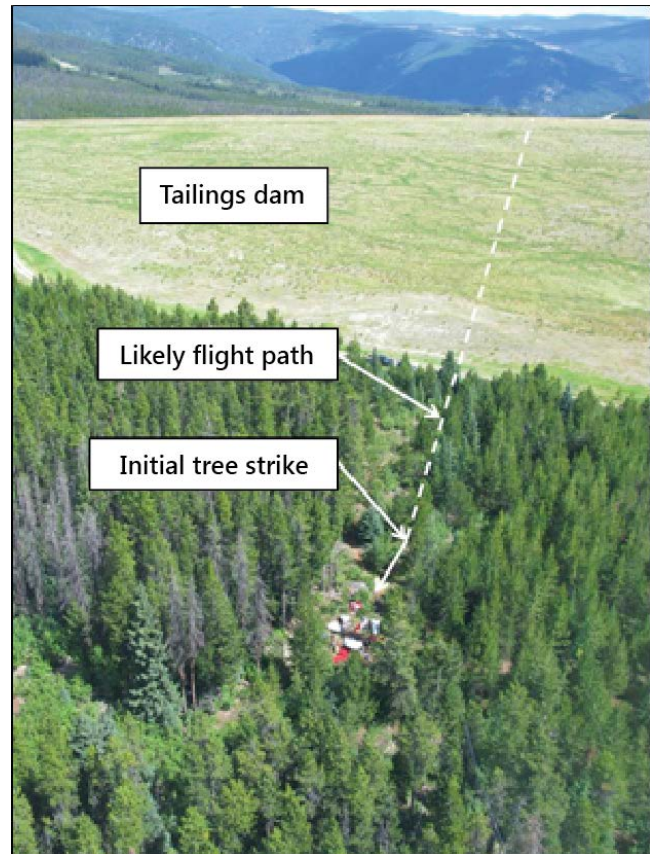
The aircraft crashed on a level, treed portion of the Brenda Mines tailings dam, about 0.7 nm southwest of Highway 97C (Photo 1), at an elevation of 4595 feet asl. Though not a published VFR route, Highway 97C follows the Trepanier Creek Valley and is often used by pilots as a route when flying west from the Okanagan Valley. The Brenda Mines site is about 10 nm north of the published VFR route from Summerland to Princeton, and the valley southwest from the Brenda Mines to the published VFR route is the logical low-ground route between the two (Figure 1).

The terrain before the treed area at the accident site is a level, grass-covered area atop the Brenda Mines tailings dam (Photo 1). Based on the aircraft's path as it struck the trees, its likely flight path took it over about 1600 feet of unobstructed grass and about 200 additional feet of forest, before it contacted the first tree. Trees immediately past the accident site, as well as those to the right of it, were about twice as tall (about 70 feet) as the trees that were overflown (about 35 feet) and struck. A parallel flight path at the same altitude, but about 1000 feet to the left, would have been over ground low enough to clear the trees at this altitude and to then have continued to Princeton.

After striking the first of 5 small trees, the aircraft travelled about 75 feet, before coming to rest. Leading-edge damage indicated that the aircraft struck the trees while banked about 45°, right-wing low. Impact with the trees and ground separated the outboard 6 feet of both wings and broke the fuselage into 3 pieces, but the aircraft remained upright. The flaps and landing gear were found fully retracted. Both propellers sustained light scoring and leading edge damage, as well as heavy bending damage.

**Photo 1.** Aerial view of the accident site, showing the likely flight path before the initial tree strike

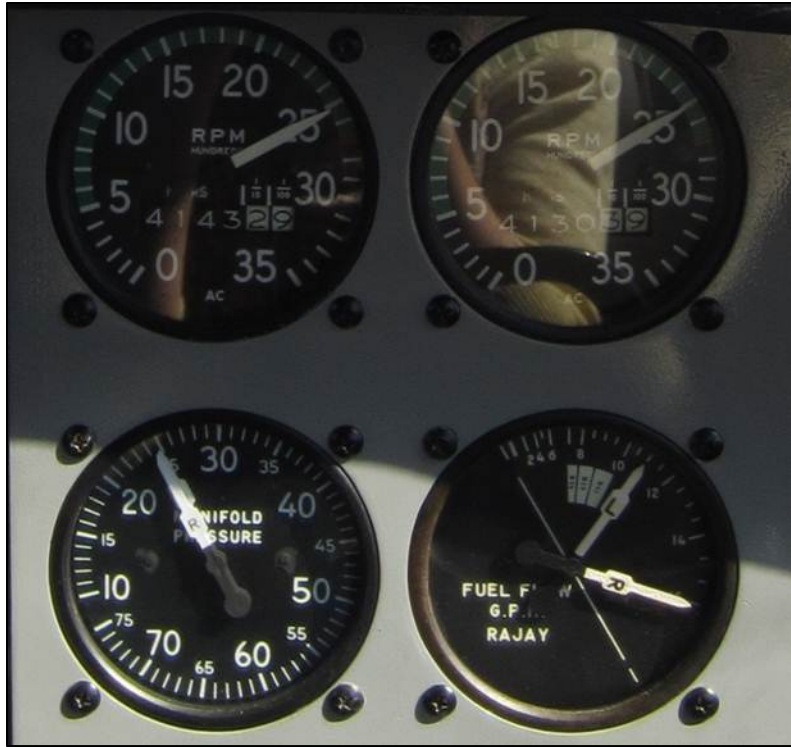
Photo 2, taken during a flight on 23 March 2012 (12 flight hours before the accident), shows the right engine's fuel-flow indication 45% higher than the left engine's fuel flow for the same throttle setting and manifold pressure. No defect was noted in the logbooks. The systems description section of the POH states that, "It is important to note that an indication of

increasing or abnormally high fuel flow is a probable symptom of restricted injector lines or nozzles." The fuel-flow gauge, marked in gallons per hour, does not directly measure fuel flow, but rather measures metered fuel pressure to the fuel nozzles. If one nozzle becomes partially or completely obstructed, fuel pressure to the remaining nozzles will increase (showing an increased fuel flow on the gauge), but the total fuel flow to the engine will not. The cylinder with the obstructed nozzle will receive a leaner mixture, while the other cylinders will receive a richer mixture. Engine vibration will increase, and although EGT will vary depending on the fuel/air mixture to each cylinder, any cylinder with a significant fuel nozzle obstruction will have a markedly decreased EGT. Engine power will be reduced. However, on engines equipped with constant speed propellers (such as the accident aircraft), rpm and manifold pressure may indicate near normal.

Photo 2. Fuel-flow indicator, 23 March 2012

No anomalies were found on the left engine. The spark plugs in 3 cylinders on the right engine showed high carbon buildup (likely indicating a rich mixture), while the spark plugs in the number 2 cylinder showed almost no carbon buildup. A partial obstruction, determined to be rust (TSB Laboratory Report LP242/2012), was found in 1 fuel nozzle (injector) on the right engine. That nozzle was found to flow to about 1/3 that of the other 3 fuel nozzles on that engine. A significant amount of rust was found on and around the steel components in the fuel-flow divider, immediately upstream of the nozzles.

The partially obstructed fuel nozzle prevented the right engine from producing as much power as the left engine. The exact amount of power reduction could not be determined, but the aircraft's climb performance on the day of the accident was far lower than the figures stated in the pilot's operating handbook. The fuel-flow indicator showed that the right engine's fuel flow was higher than the left engine's, when in fact it was lower. As a result of that incorrect indication, and of normal revolutions per minute (rpm) and manifold pressure indications, it is likely that the pilot did not recognize the problem or its consequence.
