**AVIATION INVESTIGATION REPORT
A13H0001**

**CONTROLLED FLIGHT INTO TERRAIN
7506406 CANADA INC.
SIKORSKY S-76A (HELICOPTER), C-GIMY
MOOSONEE, ONTARIO
31 MAY 2013**

Summary

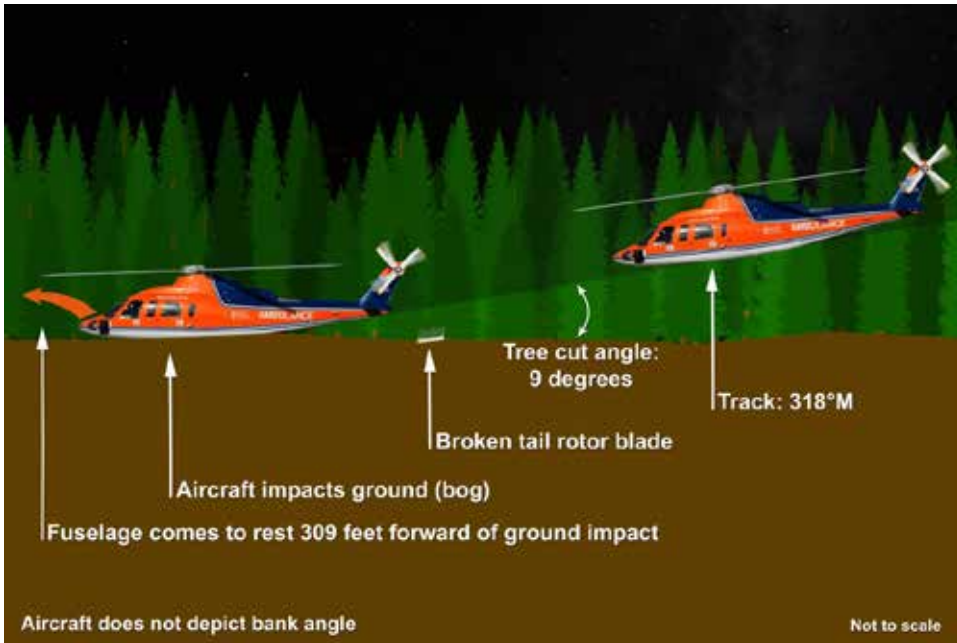
Figure 2. Depiction of C-GIMY's descent (side view)

The wreckage was located in densely wooded, swampy terrain approximately 0.8 sm from the end of Runway 06, on a bearing of 020°M (Figure 1). Based on damage to surrounding trees and ground scars, investigators determined that the aircraft collided with the ground in a steady, shallow descent angle (approximately 9 degrees), in a left-banked (approximately 20 degrees) attitude (Figure 2 and Figure 3). Although it was not possible to determine the exact speed of the helicopter at the time of the accident, the damage to the surrounding terrain and trees, length of the wreckage trail, and extent of aircraft breakup during the impact sequence indicated a high-energy state (consistent with the helicopter being at or near cruise speed) upon impact with the ground.

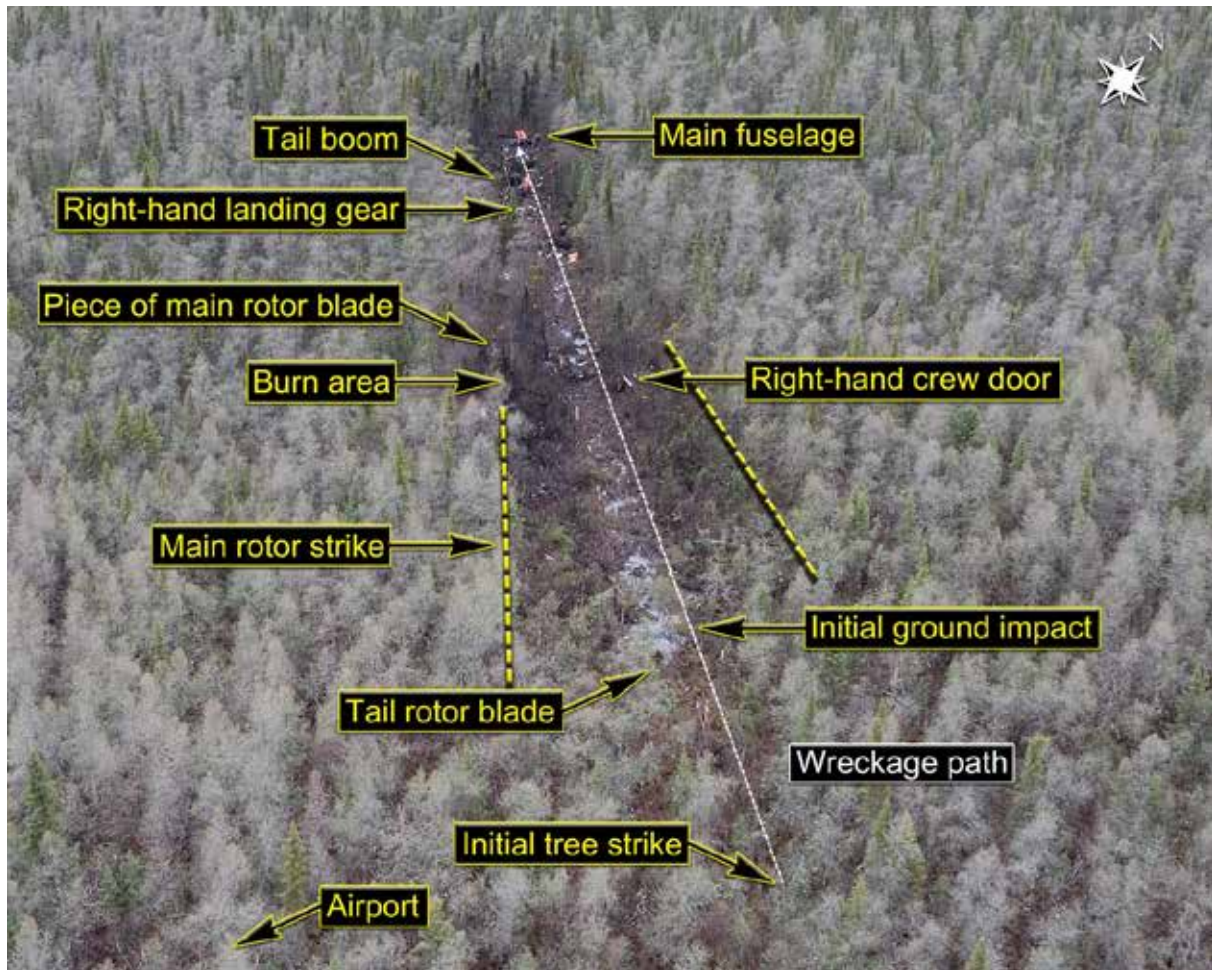
Figure 4. Overhead view of the wreckage path: 405 feet, 318°M track

The length of the crash swath path, from the first indication of contact with the trees to the location of the main wreckage, was approximately 405 feet. At the point of ground impact, the swath path was approximately 40 feet wide, gradually narrowing to approximately 20

feet, and then widening out again to form a circular, burned-out area approximately 35 feet in diameter (Figure 4).

The point of initial impact was approximately 96 feet past the first indication of damage to the tops of the trees. Between the first indication of damage to the trees and the impact point, there is a definitive pattern of cut trees. The trees are cut to within 3 feet at the lowest point, corresponding with a left-bank attitude as the aircraft descended into the trees and the fuselage made contact with the ground.

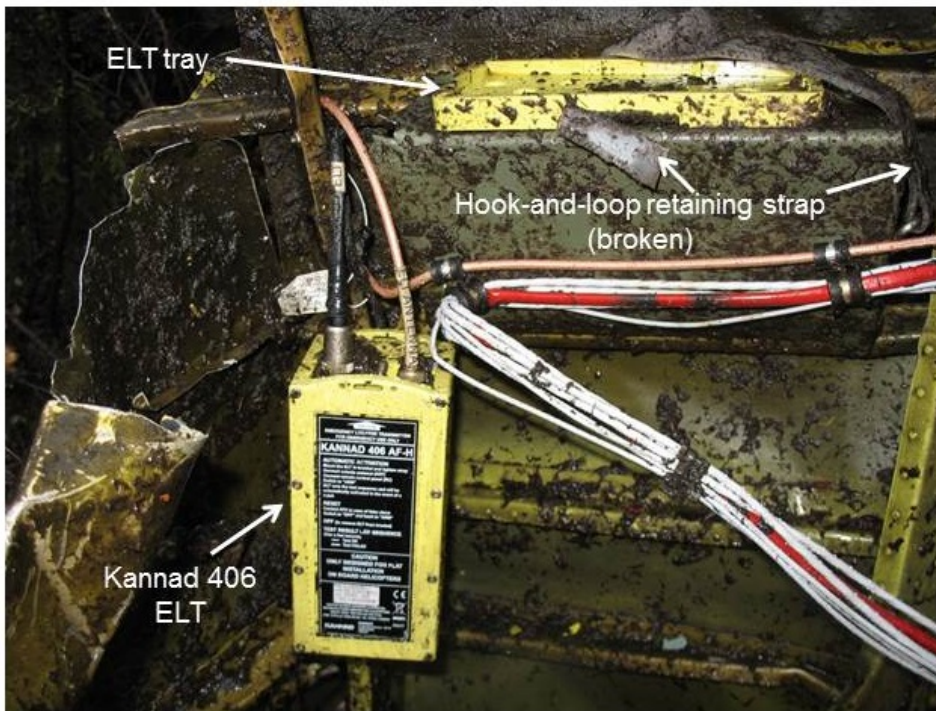
Figure 5. The occurrence aircraft's Kannad 406 MHz automatic fixed helicopter (AF-H) emergency locator transmitter (ELT) hanging by its wires

The Kannad 406 MHz AF-H ELT has a 3-position switch on the body of the ELT that allows for selection of "arm", "off", and "on". The ELT switch was found at the accident site in the "arm" position. The ELT unit, which was held in position by a hook-and-loop retaining strap, was found hanging by its wire harness by search-and-rescue (SAR) personnel. The strap was ripped near the bottom of the tray, allowing the unit to hang freely (Figure 5).

The Kannad 406 MHz AF-H ELT exhibited minor damage to its case. Functional tests were performed to determine the serviceability of the ELT. Using the internal battery, the ELT did not provide a status indication, nor did the device produce any transmissions. However, when an external power supply was used, the ELT's status light flashed repeatedly,

Additional testing of the ELT confirmed that it would be activated when subjected to impact forces that were within the specified “g” range of the unit. This confirmation, in conjunction with the fact that the ELT’s battery pack was depleted, strongly suggests that the device did activate on impact and did transmit a signal. However, no signal was received due to the damaged antenna.

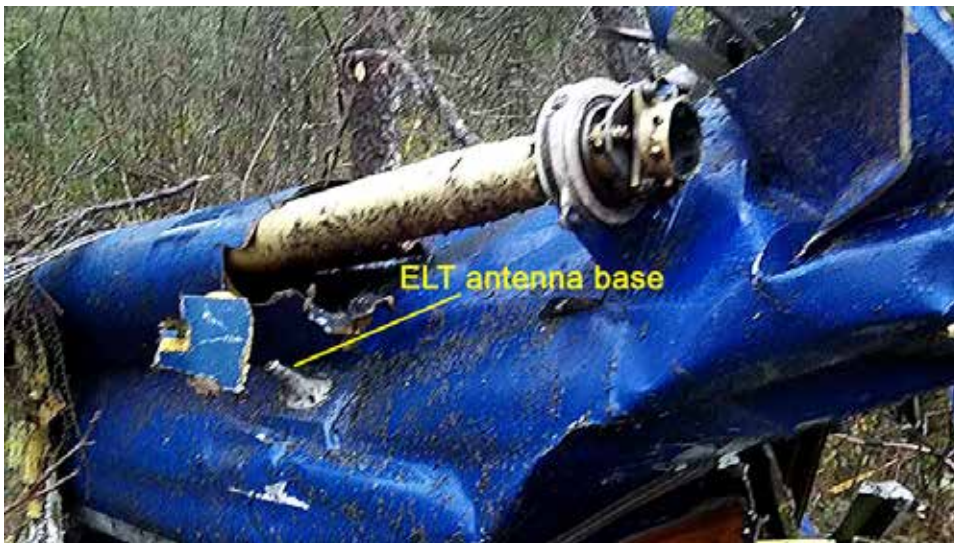
Figure 6. A frame grab from a field video of the wreckage showing the severed emergency locator transmitter (ELT) antenna

In addition to the detachment of the unit from its mounting tray, the external antenna located on the tailboom had been severed due to ground impact forces (Figure 6).
