**AVIATION INVESTIGATION REPORT
A13Q0021**

**LOSS OF CONTROL DURING HYDRAULIC PRESSURE
FAILURE TRAINING
EUROCOPTER AS350 BA HELICOPTER, C-GPHN
HÉLI-EXCEL INC.
SEPT-ÎLES AIRPORT, QUEBEC
03 FEBRUARY 2013**

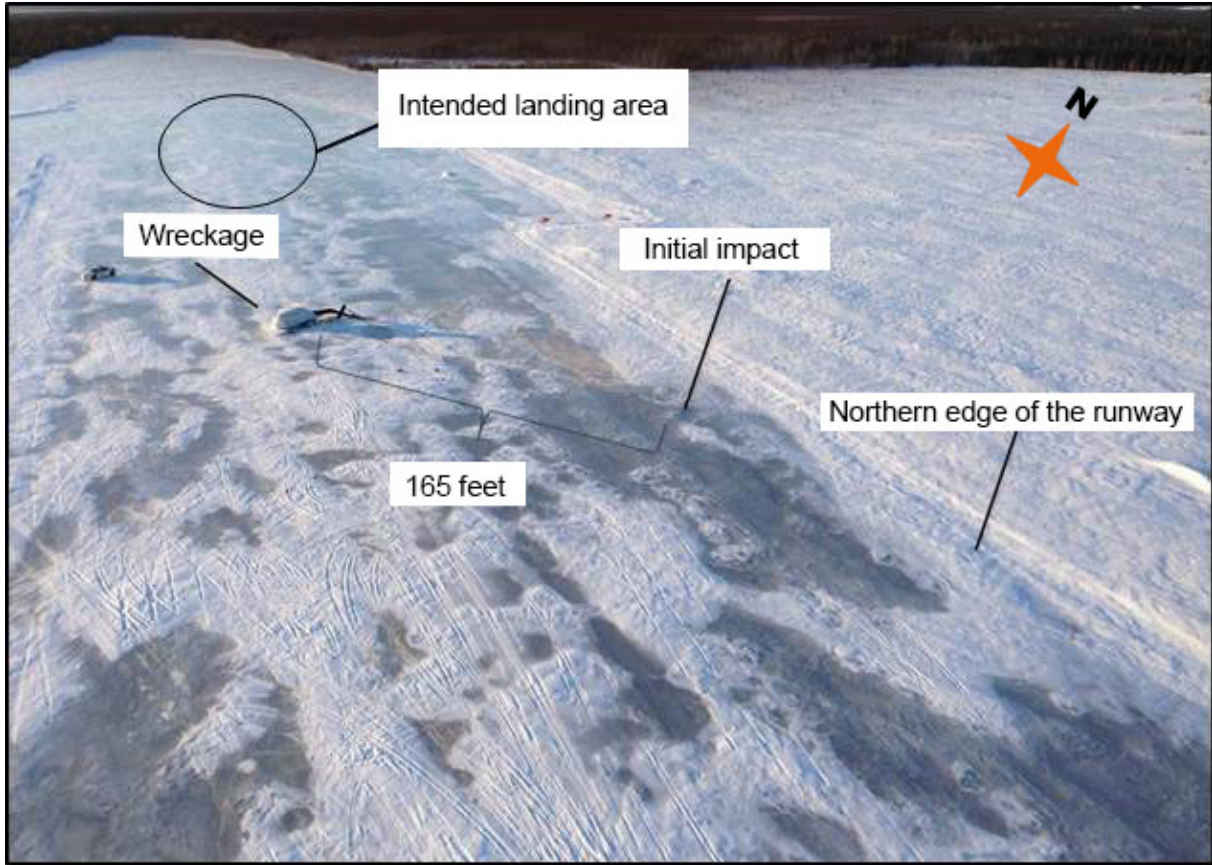
Figure 2. Aerial view of the accident site

The aircraft struck the ground in a nose-down attitude of about 45° and a left bank angle of about 100°. The first point of impact was near the northern edge of Runway 13/31 (Figure 2). The main rotor blades struck the runway first, followed by the nose of the helicopter. The aircraft slid approximately 165 feet on its left side toward the centre of the runway before coming to a stop on Runway 13/31 about 1000 feet from the threshold of Runway 13.

The collision with the ground caused major damage to the aircraft. The front part of the aircraft, including the nose, windshield, canopies and instrument panel, was torn off. The 2 pilot seats separated from their anchors. The impact caused the tail boom to bend upward and to the left; it sustained an almost full-circumference fracture about 24 inches in front of the horizontal stabilizer. The top of the fuel tank was cracked along the left side from front to rear. The 2 tail rotor blades were not damaged. The engine was still running after the crash. The observer pilot seated at the rear of the cabin had to pull the FUEL SHUT OFF VALVE lever to shut it off.

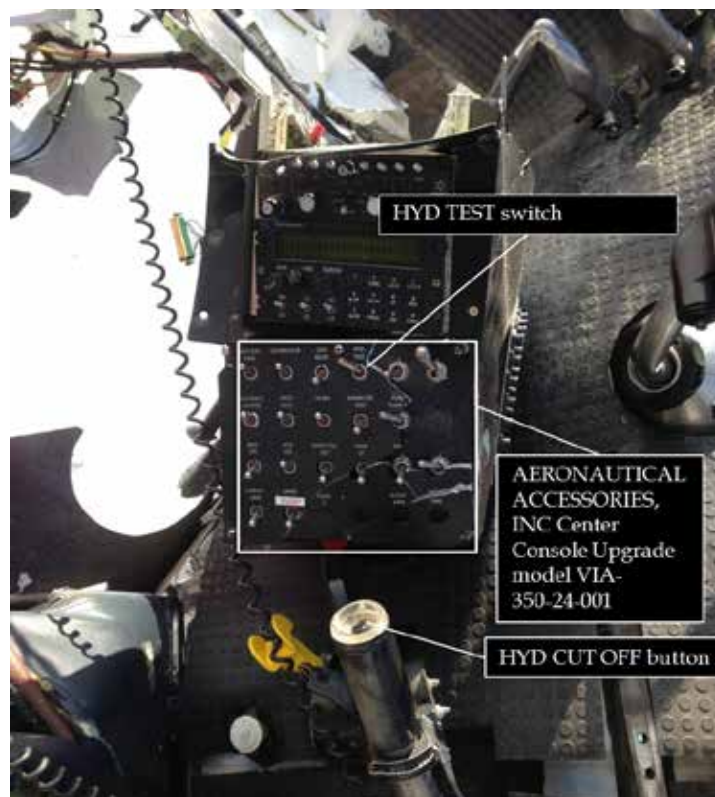
Figure 4. C-GPHN centre console, rear-to-front view in cockpit

The HYD TEST switch is located next to other similarly shaped switches (Figure 4). It was determined that the HYD TEST switch can be inadvertently actuated during flight because of its proximity to other switches. In November 2005, Eurocopter issued Service Bulletin SB 67.00.32 which recommended the installation of a retractable guard/cover (protection flap) over the switch on Honeywell centre consoles to prevent the unintentional operation of the HYD TEST switch.

Accessories, Inc. centre console is not of a specific shape and is not equipped with a protection flap, or have the "pull-to-unlock" design. Since AD CF-2007-19R1 applies to AS350s equipped with a Honeywell centre console, C-GPHN was not required to comply with the corrective measures set out in the AD.

- the HYD TEST toggle switch was pushed forward and to the left in the TEST position (Figure 4);
- the HYD CUT OFF pushbutton at the end of the collective stick was set in the CUT OFF position;
- the damages (deformation, failure) observed during examination of the drivetrain were attributable to the accident;
- a continuity and integrity check of the drivetrain revealed that it was intact before the accident;
- no pre-impact deformation or failure was noted in the flight controls.

The HYD TEST switch was not equipped with a protection mechanism. The switch was found pushed up and to the left in the TEST position. The 2 switches located diagonally on the second and third rows of the centre console were also pushed up and to the left (Figure 4). It was concluded that the 3 switches were pushed in the direction of impact, probably when the pilot in training hit the centre console. If the HYD TEST switch is not equipped with a protection mechanism, there is an increased risk of unintentional operation, which can cause the hydraulic system to depressurize.

Nonetheless, the intended purpose of the AD was to prevent the unintentional deactivation of the hydraulic system. Given the serious risks involved in such a situation, it is reasonable to think that all HYD TEST switches should be fitted with a protection flap or mechanism to prevent unintentional operation. In this instance, Aeronautical Accessories, Inc. published Aircraft Service Bulletin No. AA-13062 in December 2013 providing instructions for the replacement of the existing HYD TEST toggle switch with a “pull-to-unlock” design. Aeronautical Accessories, Inc. states that the bulletin must be complied with no later than 30 June 2014. However, in Canada, compliance with aircraft service bulletins is not mandatory for private aircraft. According to the information obtained during the investigation, TC is contemplating issuing an airworthiness directive in this regard, making a protection mechanism mandatory for the HYD TEST button on all centre console models.

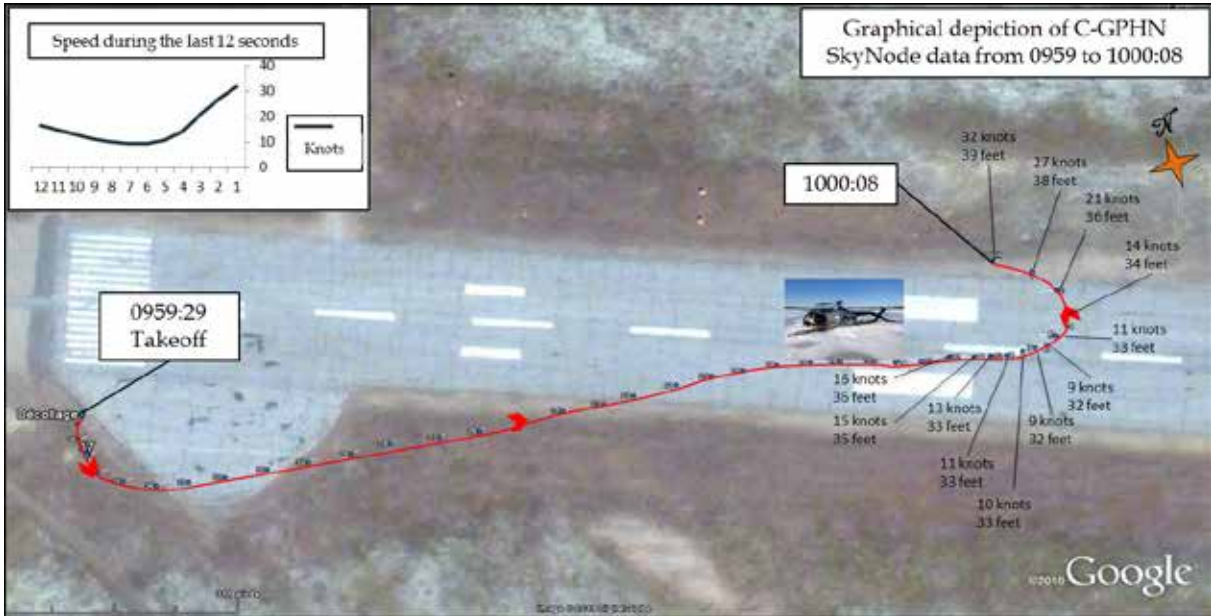
Figure 7. Flight path during last hydraulic failure drill (Source: Google Earth, with TSB annotations)

The SkyNode memory contained data from 1345:57 UTC⁹ to 1500:08 UTC. The SkyNode recorded data every 2 minutes, except for the last 2 minutes of the flight when data were recorded every second. With these data, the approximate flight path could be reconstructed (Figure 7). The last recording indicates that the helicopter was 39 feet above ground level (agl) at a groundspeed of 32 knots (Figure 8).

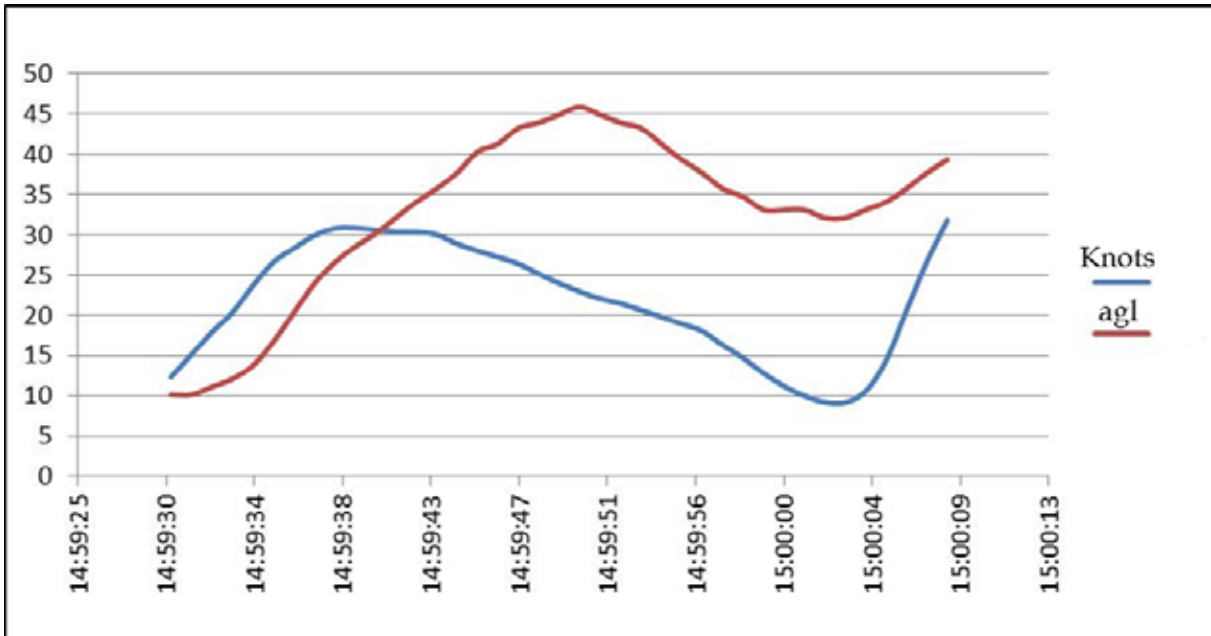
Figure 8. Groundspeed and height of the aircraft before the crash

The sudden movement of the cyclic stick forward and to the left occurred while the helicopter was accelerating from 9 to 32 knots and was not aligned with the landing point. Thus, the sudden change in direction of the aerodynamic feedback forces generated by the rotor head caused the cyclic stick to move in the direction of the forces exerted by the flight instructor and out of the palm of his hand.

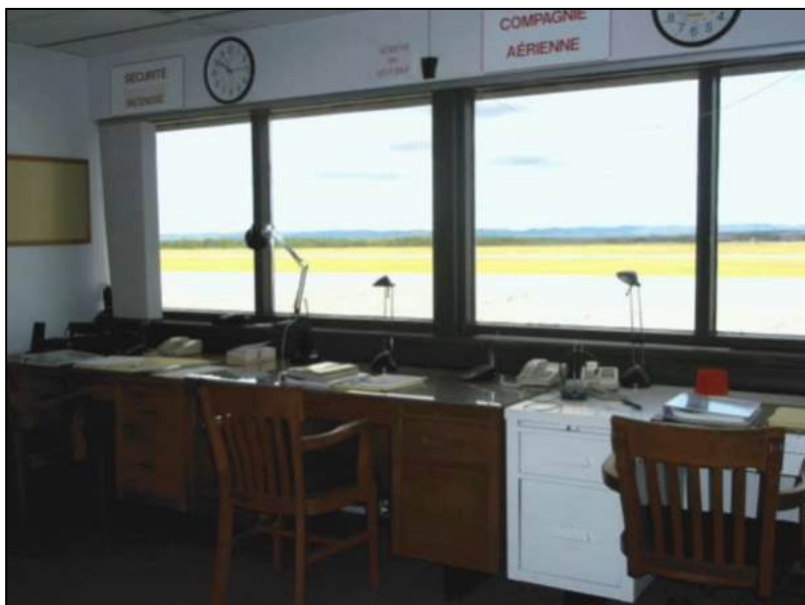
Photo 1. View of Sept-Îles Airport's emergency operations centre

However, the very nature of an emergency drill is such that some shortcomings are always identified. The presence of a large number of responders in the FSS tower impeded the specialist's work. It was also found that there was insufficient personnel at gate 7 to escort responders to the accident site.
