# AVIATION INVESTIGATION REPORT

## A15O0188

### **Collision with terrain**

Cessna 182H, C-GKNZ

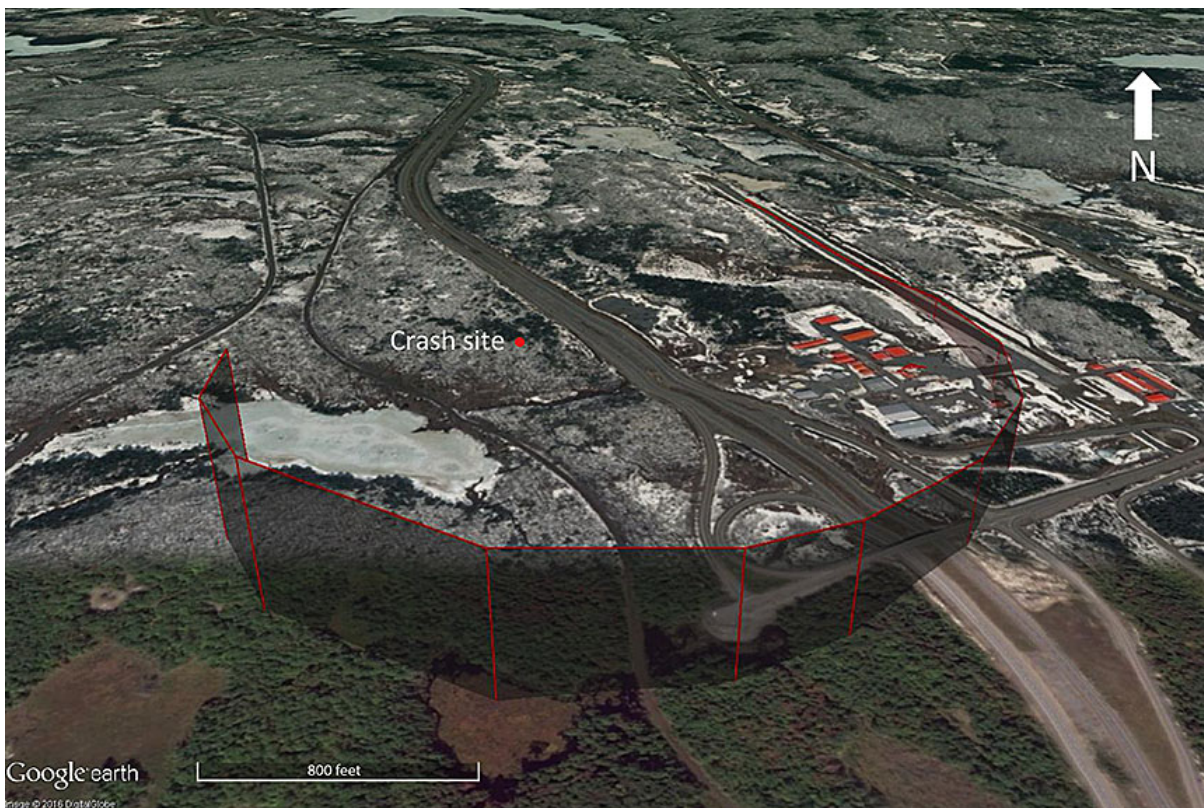
Figure 1. Flight path using recovered GPS data (Source: Google Earth, with TSB annotations)

Data recovered from an onboard portable global positioning system (GPS) showed the aircraft taxied on Runway 35 before it took off from Runway 17. The aircraft became airborne just prior to the mid-point of the runway, at 1925:15.<sup>2</sup>

As soon as the aircraft became airborne, it started a climbing right turn for approximately 90° of the heading. At 1926:02, the aircraft began to descend while continuing the right turn for an additional 180°. At 1926:05, the GPS stopped recording, and shortly afterward the aircraft collided with the terrain (Figure 1). The aircraft clipped trees in a nose-down attitude with a significant angle of bank to the right before striking the ground on a rocky downward slope.

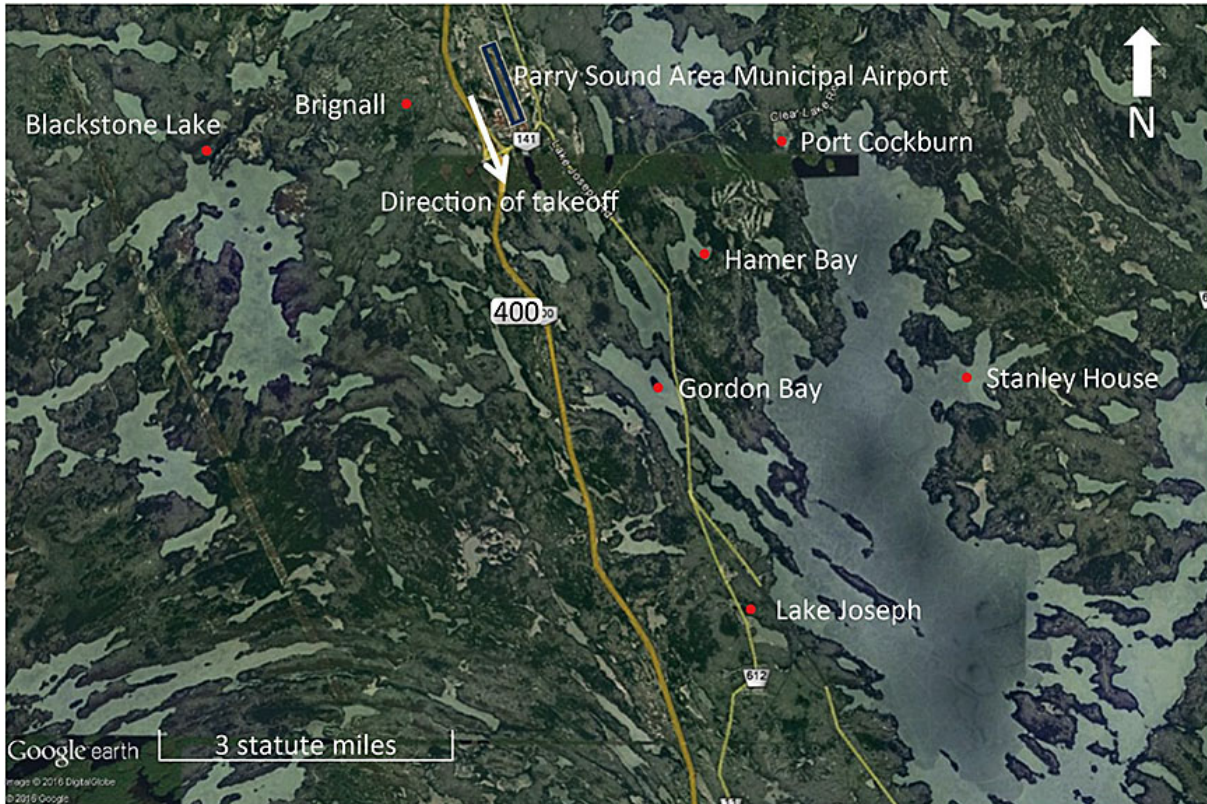
Figure 2. Departure airport and surrounding area (Source: Google Earth, with TSB annotations)

The pilot could expect some cultural lighting (e.g., cottages, traffic on Highway 400) to the south of the airport, but the availability of cultural lighting was limited to the west of Highway 400, which is the direction the aircraft turned after takeoff (Figure 2)

There would have been limited ambient illumination available from the waning crescent moon, with less than 4% of the moon's visible disc illuminated.<sup>6</sup> The new moon took place on 11 November 2015, 2 days after the occurrence. Other pilots operating in the vicinity of CNK4 that evening reported that there was no discernable horizon when looking to the west.
