AVIATION INVESTIGATION REPORT

A16Q0119

Loss of control and collision with terrain

Cessna U206F, C-FWBQ

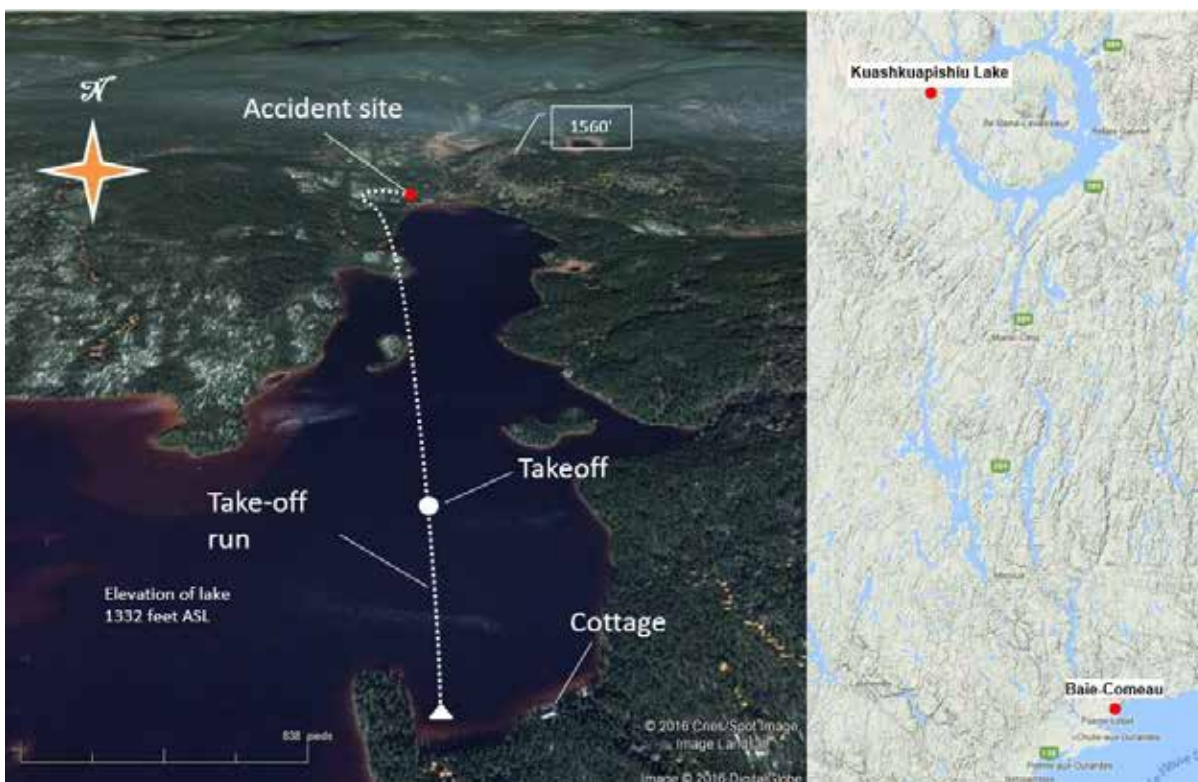
Figure 1. Trajectory of the aircraft during takeoff at Kuashkuapishiu Lake (51° 31'01.12 N, 069° 12'03.47 W) (Source: Google Earth, with TSB annotations)

A few moments later, the engine stopped and the pilot felt a reduction in the response to elevator and aileron control input, and at the same time noticed a 20-knot reduction in airspeed. The pilot decided to return to Kuashkuapishiu Lake and began a right turn by applying the right rudder pedal. The stall warning alarm then began sounding. The right wing dropped, and the aircraft nosedived.

The pilot pushed the control yoke forward. The aircraft lost altitude and crashed into a forested area a few metres from the lake tributary (51°30'58.95" N, 069°12'2.92" W). An intense fire broke out immediately upon impact. Only the pilot, whose clothes were on fire, was able to escape from the wreckage and dive into the river.

The observed takeoff run on the water during the occurrence flight was approximately 1600 feet. The aircraft had not yet reached 200 feet AGL when it was approximately 7000 feet from the point where the takeoff run had commenced.

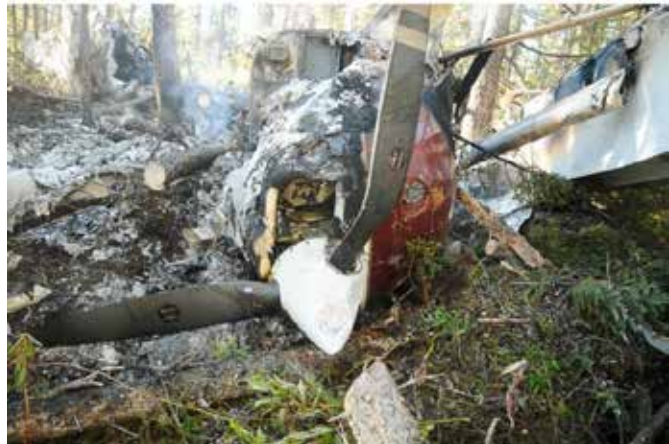
Figure 6. View of engine and propeller

Following the accident, the engine was sent to the TSB Engineering Laboratory in Ottawa for disassembly and examination. No abnormalities were found on the engine. However, disassembly of the engine-driven fuel pump revealed that the coupling shaft between the pump and the engine was sheared. No other sign of failure that might have contributed to the accident was found. No indication of engine or propeller rotation was observed.

Examination of the engine-driven fuel pump was unable to determine the cause of the sheared coupling shaft. However, examination of the area where the coupling shaft sheared indicated that the shear occurred while the engine was running at high speed, rendering it instantly inoperative and cutting off the engine's fuel supply. The pump had been overhauled on 15 October 2009 by a certified maintenance organization and had logged around 253 hours in service since its installation.

The 3-blade propeller (McCauley D3A34C401-C) was coupled to the engine. An examination of the propeller at the accident site and at the TSB Engineering Laboratory did not reveal any signs of rotation at impact. The blade that was perpendicular to the top of the engine was not bent or twisted. The 2 other blades were bent backward and showed no sign of torsion (Figure 6). There were no further indications of propeller rotation observed on the trees or ground.
