AVIATION INVESTIGATION REPORT

A17C0132

Loss of control on landing and runway excursion

Fairchild SA227-AC Metro III, C-FLRY

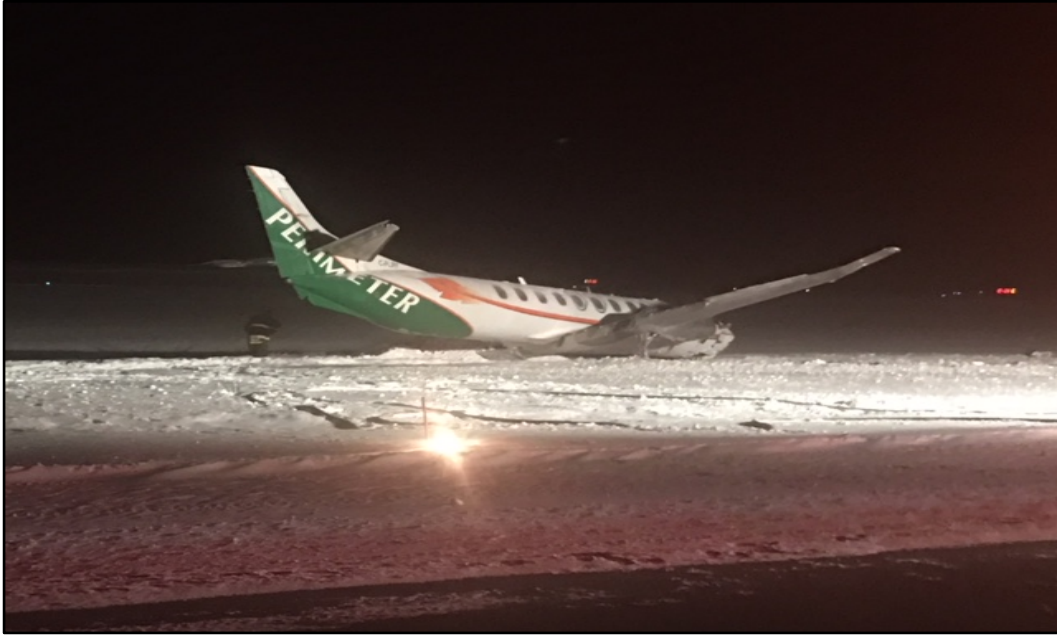
The left main landing gear and the nose landing gear were torn out and the nose section of the aircraft was severely distorted (Figure 1). The right wing-tip was bent upward and the left wing exhibited damage to the leading edge, wing-tip and flap. Both sets of propeller blades were shattered down to the blade roots. The left propeller blades were found in the feathered position and the right propeller blades were found at a low angle, or start lock, position.

Figure 1. The occurrence aircraft after coming to a rest (Source: Thompson Regional Airport Authority)

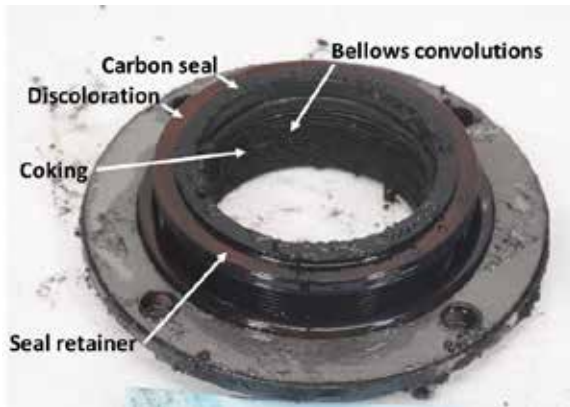
Figure 2. Air-oil seal assembly (stationary seal), showing discoloration and coking

The rear turbine air-oil seal assembly was removed and sent to the TSB Engineering Laboratory for further analysis. Other than the presence of coking, no abnormalities with the seal were noted.

An inadequate seal between the carbon seal and rotor seal and negative pressure within the scavenge pump unit likely drew in hot engine exhaust, resulting in elevated temperatures and discoloration of the rear turbine air-oil seal assembly. Oil within the scavenge pump unit leaked past the rear turbine air-oil seal, resulting in further coking on the carbon seal and oil to leak externally from the engine.

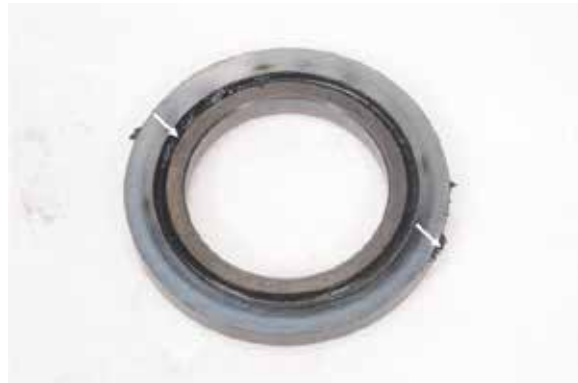
Figure 3. Air-oil seal assembly (rotor seal), with coking indicated by the white arrows
