# Air Transportation Safety Investigation Report A18C0018

## **BRAKE FAILURE AND GROUND COLLISION**

Private Cessna Citation Bravo 550, N4AT  
and  
Morningstar Partners Ltd., Bombardier CL-600-2B16, C-FXWT  
Winnipeg/James Armstrong Richardson International Airport, Manitoba  
15 April 2018

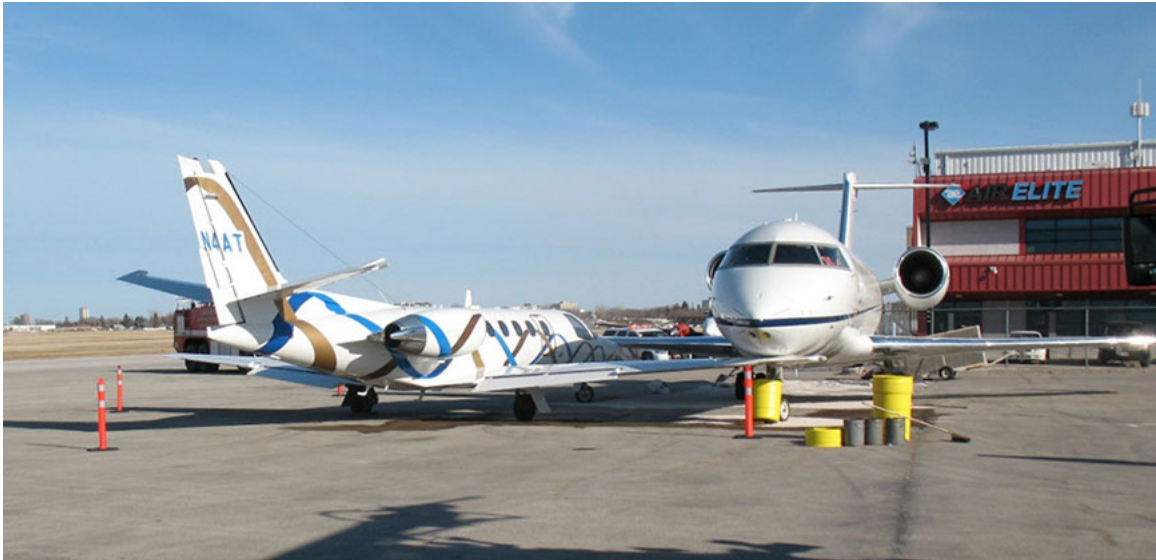
The Cessna's right wing subsequently collided with the nose gear of a Morningstar Partners Ltd. Bombardier CL-600-2B16 (Challenger 605) aircraft (registration C-FXWT, serial number 5824), which was parked facing the Cessna. As the Cessna's right wing contacted the Challenger 605's nose gear, the Cessna pivoted right and its nose contacted the Challenger 605's right wing (Figure 1).

Figure 1. Collision site, showing N4AT (left) and C-FXWT (right)

As a result of the collision, both aircraft sustained substantial damage.

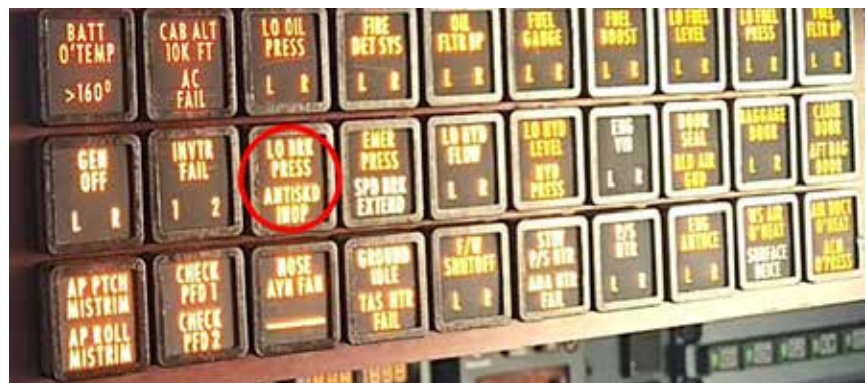
Figure 2. Annunciator panel in test mode with all lights illuminated and the LO BRK PRESS annunciator light circled

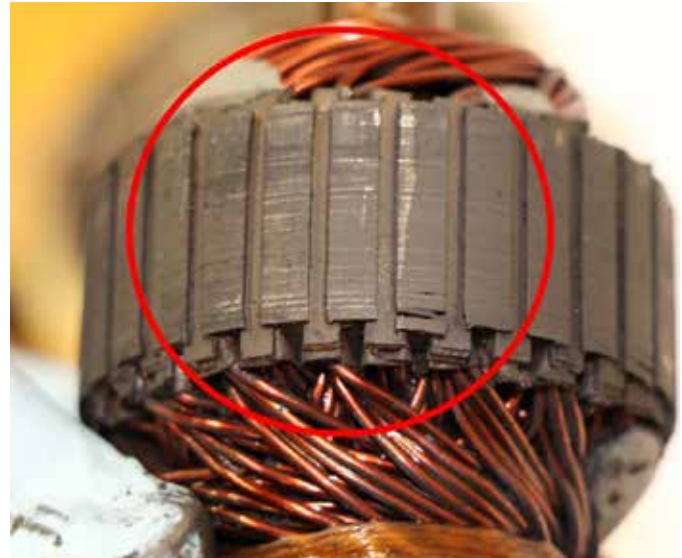
The TSB's on-site examination of the aircraft and subsequent laboratory testing of the hydraulic motor and pump assembly revealed that it would not operate. Disassembly of the motor revealed excessive wear of the armature

bearings and scarring on both the armature (Figure 3) and the stator (Figure 4). The scarring is indicative of the armature making contact with and binding against the stator.

Figure 3. Scarring marks on armature

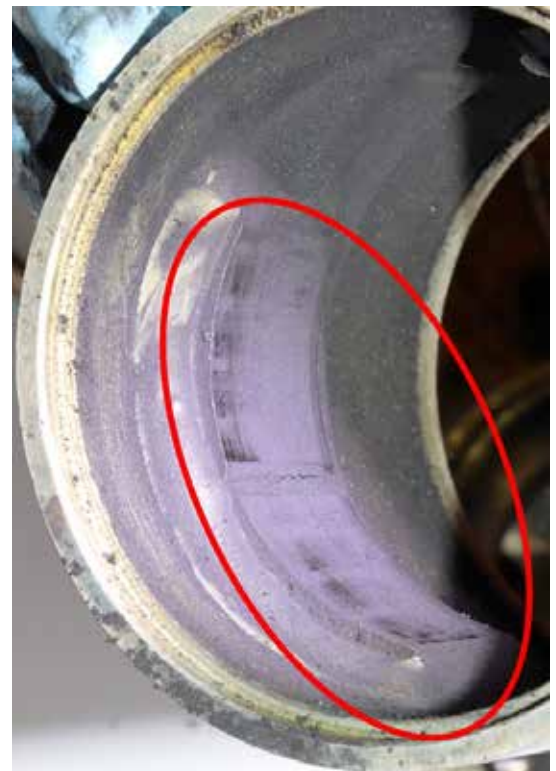
Figure 4. Scarring marks on stator

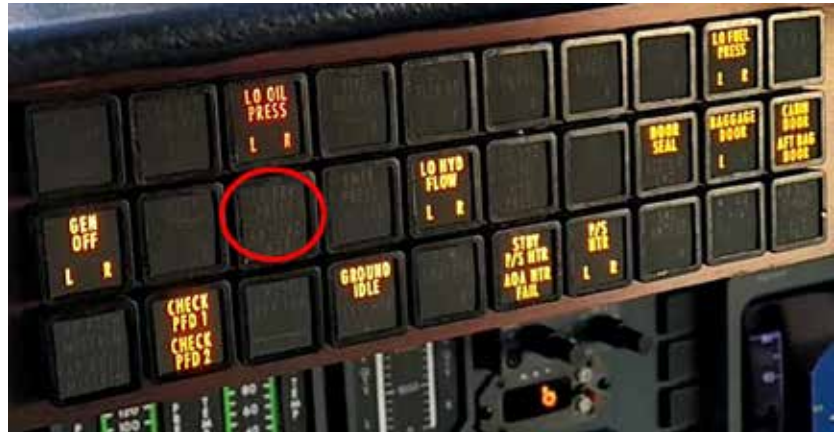
On-site examination revealed that the LO BRK PRESS annunciator light would not illuminate when the brake pressure was below 750 psi (Figure 5).

Laboratory testing of the power brake low-pressure switch revealed that the switch was in a constant open state.<sup>5</sup> Further analysis

revealed internal contamination with hydraulic fluid and damage to the secondary seal. The pressure plate was found jammed in the open position, likely the result of corrosion caused by hydraulic fluid. The open state of the switch prevented the power brake low-pressure light on the annunciator panel from illuminating in a low-brake-pressure situation.

Figure 5. Annunciator panel during on-site examination of occurrence aircraft
