AIR TRANSPORTATION SAFETY INVESTIGATION REPORT A18Q0030

RUNWAY OVERRUN ON LANDING

Strait Air (2000) Ltd.
Beechcraft King Air A100, C-GJXF
Havre St-Pierre Airport, Quebec
26 February 2018

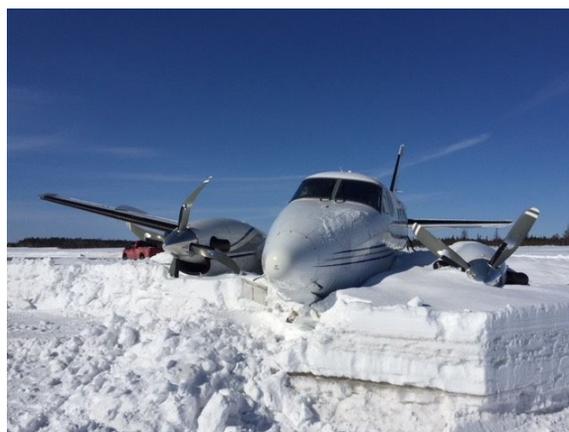
The force of the impact with the snowbank caused the propellers to halt abruptly and the blades to bend backward. It also caused substantial damage to the left landing gear and wings (Figure 2).

Figure 2. Wreckage of the occurrence Beechcraft King Air A100 (Source: TSB)

Despite the substantial damages to the landing gear and the wing structure caused by the impact with the snowbank, the deceleration forces did not jeopardize occupant survivability.⁴⁵ However, half of the occupants received minor injuries.

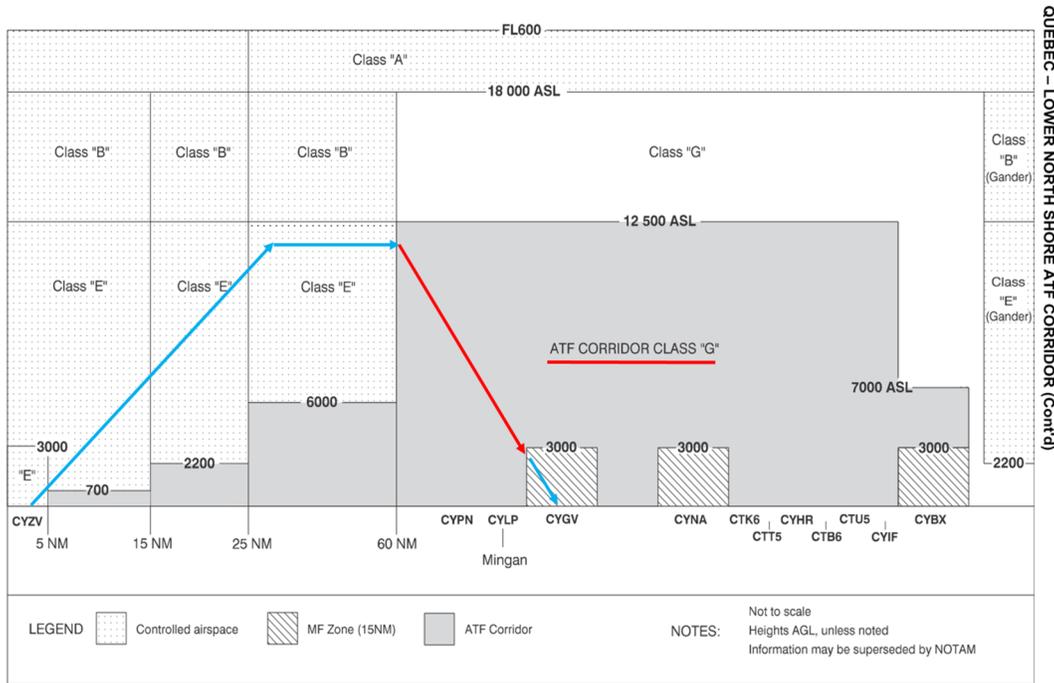
Figure 3. Aircraft’s path between the Sept-Îles and Havre St-Pierre airports: the absence of communications in the aerodrome traffic frequency corridor is shown in red (Source: NAV CANADA, Canada Flight Supplement, effective 01 February 2018 to 29 March 2018, Planning section, p. C98, with TSB annotations)

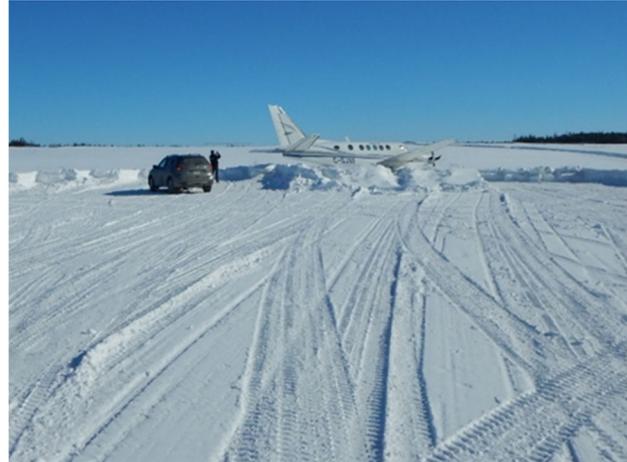
When they arrived on the scene, TSB investigators noted that the flaps were raised, the fuel system was cut and the electrical system was off. The pitch of both propellers was practically zero (0°), and all of the propeller blades were bent backwards. The landing gear collapsed and bent backwards, and the engine air inlets were blocked by compacted snow.

Figure 6. Position of the wreckage at the end of the runway (Source: TSB, photo taken 2 days after the accident)

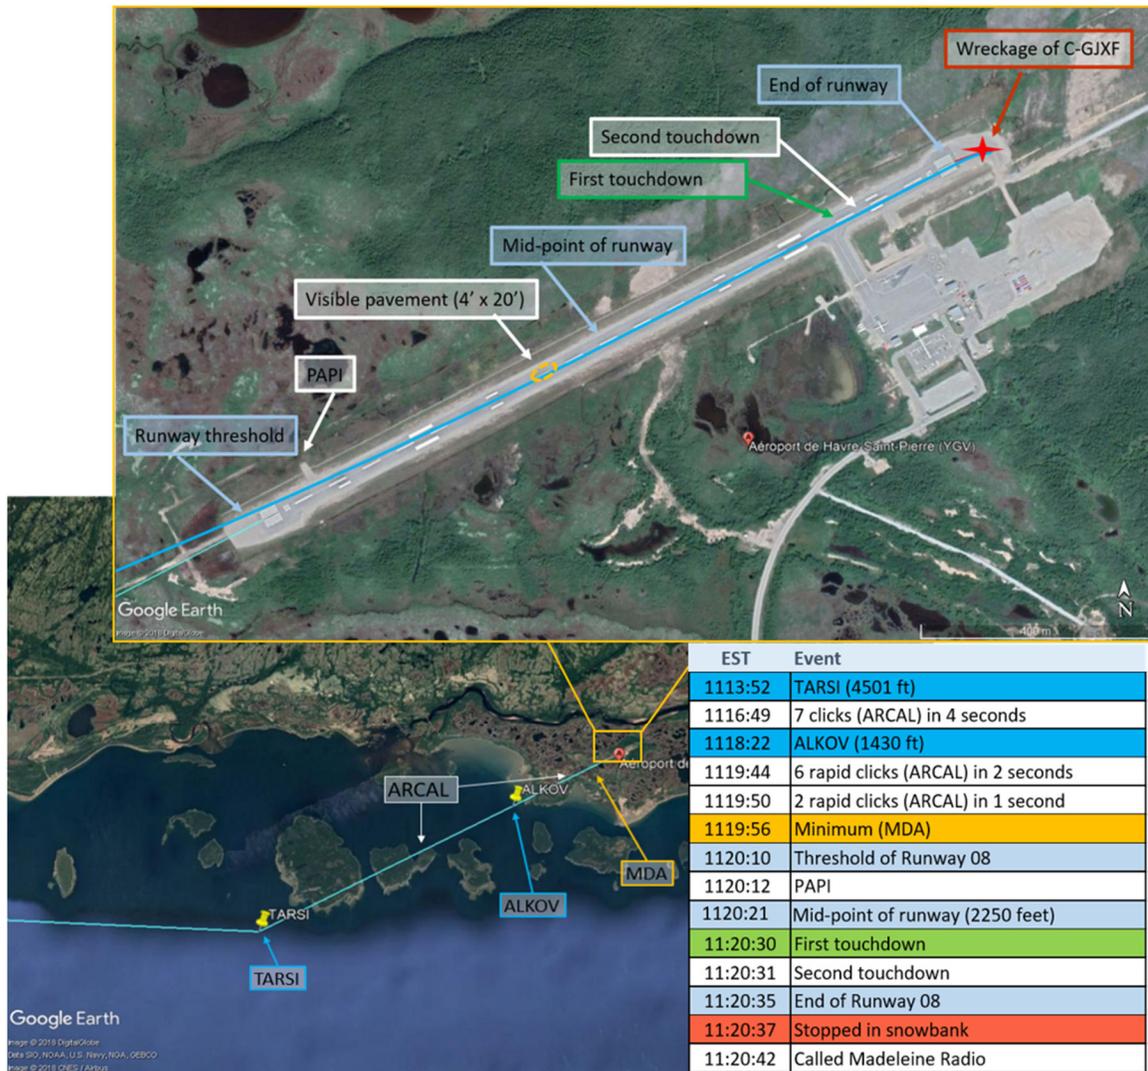
Given the lack of GPS data, the aircraft's approach and landing path was calculated using radar data, recordings of conversations with ATC, observation of the touchdown point, and testimonies. These calculations assisted in determining the aircraft's position and speed during approach, the moment when the aircraft crossed the runway threshold and the length of time the aircraft was flying over the runway before touching down (Figure 7).

Figure 7. Approach path of the aircraft on final and over the runway (Source: Google Earth, with TSB annotations)

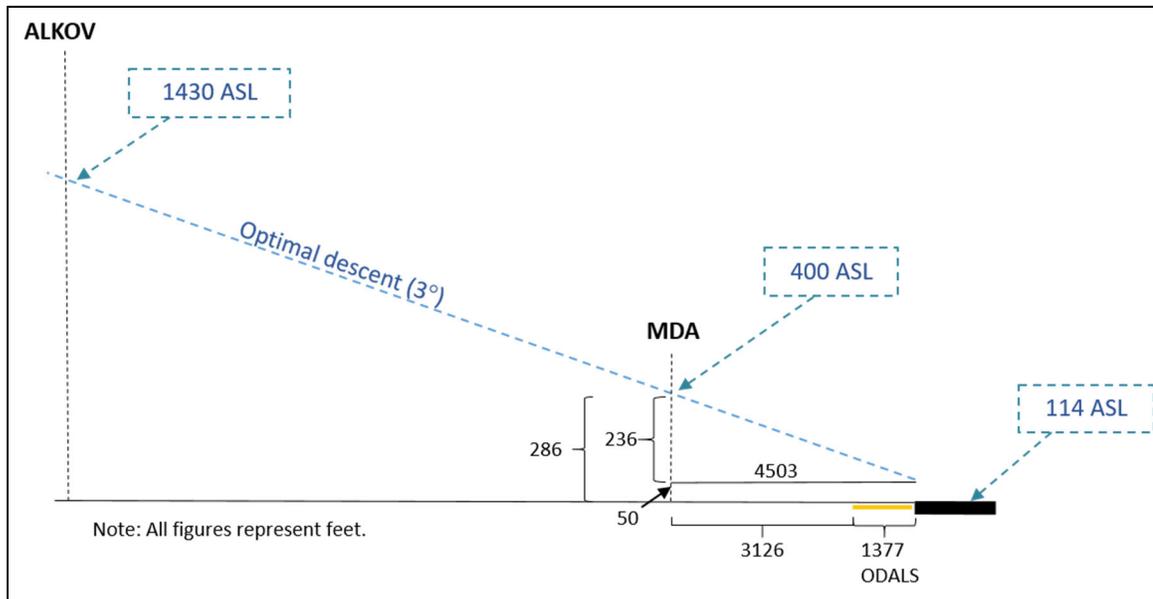
It was unlikely that the flight crew could see the visual references required at the MDA given that a visibility of $\frac{1}{4}$ SM corresponds to 1320 feet. Also, given that the runway and surrounding area were covered with snow, the runway surface would have been difficult to see, reducing the probability of a landing at CYGV.

Figure 12. Distance from the threshold and the omnidirectional approach lighting system at the minimum descent altitude (Source: TSB)
