AIR TRANSPORTATION SAFETY INVESTIGATION REPORT A19P0059

ENGINE POWER LOSS, FORCED LANDING INTO TREES

Lakes District Air Service Ltd.
Cessna 182E, C-FLVN
Smithers, British Columbia, 50 NM N
04 May 2019

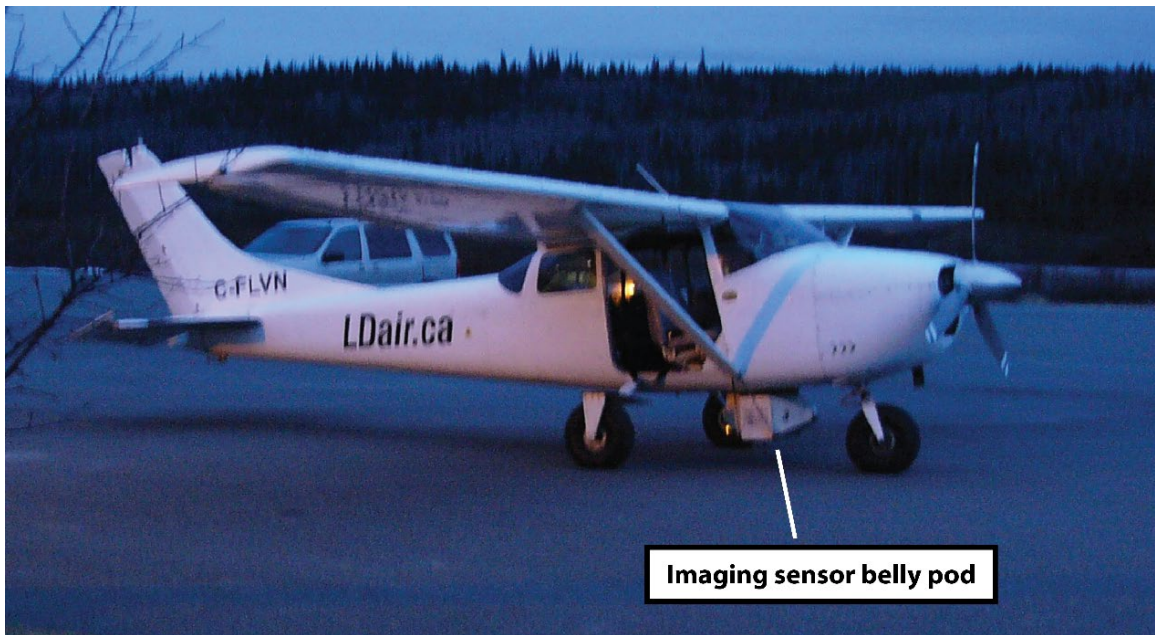
Figure 1. The occurrence aircraft on the morning of the accident with imaging sensor belly pod installed (Source: Precision Vector Aerial Inc., with TSB annotation)

On 01 May 2019, an imaging-sensor-equipped belly pod was installed on the aircraft (Figure 1), as per Supplemental Type Certificate (STC) SA4-662. On 02 and 03 May, flights were conducted to test and calibrate the scanning equipment to detect underground hot spots in areas of previous fire activity. During those flights, it was determined that the best scanning results were obtained when the aircraft flew at a height of between 3000 and 4000 feet above ground level (AGL) and a groundspeed between 80 and 90 knots. It was also determined that the scans were best performed early in the day, before solar heating of ground objects resulted in erroneous infrared signatures.

Imaging sensor belly pod

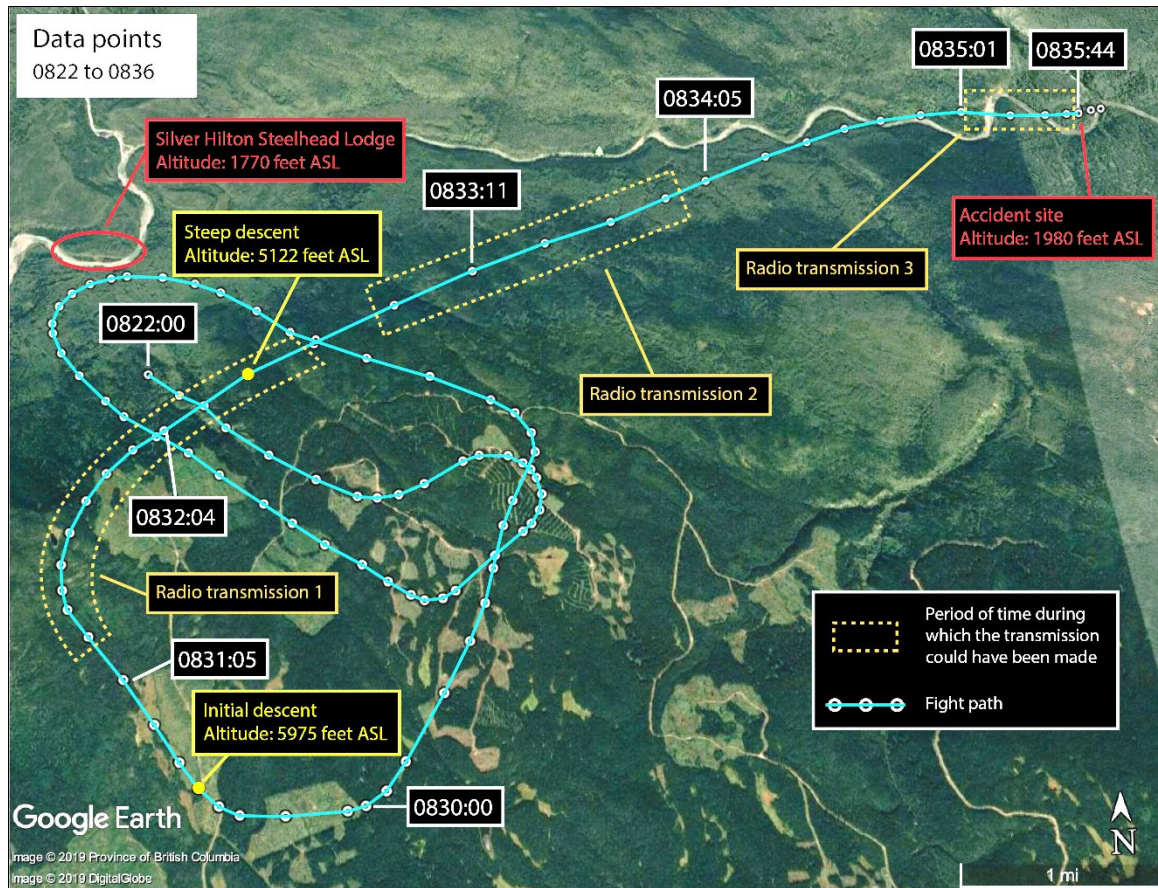
Figure 2. Flight path of the occurrence aircraft (dotted line) with associated events (Source: Google Earth, with TSB annotations)

The aircraft then continued 36 NM further north-northwest to the 2nd scanning site, 86 NM from CYPZ and about 48 NM north of Smithers. Radio check-ins confirmed normal operation, including a check-in at 0821, after more than an hour of scanning in the 2nd area. Shortly after that radio check-in, the aircraft's engine performance degraded. At 0832, the pilot advised the NWFC dispatchers that the aircraft would be landing at the Silver Hilton Steelhead Lodge airstrip,⁴ which was located approximately 2.5 NM to the northwest (Figure 2, radio transmission 1).

At 0833, the pilot transmitted a Mayday call to the NWFC dispatchers indicating that the flight would be unable to reach the Silver Hilton Steelhead Lodge airstrip and stated that he would "land 5 miles west"⁵ of the airstrip (Figure 2, radio transmission 2).

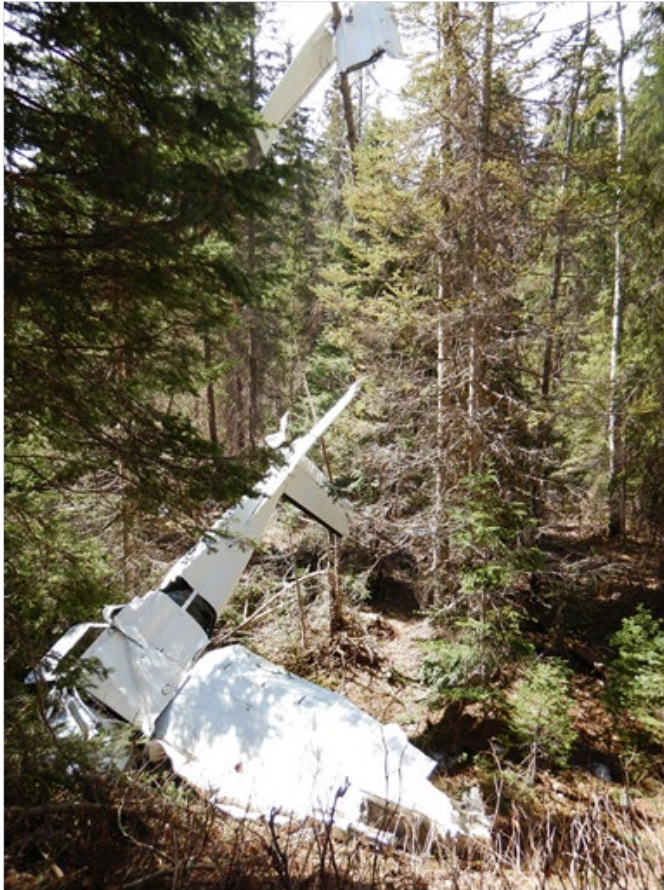
Figure 3. The occurrence aircraft at the accident site, with the right wing atop a tree (Source: TSB)

The aircraft struck multiple treetops along a nearly 500-foot-long path eastbound before striking a large tree trunk and descending steeply, coming to rest nose-down at the base of a small berm. The aircraft was destroyed due to collision with trees and terrain (Figure 3).

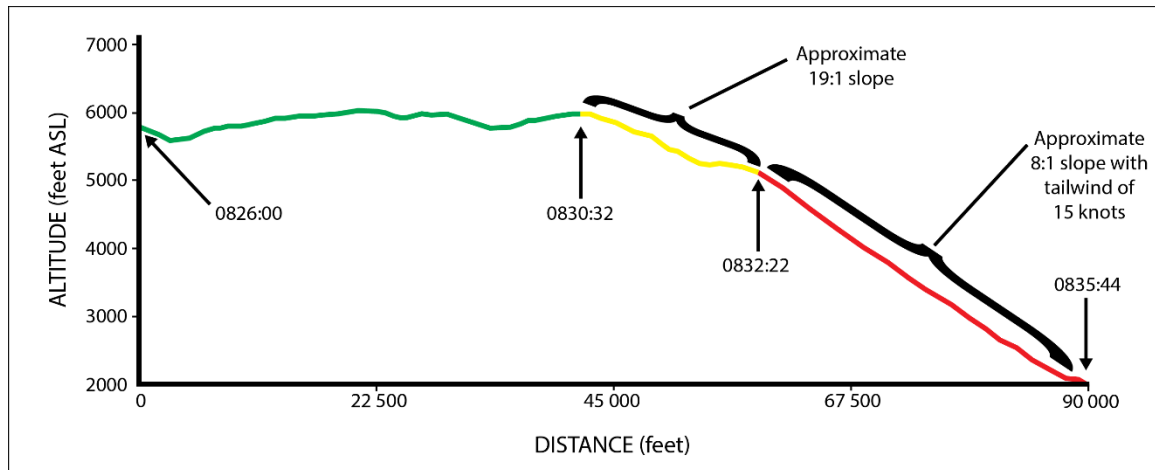
Figure 4. Occurrence aircraft altitude profile for the last 10 minutes of the flight (Source: TSB)

The flight was conducted under visual flight rules and in daylight visual meteorological conditions. The aircraft was equipped with a Garmin Aera 795 GPS. Data from this GPS were recovered and are presented in Figure 4. The investigation determined that the Silver Hilton Steelhead Lodge airstrip was not in the GPS database, nor was it required to be according to company procedures or Transport Canada regulations.

The GPS (global positioning system) data shows that when the aircraft's performance started degrading, the aircraft started a shallow descent (about 19:1 glide ratio) that lasted for almost 2 minutes, consistent with partial engine power. This was followed by a steeper descent (about 8:1 glide ratio) that lasted for over 3 minutes, consistent with a complete engine power loss. The ice that likely formed in the carburetor would have initially reduced the engine's ability to produce enough power to maintain altitude and eventually led to a complete loss of power.

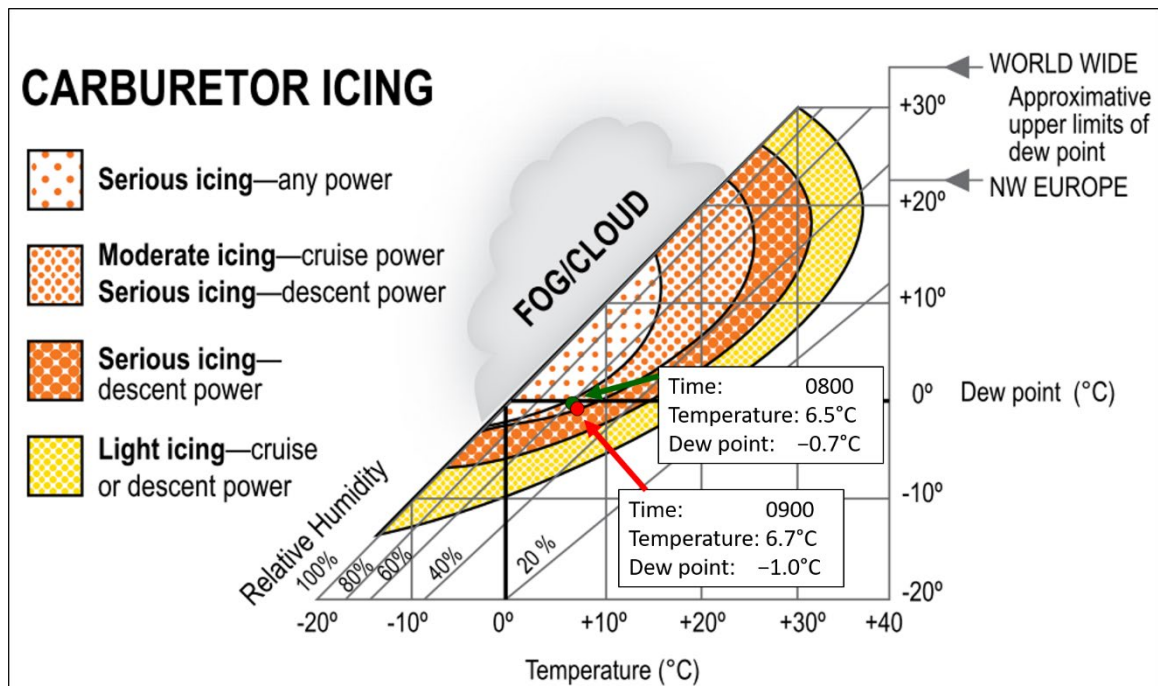
Figure 5. Carburetor icing potential based on ground-level weather conditions at Nilkitkwa, BC (Source: Transport Canada, TP 14371, Transport Canada Aeronautical Information Manual [TC AIM], AIR – Airmanship [10 October 2019], section 2.3, with TSB annotations)

To help determine whether atmospheric conditions are likely to produce carburetor ice, charts that compare outside ambient temperature and dew point have been produced (Figure 5).

The chart indicates that, based on the temperature and dew point at the weather station 14 NM from the accident site at the time of the occurrence, the conditions were conducive to serious carburetor icing even at cruise power. Although the dew point at the aircraft's location is not known, nearby rain showers indicate humidity at least as high as that at the weather station. When a dewpoint is not precisely known, the presence of precipitation should indicate to pilots that atmospheric conditions are high in relative humidity.¹¹ Furthermore, the likelihood of accumulating carburetor ice increases as both relative humidity increases and air temperature decreases towards 0°.¹²
