AIR TRANSPORTATION SAFETY INVESTIGATION REPORT A19Q0091

LOSS OF CONTROL ON TAKEOFF AND COLLISION WITH GROUND

Cargair Ltd.
Piper PA-23-250 Aztec, C-GDUL
Trois-Rivières Airport, Quebec
18 June 2019

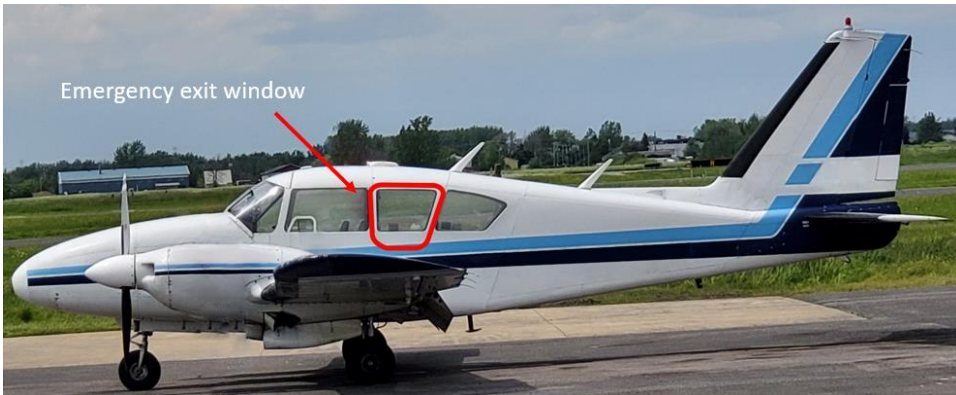
An emergency exit window is located behind the pilot's seat on the left side of the aircraft (Figure 5). The panel has a weatherproof plastic cover when it is installed, and this cover should only be removed in case of emergency.

Figure 5. Side view of the Piper PA-23-250 aircraft showing the emergency exit window (Source: TSB)
