Air Transportation Safety Investigation Report A20A0027

LOSS OF CONTROL AND COLLISION WITH TERRAIN

Privately registered
Robinson R44 Raven II (helicopter), C-FPBL
Thorburn Lake, Newfoundland and Labrador
20 July 2020

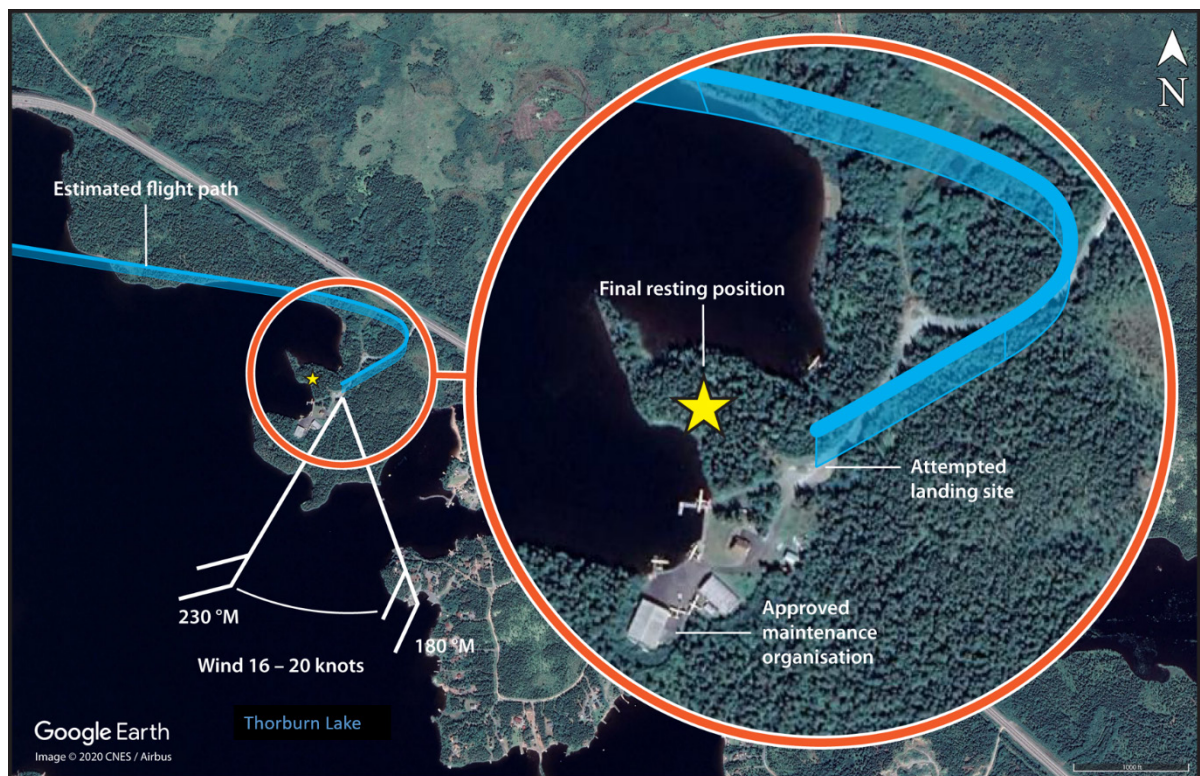
Figure 1. Estimated flight path, derived from global positioning system data (Source: Google Earth, with TSB annotations)

At approximately 1535, the occurrence helicopter made a right base leg turn onto the final approach heading of 240° magnetic (M). The wind direction at the time varied from 180°M to 230°M at an estimated speed of 16 to 20 knots. The occurrence pilot continued his approach to the landing site and entered an out-of-ground-effect hover over the landing site, just below the tree tops (Figure 1). Once established in the hover, the pilot determined there was not enough room to continue with the landing and initiated a vertical climb.

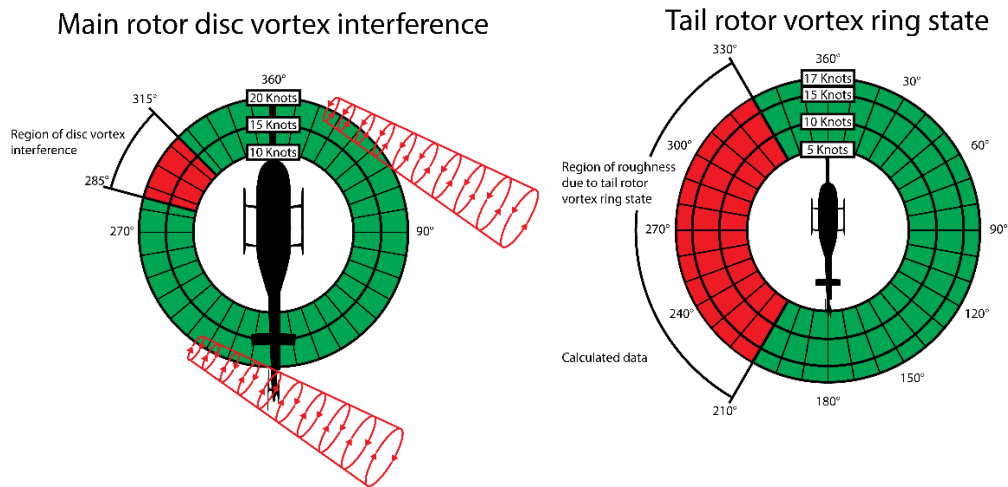
Figure 3. Main rotor disc vortex interference and tail rotor vortex ring state (Source: TSB, based on figures included in Federal Aviation Administration, Advisory Circular 90-95: Unanticipated Right Yaw in Helicopters [1995])

In addition, 4 relative wind azimuth regions can produce an environment that is conducive to LTE (Figure 3):

- main rotor disc vortex wind (winds from 285° to 315° relative to the helicopter);
- weathercock stability (winds from 120° to 240°);
- tail rotor vortex ring (winds from 210° to 330°); or
- loss of translational lift (winds from all directions).⁵

At the time of the occurrence, the helicopter was approximately 130 pounds below the maximum gross weight and in an out-of-ground-effect hover. Winds were estimated to be gusting up to 20 knots, turbulent, and approaching the helicopter from the left. Given these conditions, the helicopter was operating in a high power regime within the critical wind azimuth regions of the main rotor disc vortex wind and tail rotor vortex ring that could induce an unanticipated yaw.
