Air Transportation Safety Investigation Report A20P0080

COLLISION WITH TERRAIN

Aberdeen Helicopters Ltd.
Airbus Helicopters AS 350 B2 (helicopter), C-FAHC
Stewart, British Columbia, 45 NM NNW
17 August 2020

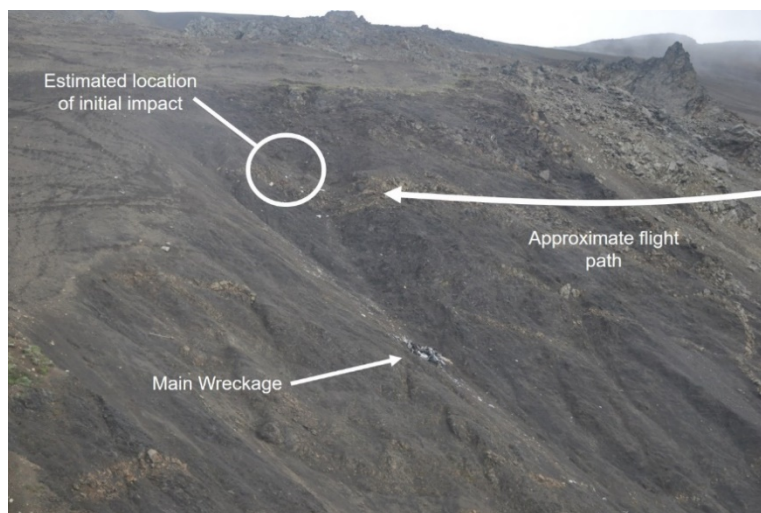
The wreckage was found at approximately 5500 feet ASL on a steep mountainside (Figure 2). The damage was consistent with a high-energy impact. Most of the aircraft was consumed by the post-impact fire with the exception of the tail boom and the floorboard area of the cabin.

All 3 main rotor blades remained attached to the rotor head and exhibited impact

damage consistent with high rotational energy of the rotor system as well as thermal damage. Impact signatures and markings on the tail rotor and driveshaft were consistent with tail-rotor driveshaft rotation at impact. Functional continuity of the flight control system and main rotor drive system could not be determined due to the damage from impact forces, but the flight controls were traced from the flight controls and remaining linkages to the main rotor and tail rotor systems. The engine

Figure 2. Occurrence site on 26 August 2020, looking northeast (Source: TSB, with TSB annotations)

was also damaged from impact forces, and there was fire damage to the outside accessory areas. The first stage compressor showed leading edge damage consistent with the ingestion of dirt or rocks.
