AIR TRANSPORTATION SAFETY INVESTIGATION REPORT A21A0024

STALL AND COLLISION WITH TERRAIN

Forest Protection Limited
Air Tractor, Inc. AT-802, C-GJJX
Popple Depot, New Brunswick
11 August 2021

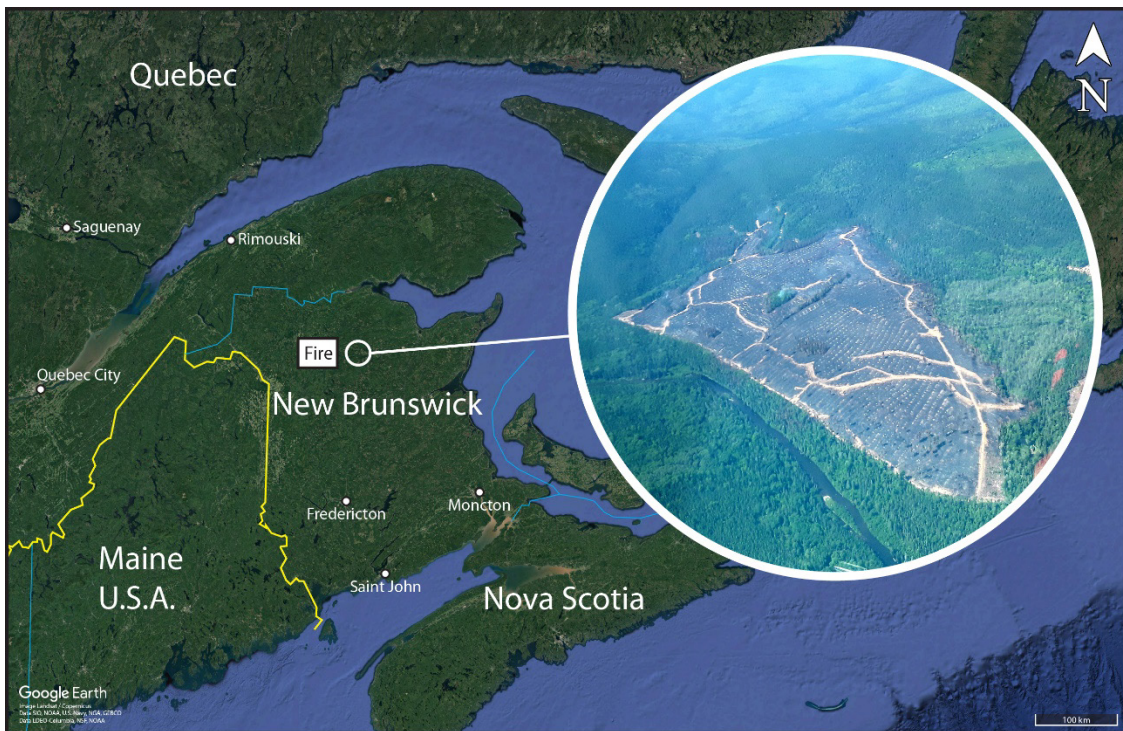
Figure 1. Map of the location of the Popple Depot fire, which includes an inset photo taken 5 days after the occurrence (Main image source: Google Earth, with TSB annotations; inset image source: Department of Natural Resources and Energy Development)

The first aircraft to arrive in the vicinity of the fire was the Bird Dog. The fire was located within an area of partially harvested trees, approximately 50 hectares in size (Figure 1).

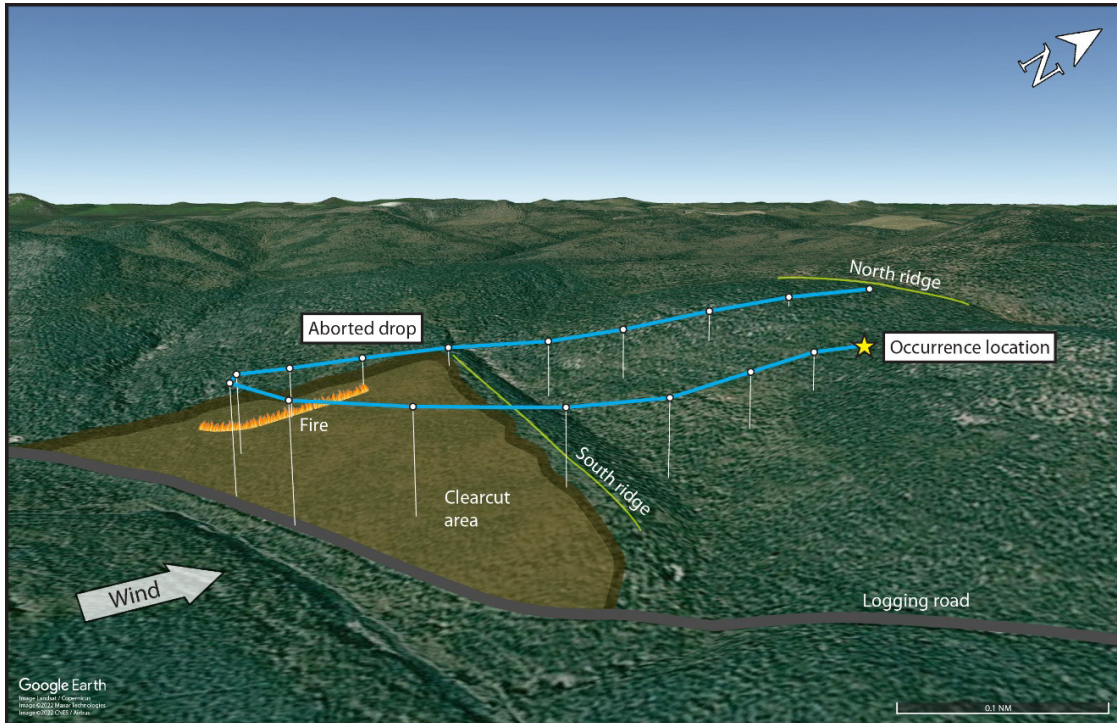
Figure 2. Approximate flight path profile (Source: Google Earth, with TSB annotations)

At 1552:13, Tanker 624 crested the first ridge (north ridge) (Figure 2). At this point, Tanker 624 was at 2000 feet above sea level (ASL) and travelling at 92 knots indicated airspeed (KIAS).

At 1552:31, Tanker 624 crested the second (south) ridge. In an attempt to prevent the aircraft from accelerating while flying downhill and descending to the drop height,⁸ the pilot set the flaps to a fully extended flap position (flaps 30°) and reduced the aircraft's power lever to the idle position. Not being properly aligned to enable a safe drop, the pilot of Tanker 624 commenced an aborted drop. The pilot increased power to approximately 2200 foot-pounds of torque (53% of take-off power⁹), retracted the flaps to 20°, initiated a steep left-hand turn at a 45° angle of bank, and informed the AAO (Figure 3). Tanker 624 was at 1600 feet ASL and 100 KIAS when the go-around was initiated. At this altitude, the aircraft was between 60 and 100 feet above ground level (AGL).

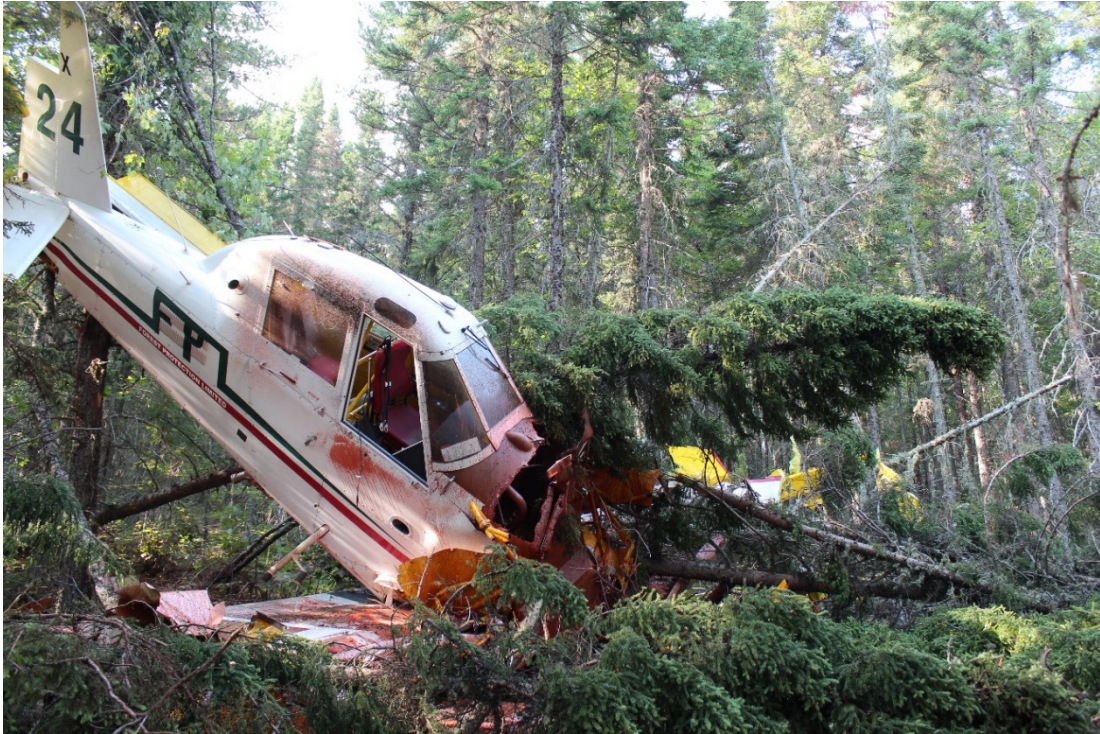
Figure 7. Wreckage of the occurrence aircraft (Source: TSB)

The aircraft struck a number of trees before it made contact with the forest floor. As a result of the impact with the ground, the fuselage was displaced from the wing centre section. The propeller and reduction gearbox had detached from the engine, which itself had detached completely from its mounting structure. The front section of the aircraft from the aft hopper wall forward was destroyed. The leading edge of each wing was found displaced rearward due to impact with the ground, and both wingtips had been destroyed by impact with the trees. Both horizontal stabilizers were partially detached from the fuselage. Each main landing gear had detached from the aircraft structure. The cabin area remained almost completely intact with the majority of the damage located in the areas of the windscreen, engine control quadrant, and instrument panel. On-site wreckage examination did not reveal any pre-impact failures (Figure 7).
