AIR TRANSPORTATION SAFETY INVESTIGATION REPORT A21O0127

RUNWAY OVERRUN

I.M.P. Group Limited
Embraer EMB-505 (Phenom 300E), C-GRIA
Kingston/Norman Rogers Airport, Ontario
30 November 2021

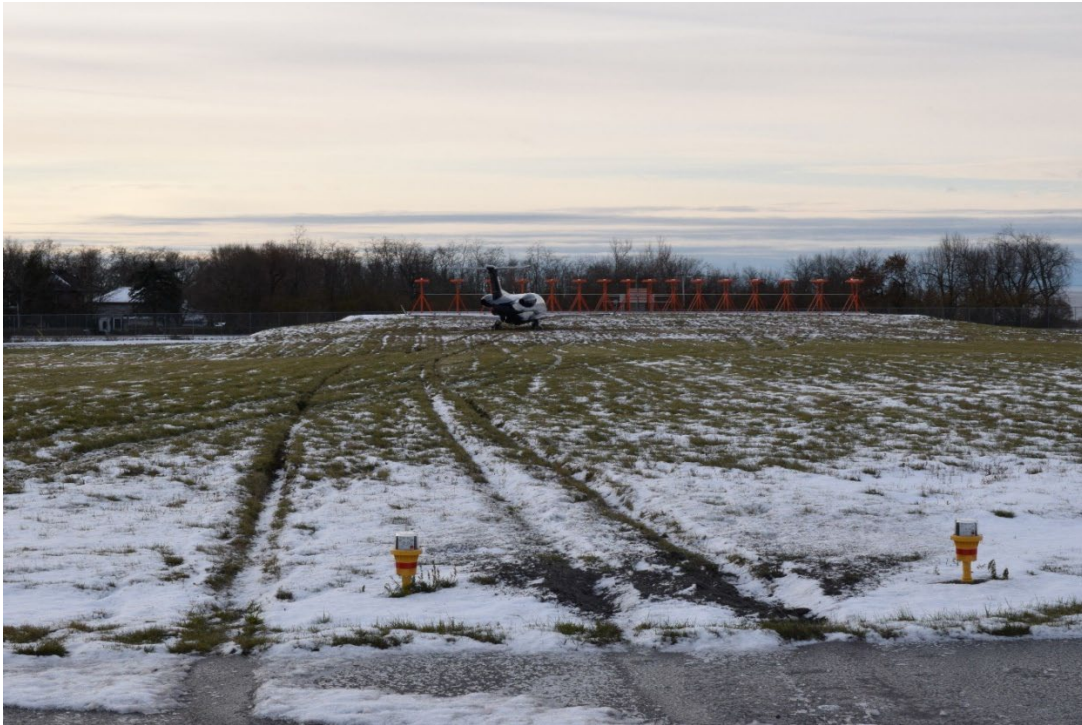
The aircraft overran the runway while skidding slightly to the left, with the nose to the right of the aircraft track. The overrun began approximately 45 feet left of the centreline at a speed of 61 knots. The aircraft continued to slide onto the soft grassy area beyond the runway's end for approximately 400 feet before coming to a stop 30 feet left of the runway extended centreline and 48 feet short of the approach lighting structure for Runway 01 (Figure 1), remaining within the runway-end safety area (RESA) throughout the overrun.

Figure 1. The occurrence aircraft taken the morning after the overrun (Source: TSB)
