AIR TRANSPORTATION SAFETY INVESTIGATION REPORT A21W0098

FUEL STARVATION

Air Tindi Ltd.
de Havilland DHC-6-300 Twin Otter, C-GNPS
Fort Providence, Northwest Territories, 6.7 NM NW
01 November 2021

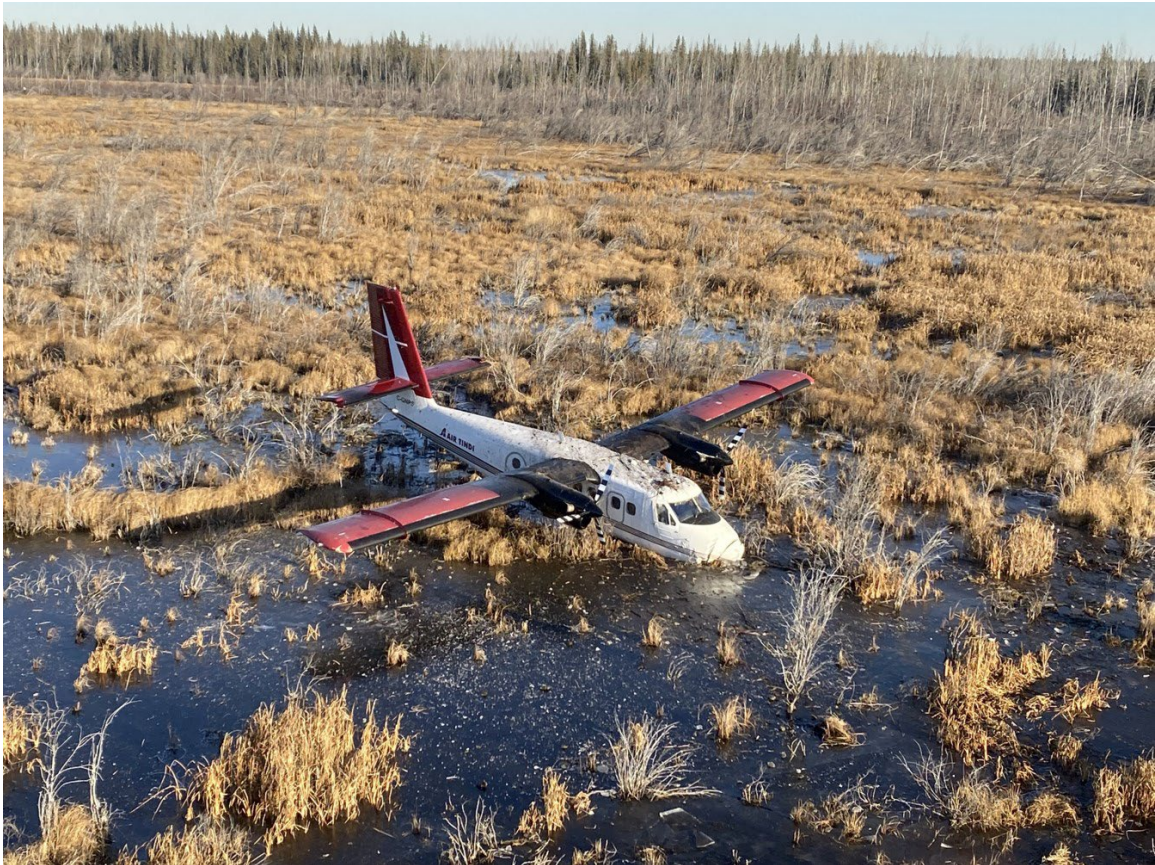
Figure 2. Photo of the occurrence aircraft after the forced landing in the muskeg, looking east (Source: Air Tindi Ltd.)

The aircraft remained upright during the landing and damage was limited to the nose bulkhead area at station 60. The nose landing gear was displaced rearward and there was associated wrinkling of nose skins and nose structure.

The aircraft touched down in partially frozen muskeg. No trees were struck during the approach or after touchdown. The aircraft remained upright, which contributed to the damage being limited to the nose landing gear and associated structure.

As a result of fuel starvation, the flight crew conducted a forced landing into muskeg, which resulted in significant aircraft damage.

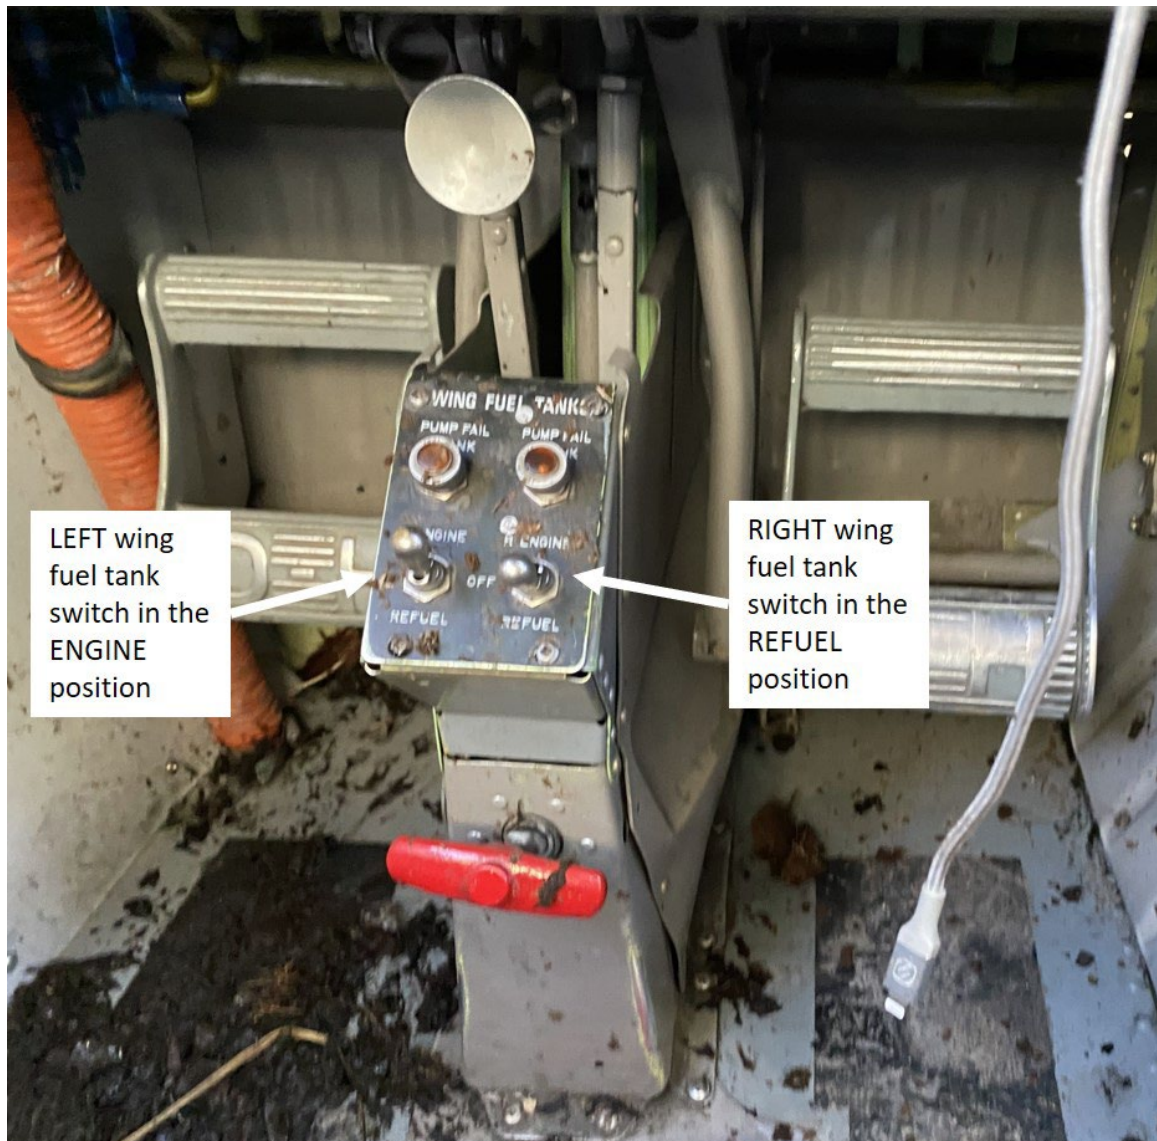
Figure 3. Photo of the occurrence aircraft's wing fuel tank panel after the accident (Source: Air Tindi Ltd., with TSB annotations)

The aircraft fuel quantity indication and alerting systems were functional and performed as designed. There were no leaks or abnormalities in the aircraft airframe or engine fuel systems.

When the left engine was shut down, fuel was being drawn from the left-wing tank. After the left engine shutdown, 5 U.S. gallons of fuel remained in the left-wing fuel tank. With the left engine shut down and the associated fuel pump off, this fuel was unavailable to the right engine unless the flight crew reconfigured the fuel system. Five minutes later, the flight crew noticed that the PUMP FAIL R TANK light had illuminated, indicating that the quantity was getting low. It was calculated that there would have been about 1 U.S. gallon in that right-wing tank at this time.

When the captain moved the right wing fuel tank switch from ENGINE to OFF, to return to feeding the right engine from the forward main fuel tank, he likely went through the OFF position to the REFUEL position. Rather than feeding the right engine, this setting would have transferred fuel from the forward main tank to the right-wing fuel tank, which is consistent with the 7 U.S. gallons of fuel found in the right tank after the forced landing. The fuel system could have transferred 6 U.S. gallons from the main fuel tank to the wing tank in the 4 minutes before the right engine flamed out. Additionally, with the switch in the REFUEL position, fuel from the right-wing fuel tank was not available to the right engine.
