AIR TRANSPORTATION SAFETY INVESTIGATION REPORT A22O0146

RUNWAY INCURSION

Greater Toronto Airports Authority
Maintenance Vehicle 31
Toronto/Lester B. Pearson International Airport, Ontario
15 October 2022

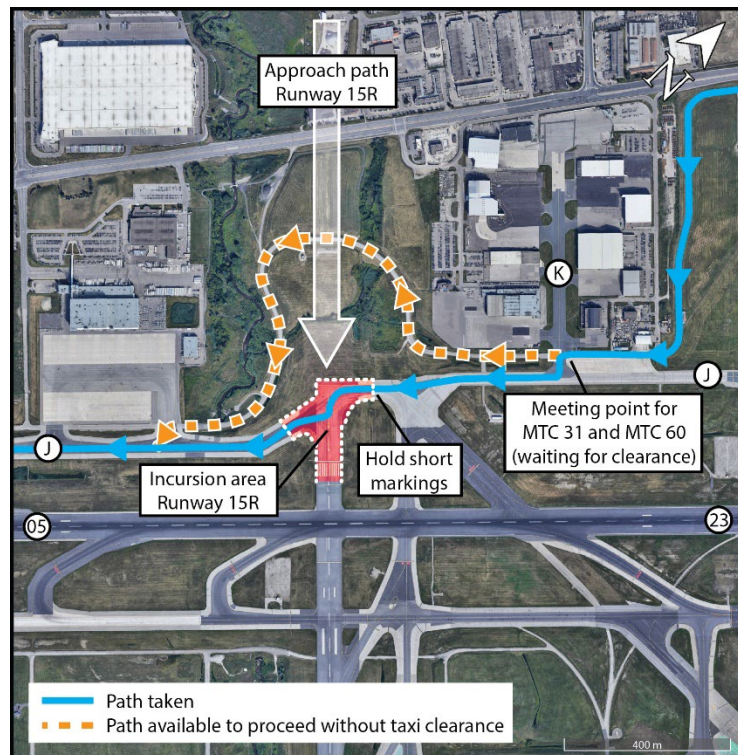
Figure 1. Maintenance 31's path (solid line) and the alternate route (dashed line) (Source: Google Earth, with TSB annotations)

Although the North Service Road would have allowed them to drive to a position west of Runway 15R without requiring a taxi clearance or crossing the runway, they instead planned a more direct route via Taxiway J (Figure 1). This

route would require a taxi clearance and clearance to cross the runway; however, it was frequently used by the drivers of MTC 31 and MTC 60, as well as other GTAA drivers.
