AIR TRANSPORTATION SAFETY INVESTIGATION REPORT A22Q0122

LOSS OF CONTROL AND COLLISION WITH WATER

True North Airways Inc.
de Havilland DHC-3 Otter, C-FDDX
Pluto Lake, Quebec
12 October 2022

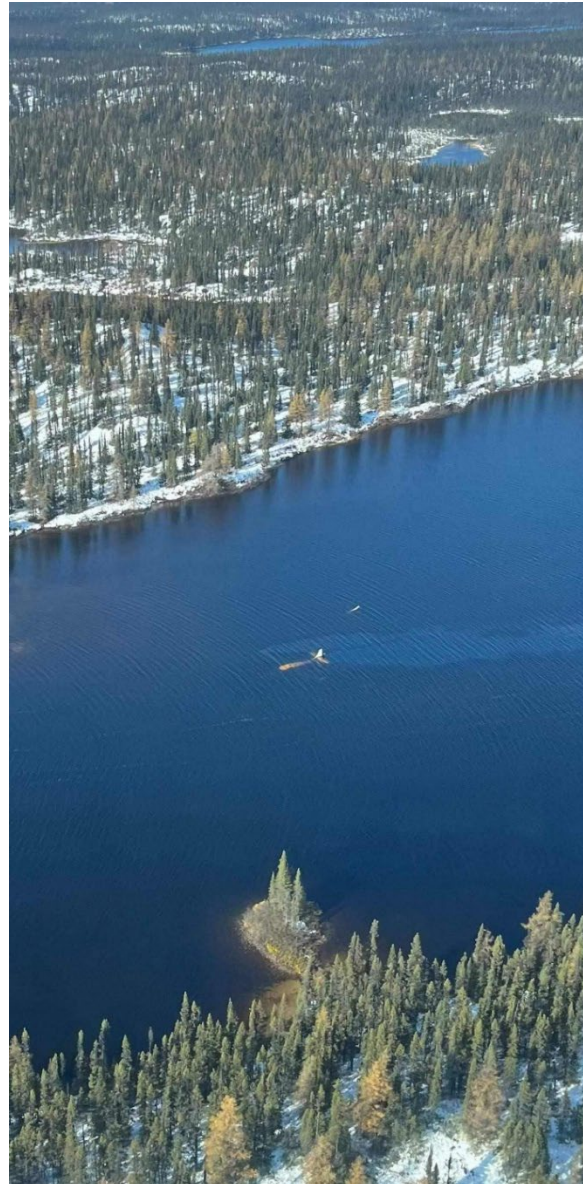
It took only a few minutes for the 2 passengers to arrive at the aircraft. At this point, the aircraft was almost fully submerged, with only the tail sticking out above the surface of the water (Figure 2).

Figure 2. Occurrence aircraft after the collision with water (Source: Department of National Defence search and rescue aircraft, with permission)

Hydrodynamic impact damage on the occurrence aircraft shows that it impacted the surface of the lake while in a left bank and slight nose-low attitude. During the impact sequence, the left forward wing spar became detached from the fuselage and was canted rearward; the aft spar remained attached to the fuselage. The aft inboard section and respective flap contacted the cabin and compromised the cabin structure. The left float was significantly damaged and remained partially attached to the fuselage. The right float was completely detached. The engine, cowlings, and engine mount were displaced from the original position, but all remained attached.

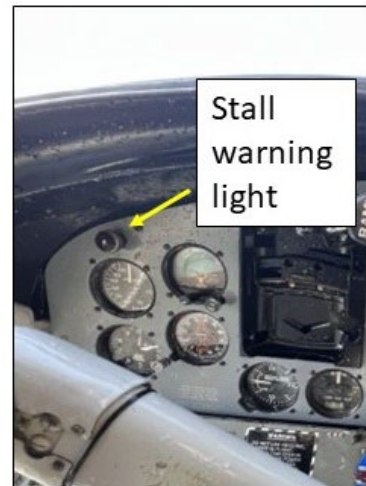
Figure 3. Stall warning light (Source: McLarens Aviation Limited, with permission)

The occurrence aircraft had a stall warning light, which was installed on the instrument panel and designed to illuminate when the aircraft approached a stall condition. For the warning to be received by the pilot, the light needed to attract the pilot's attention to the inside of the aircraft, on the instrument panel, and the pilot needed to see and recognize this light.

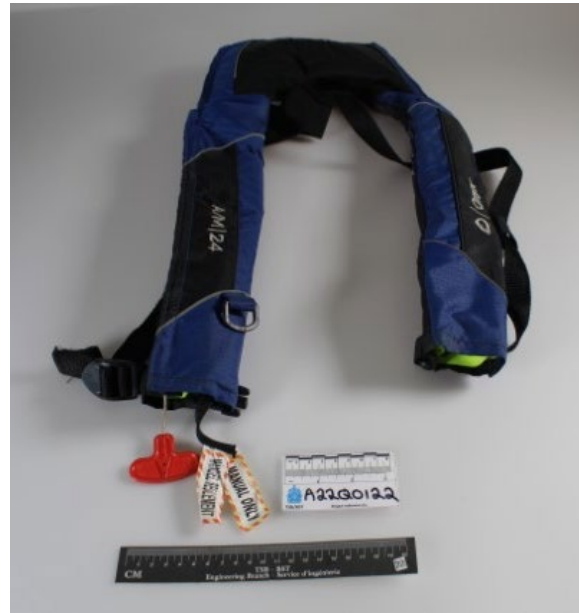
The investigation could not determine whether the pilot pulled the inflate handle, the "MANUAL ONLY" tag, or another strap. Given that he was so close to shore, with the weight of waterlogged clothing weighing him down, the pilot did not spend much time attempting to inflate the PFD; rather, he chose to discard his heavy jacket, along with the accompanying PFD over it.

Figure 4. Example of an Onyx A/M-24 manual/automatic personal flotation device recovered from the occurrence aircraft. This is the same model as the one the occurrence pilot had. (Source: TSB)

For unknown reasons, the pilot encountered difficulty inflating his PFD, and because of his proximity to the shore, he removed it to make it easier to swim.
