AIR TRANSPORTATION SAFETY INVESTIGATION REPORT A22Q0142

MAIN ROTOR BLADE FAILURE IN FLIGHT

Unregistered
RotorWay Exec (amateur-built helicopter)
Lefebvre, Quebec
29 November 2022

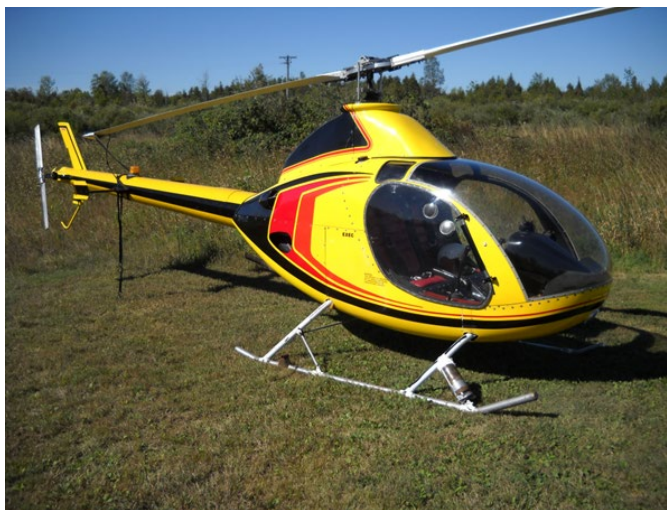
Figure 2. Occurrence aircraft, photo taken in 2011
(Source: Adam Hunt, with permission)

The aircraft, an amateur-built 2-seat, 2-bladed RotorWay Exec helicopter (Figure 2), was equipped with a 150 hp 4-cylinder RotorWay RW152 liquid-cooled engine. The aircraft had been registered for the first time in March 1996 (registration C-FXOA). The certificate of registration was cancelled on 24 July 2018 by the owner at the time. According to information gathered, the occurrence pilot reportedly acquired the occurrence helicopter in July 2018, but Transport Canada did not receive a registration application for this aircraft; therefore, it had not been registered since July 2018.
