AIR TRANSPORTATION SAFETY INVESTIGATION REPORT A23O0091

FUEL EXHAUSTION AND COLLISION WITH TERRAIN

Privately registered
Cessna 150B, C-GFFG
Alexandria Aerodrome, Ontario
26 July 2023

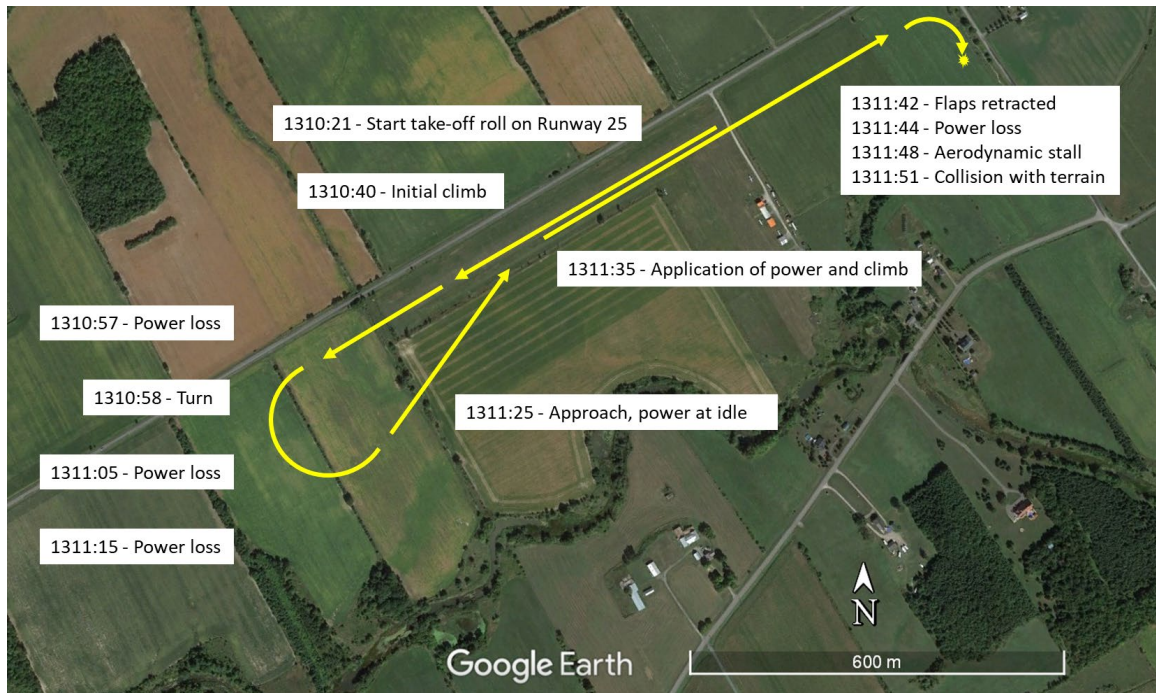
At 1255, the aircraft arrived at CNS4, completed 2 circuits, and landed on Runway 25. It was then repositioned for takeoff on the threshold of Runway 25. At 1310:57, shortly after taking off and when the aircraft was below 200 feet above ground level (AGL), the engine experienced a momentary partial power loss. The instructor pilot, who was seated in the right seat, took control of the aircraft and performed a low-level 180° left turn to conduct an approach to Runway 07. During the turn, the aircraft experienced 2 additional partial power losses (at 1311:05 and 1311:15). The aircraft banked steeply before re-aligning over and approximately half-way down the runway. At 1311:35, with less than 1000 feet of runway remaining, the instructor pilot reapplied power before the aircraft touched down and initiated a go-around.

At 1311:42, during the climb, when the aircraft was just below 100 feet AGL and as the airspeed fluctuated between 50 and 60 mph indicated airspeed, the flaps were retracted from the 10° position to the UP position. At 1311:44, the engine rpm decreased from 2450 to 1300 rpm. The instructor pilot began a steep right turn during which the airspeed decreased further and the bank angle increased to about 45°. At 1311:48, the aircraft entered an aerodynamic stall, continued to roll to the right, descended in a steep nose-down attitude, and collided with terrain (Figure 1).

Figure 1. Sequence of events and estimated flight path at Alexandria Aerodrome (Source: Google Earth, with TSB annotations)

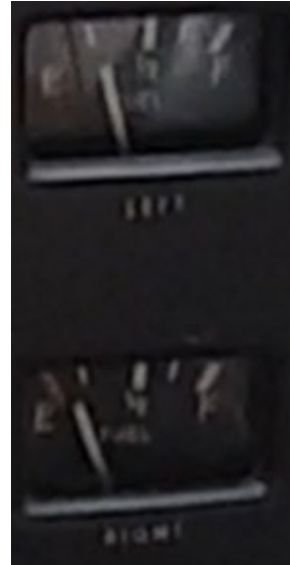
As discussed in a 2-part safety review of the Cessna 150 published in *Flying in Ireland*, the fuel gauges in this aircraft model have been known to be inaccurate and unreliable.^{6,7} In addition, the TSB has investigated previous occurrences involving inaccurate fuel gauges in aircraft with similar gauges.⁸

In this occurrence, the recorded video from the personal video camera showed that the fuel quantity indicators displayed similar indications at 1236 (Figure 3), when the aircraft departed CNV4, and at 1311 (Figure 4), just before the accident.

Figure 3. Fuel quantity indicator at 1236 (Source: recorded video)

Pilots are reminded to ensure there is sufficient fuel on board, including reserves, for their intended flight, and to continuously monitor fuel levels during the flight.

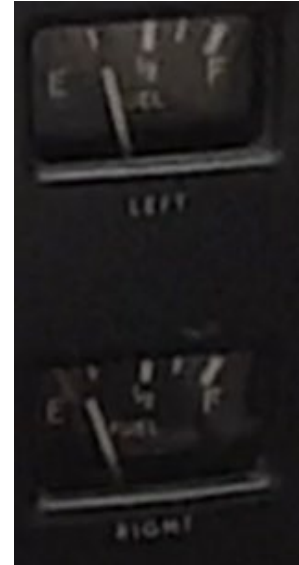
Post-occurrence fuel calculations indicate that, given the weight of the occupants and cargo on board, the aircraft was likely overweight by as much as 69 pounds at the time of departure from CSE4. The estimated fuel at the time of departure from CSE4 likely would not have been sufficient to complete the flights that were conducted, not to mention maintaining a 30-minute reserve.

Figure 4. Fuel quantity indicator at 1311 (Source: recorded video)
