# AIR TRANSPORTATION SAFETY INVESTIGATION REPORT A23Q0041

## STALL AND COLLISION WITH TERRAIN

Privately registered  
Cessna 150G, C-FWGF  
Saint-Rémi, Quebec  
21 April 2023

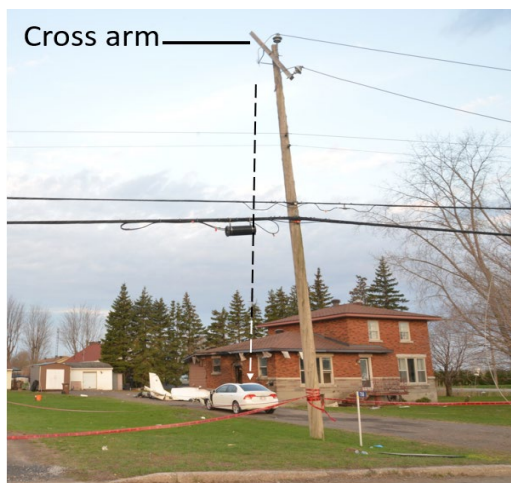
The angle formed by a line drawn between the top part of the hydro pole near the house and the automobile was approximately 45° (Figure 1), suggesting that the aircraft's horizontal speed was low when it collided with the power lines.

Figure 1. Hydro pole and dotted line showing the angle of the pole in relation to the automobile (Source: TSB)

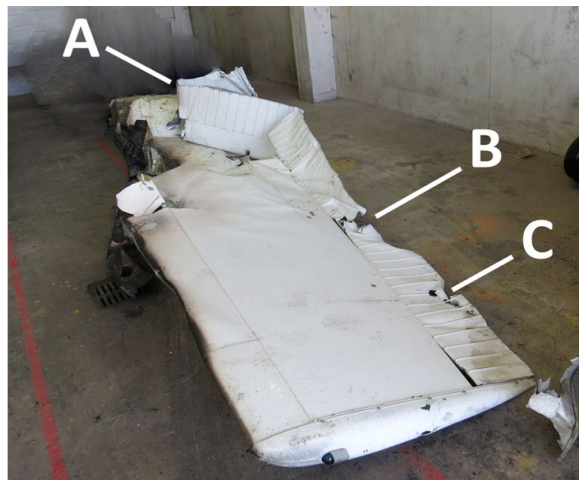
The examination of the aircraft's right wing revealed 3 dents along the trailing edge (Figure 2): 2 consistent with an impact with a power line (A and C) and the other one (B) consistent with an impact with the cross arm of the hydro pole. The left wing did not exhibit any damage due to impact with the power lines or the hydro pole.

Figure 2. The aircraft's damaged right wing with dents made by impact with the power line (A and C) and the cross arm of the hydro pole (B) (Source: TSB)
