AVIATION OCCURRENCE REPORT

ENGINE POWER LOSS/LOSS OF CONTROL

**ARCTIC WINGS AND ROTORS
PILATUS BRITTEN-NORMAN BN2A-20 ISLANDER C-GMOP
TUKTOYAKTUK, NORTHWEST TERRITORIES 7.7 mi SE
03 DECEMBER 1993**

REPORT NUMBER A93W0204

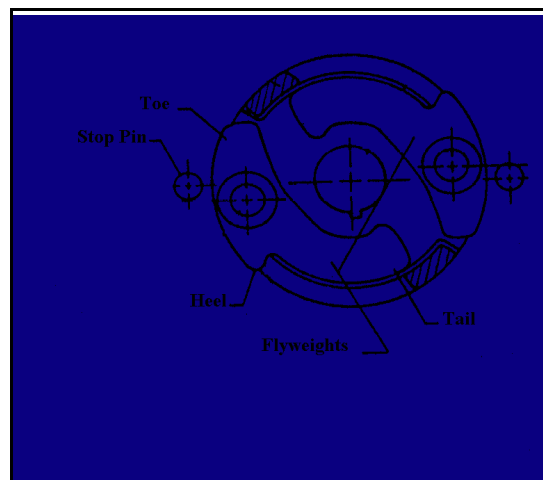
Figure 1 - Impulse Coupling

The right engine was fitted with two Bendix magnetos (S6LN-1227). The left magneto had excessive wear between the flyweight and axle pin, which allowed the flyweight to extend and jam against the case-mounted stop pin. The sudden stoppage of the magneto overloaded the secondary gear train for the left magneto, sheared the alignment dowel, and stripped the retaining bolt threads on the main crankshaft drive gear. When the crankshaft drive gear stopped, all the accessories stopped, including the right magneto.

The impulse coupling consists of two flyweights and spring assemblies which are part of the magneto drive coupling (see Figure 1). During engine starts, the toe of the flyweight contacts a stop pin on the magneto housing, preventing the magneto from turning. As the engine turns, the magneto drive gear winds the spring until it releases and rotates the magneto rapidly to send a very intense spark to the sparkplug. As engine rpm increases, centrifugal force pulls the tail of the flyweight outward, which rotates the toe inward, preventing the toe of the flyweight from contacting the stop pin.

The flyweight pivots on an axle, which, if worn excessively, will permit the heel of the flyweight to strike the stop pin and eventually jam. The clearance between the flyweight and axle pin was found to be worn beyond the prescribed limits of .016 inches. The side-play between the axle pin and the flyweight that jammed was found to be .046 inches, and between the opposite axle pin and the flyweight there was .076 inches. The area between the heel and the toe of the flyweight exhibited an indentation that corresponded with a groove worn in the stop pin.

The magneto impulse coupling flyweights were worn beyond the prescribed limits. When the flyweight jammed against the stop pin, the secondary gear train failed and the engine stopped abruptly.

On 04 April 1994, Teledyne Continental issued Mandatory Service Bulletin MSB 645, which superseded SB599D. The reason for the bulletin was to decrease operational wear rates on impulse couplings and to prevent engine stoppage. The bulletin requires 100-hour inspections of riveted impulse couplings. Couplings which do not meet the detailed coupling inspection criteria are to be replaced with new snap ring assemblies.
