AVIATION OCCURRENCE REPORT

BRAKE MALFUNCTION

PROVINCIAL AIRLINES LTD.
PIPER PA-31-350 NAVAJO CHIEFTAIN C-GWLW
FOX HARBOUR, NEWFOUNDLAND
27 JUNE 1994

REPORT NUMBER A94A0124

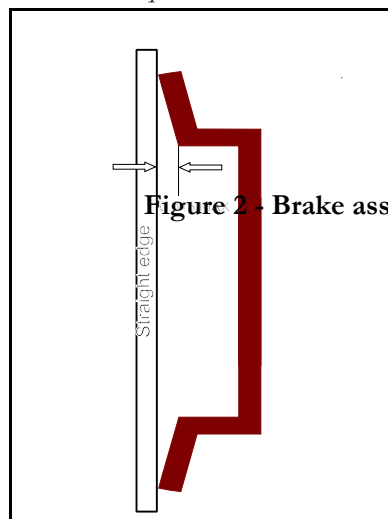
Figure 2 - Brake assembly

Brake Linings/Left Brake: All six brake linings met and exceeded the minimum thickness requirements specified by the CMM. The steel backing on some of the linings was warped and bluish in colour.

Pressure Plate/Left Brake: Three brake linings are attached to the pressure plate and are located on the brake piston side of the brake disc.

The linings are attached to pins that are riveted to the pressure plate. The pressure plate was warped, all six pins were loose in the pressure plate, and several pins had elongated their respective holes.

The left brake pressure plate loose pin condition most probably was present during the brake work as there were no impact marks around the pins to indicate that the condition was a result of the landing event. This condition could have produced a slight brake lining movement or shift when the brakes were first applied.

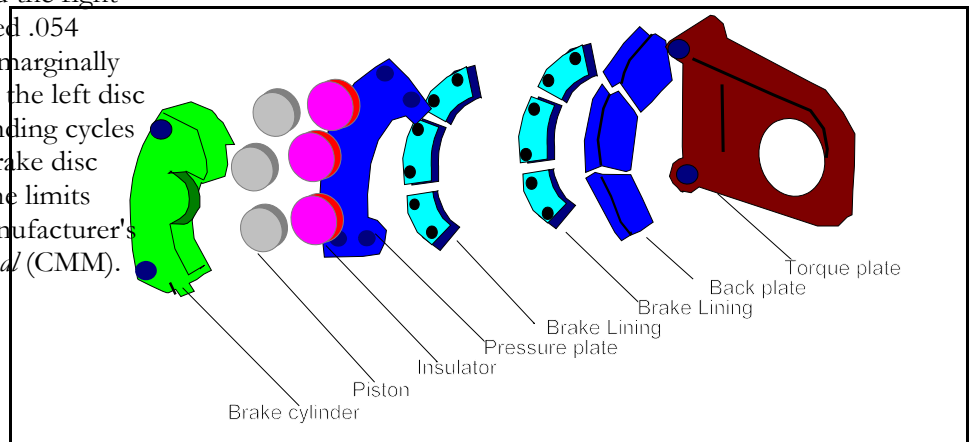
Figure 1 -

Wheel Brake Cylinders: Both brake cylinders were intact and showed no evidence of cracks or external leakage.
 Brake discs: Both brake discs were coned beyond the manufacturer's .015-inch limit. The left wheel brake disc was coned .139 inches and the right wheel brake disc was coned .054 inches. The left disc was marginally thinner than the right and the left disc had accumulated more landing cycles since installation. Both brake disc thicknesses were within the limits specified by the brake manufacturer's *Component Maintenance Manual (CMM)*.

The excessive brake disc coning indicated that the discs had experienced higher-than-normal temperatures. The greater number of landing cycles accumulated by the left brake disc probably contributed to the greater coning observed on that disc. The extent of disc coning present when the brake repairs were completed could not be determined. A severely coned brake disc can cause brake drag, decreased braking efficiency and requires increased brake pedal travel to align the brake linings with the brake disc. The severely coned discs were the cause of the spongy pedal condition.

It is possible that the left brake was dragging and that the additional heat produced during the taxi, landing, and take-off phase that followed was responsible for the additional coning as seen on the left disc. The brake drag would have been caused by the reduced running clearance between the coned left brake disc and the new brake linings. There was no brake drag on the right brake because the right brake linings had not been replaced.

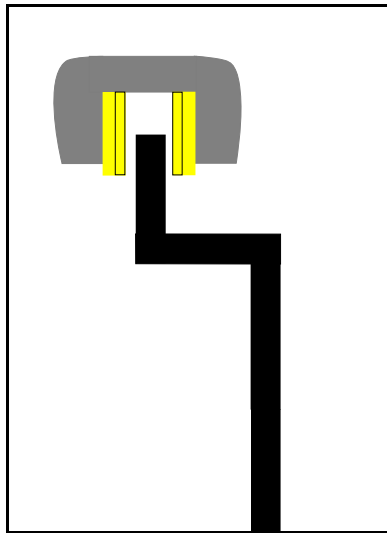
Figure 3 -

Brake Linings/Right Brake: All six brake linings had minimal material remaining. Two of the three back plate linings were worn to the point that the retaining pin hole outlines were visible on the lining face. The CMM states that the lining is worn beyond limits when the holes for the pins are visible on the brake lining surface.

The three pressure plate linings were worn to near minimum thickness limits.

Pressure Plate/Right Brake: The right brake pressure plate was warped but the brake lining retaining pins were secure in the plate.

Since the six right brake linings exhibited much greater wear than the left brake linings, it is probable that only the six left brake linings were replaced during the brake maintenance and not the nine brake linings as identified by the Parts and Rectification sheet. It could not be determined what the right brake lining condition was when the maintenance was carried out.
