**AVIATION OCCURRENCE REPORT**

**FLIGHT INTO TERRAIN**

**WESTLAND HELICOPTERS INC.  
BELL 206 BIII JETRANGER C-GRAH  
HOUSTON, BRITISH COLUMBIA 2.5 mi N  
29 JANUARY 1994**

**REPORT NUMBER A94H0001**

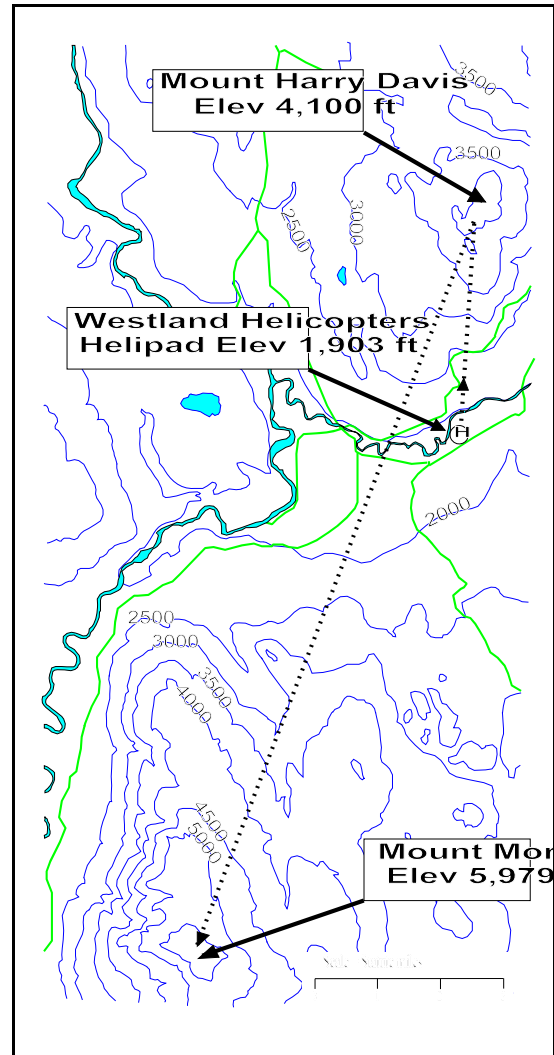
Figure 1  
Area of Intended Flight

In order to climb above the fog layer in the Houston area, the pilot intended to proceed to the northeast of Houston using the rising terrain of Mount Harry Davis as a visual reference. Once above the fog layer, the intent was to proceed to Mount Morice by following mountain peaks and ridges (refer to Figure 1).

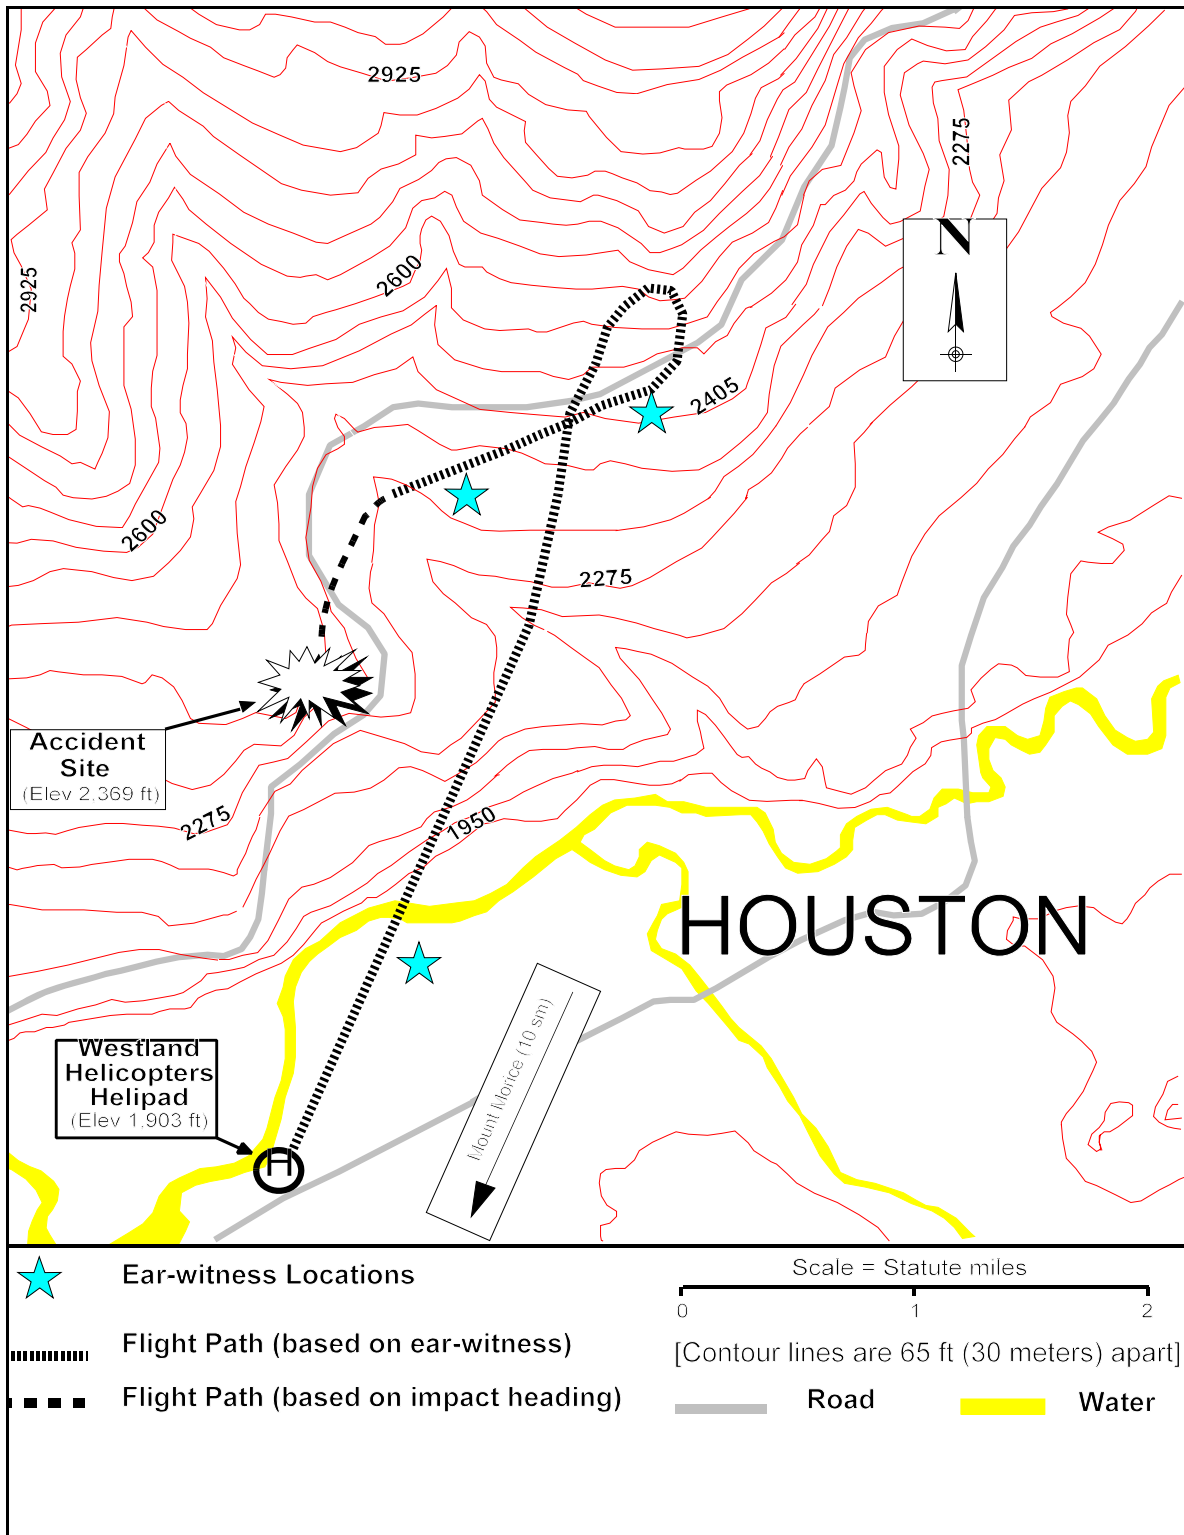
*Appendix A - Estimated Flight Path*

The helicopter collided with the terrain at latitude 54°24'N and longitude 126°40'W, at approximately 1215 PST, at an elevation of 2,369 feet above sea level (asl)<sup>3</sup> (refer to Appendix A).
