## **AVIATION OCCURRENCE REPORT**

### **RISK OF COLLISION**

**BETWEEN  
DELTA AIR LINES LOCKHEED L1011 N740DA  
AND  
BRITISH AIRWAYS BOEING 747 G-AWNH  
NORTH ATLANTIC  
08 MARCH 1995**

**REPORT NUMBER A95A0046**

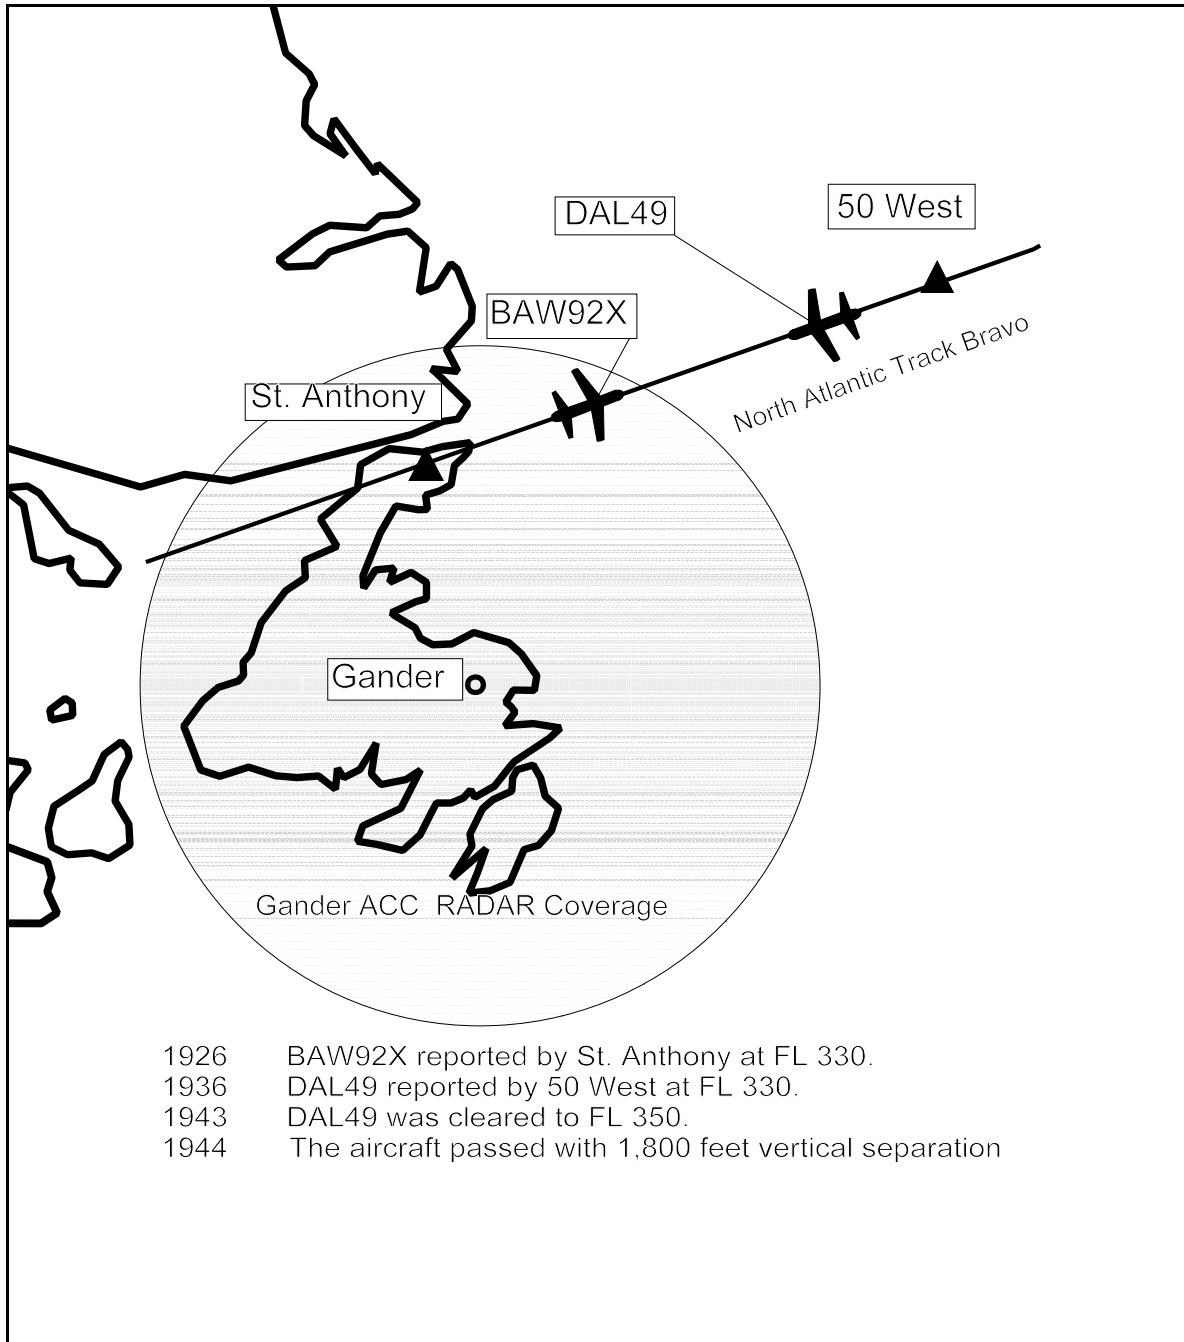
*Appendix A - Occurrence Location Diagram*

DAL49 passed about 1,800 feet above and one mile south of BAW92X, where the required separation was 2,000 feet vertically. The two aircraft had been closing at a combined speed of 980 knots, and at 30 miles were less than two minutes apart. The occurrence took place at 52°25'N, 52°40'W at approximately 1944, during daylight hours. (See Appendix A.)
