AVIATION OCCURRENCE REPORT

AIRFRAME FAILURE - WING

**MAGAL CUBY II (ULTRALIGHT) C-IEXR
LEGAL, ALBERTA 4 NM W
09 SEPTEMBER 1995**

REPORT NUMBER A95W0166

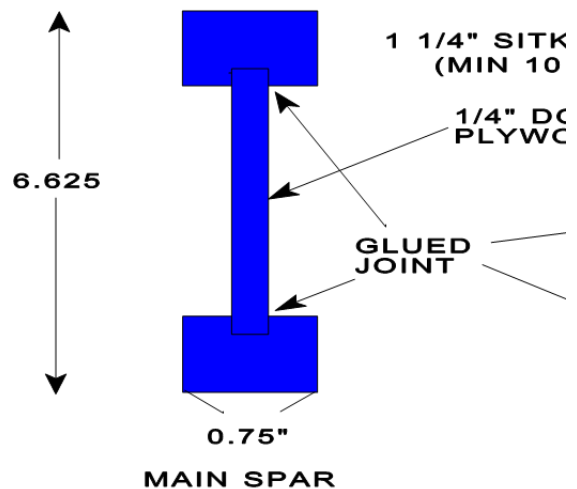
The Cuby II aircraft is a two-place, side-by-side, high-wing, conventional-gear monoplane. The designer's sketch specifies the cross-sectional dimensions of the spar caps as follows: the top main wing spar caps are to be constructed of 1 1/4 inch high by 3/4 inch wide Sitka spruce; the lower spar caps are to be 1 inch high by 3/4 inch wide, and also of Sitka spruce. The main spar caps are to be joined by 1/4 inch wide Douglas fir shear webbing.

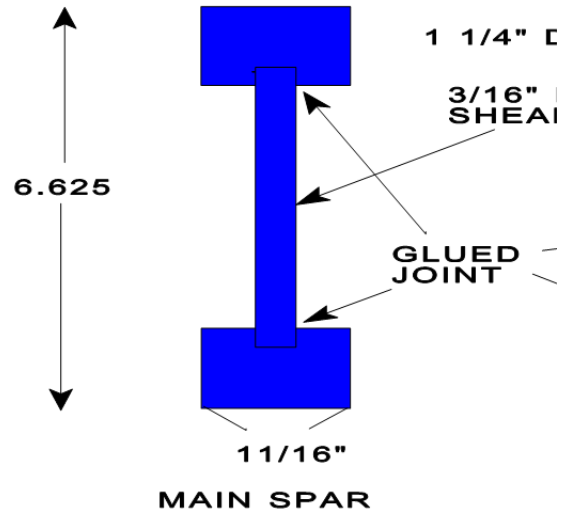
Examination of the aircraft's failed left wing spars indicated that they were not constructed in accordance with the designer's sketch. The wood grain orientation of the failed spar caps was found to be at 90 degrees to the direction recommended and was unsatisfactory for straightness. The spar caps and webs were under-dimensioned; 3/16 inch mahogany had been substituted for the 1/4 inch fir plywood shear web called for in the sketch. In addition, the spar cap wood material was fir and not sitka spruce, as specified. Further examination reveals that the structural stability of the aircraft's wing design was questionable. Any sort of aerobatic manoeuvre, particularly ones requiring positive high angles of attack for entry, would be hazardous. There was also evidence of previous damage to the left wing in the form of a left wing tip spar and fabric repair. There were no wing inspection ports to allow for adequate periodic inspections of the internal wing structure.

The left wing structural failure may have been the result of a previous occurrence where the left wing tip had been damaged then inadequately inspected at the time of the repair. Given the leverage that existed during the wing tip strike, damage may have been done to the spar further inboard. Since ultralight aircraft are exempt from the requirement for a licensed engineer to reference a repair in an aircraft log-book, it was not possible to determine what had occurred. Normal load reversals on the spar while in service would include flight loads, landing loads, and the loads experienced while tied down. The questionable design and construction of the wing would typically result in a reduction in bending strength. Although wooden spars are susceptible to deterioration because of age and damage to a far greater degree than other spar materials, the means of actually examining these spars on the aircraft was very limited. Inspection of the wooden spar surfaces would be almost impossible without the installation of additional inspection ports.

fracture was a result of compression damage, since the spars appeared to have been original to the aircraft, which was manufactured in 1985.

Examination of the wreckage revealed that the aircraft had not been constructed in accordance with the manufacturer's suggestions. An article in issue 2/95 of Transport Canada's *Aviation Safety Ultralight and Balloon* discussed this aspect of the accident and indicated that the manufacturer was sending a related Air Safety Advisory to all known Cuby I and Cuby II owners.

In light of the identified wing design deficiencies, and the number of Magal Cuby II ultralights on the Canadian Civil Aircraft Register, a TSB Aviation Safety Advisory was sent to Transport Canada on the need to inform the ultralight community of the design shortcomings with at least some Cuby II aircraft.
