AVIATION OCCURRENCE REPORT

RISK OF COLLISION

REPORT NUMBER A96A0138

Martinair Holland Boeing 767 P-HMCL
and
Air France Boeing 747 F-BPVS
Stephenville, Newfoundland 45 nm NW
27 July 1996

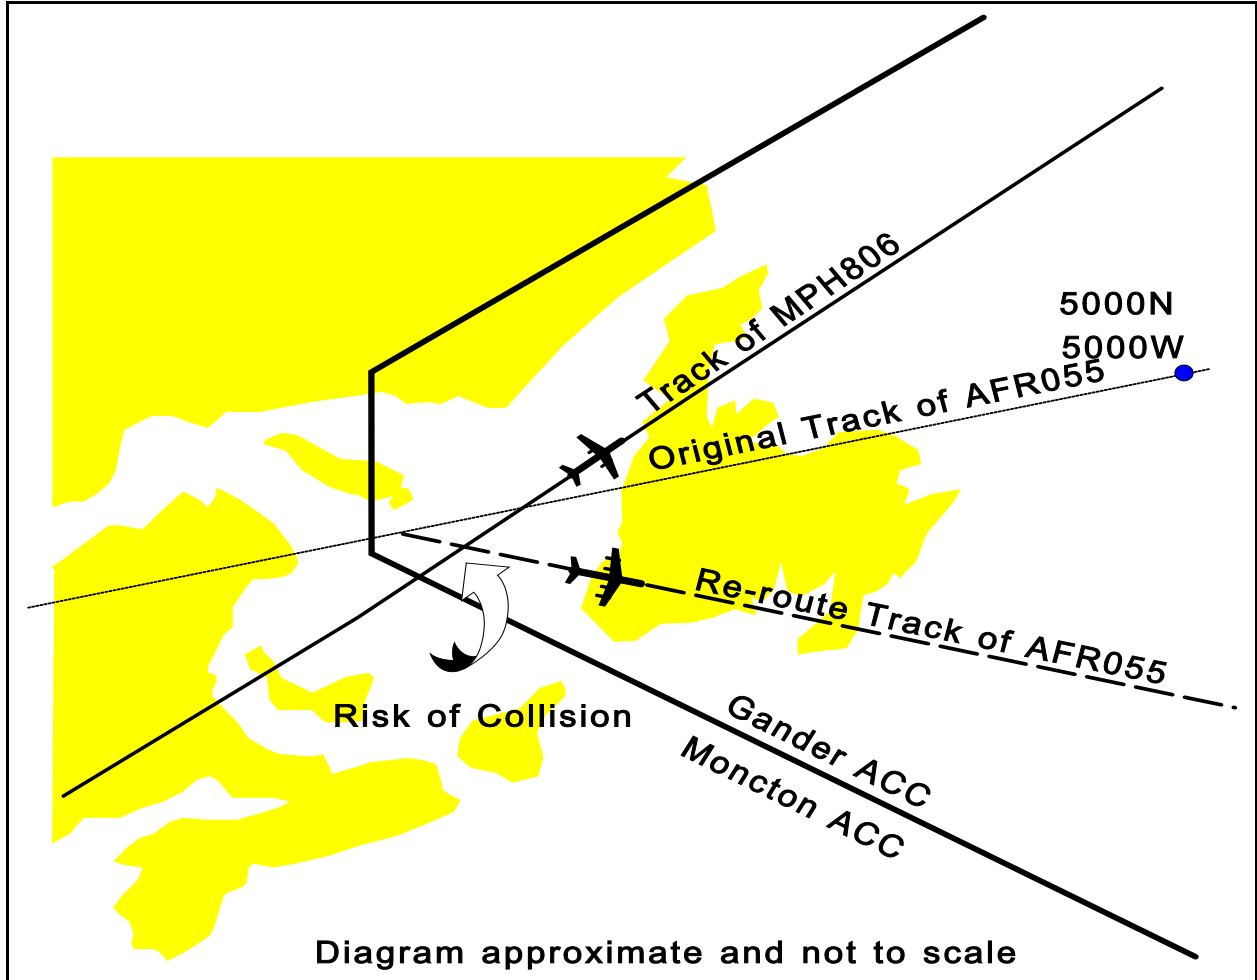
Appendix A - Flight Path Diagram

Martinair 806 (MPH806), a Boeing 767, was eastbound at flight level (FL) 330 from Newark to Amsterdam via EBONY and DOTTY. Air France 055 (AFR055), a Boeing 747, was eastbound at FL330 from Chicago to Paris via Killaloe VOR, Gander. The routing of the two aircraft placed them on converging tracks. (See Appendix A.)

At 2315:47, MPH806 and AFR055 were handed off to the Gander controller, who, at 2318:30, instructed AFR055 to proceed direct to St. John's. This re-routing of AFR055 produced about a 20° change in the aircraft's heading and established the final point of convergence with MPH806. The controller was later unable to explain why he was unaware of the conflict between the two aircraft. A controller can put a range bearing line (RBL) between two aircraft that are converging to determine the exact distance between the aircraft and to serve as another reminder of a potential conflict. The controller did not have an RBL established
