## Aviation Investigation Report

### In-Flight Fire Leading to Collision with Water

McDonnell Douglas MD-11 HB-IWF

Report Number A98H0003

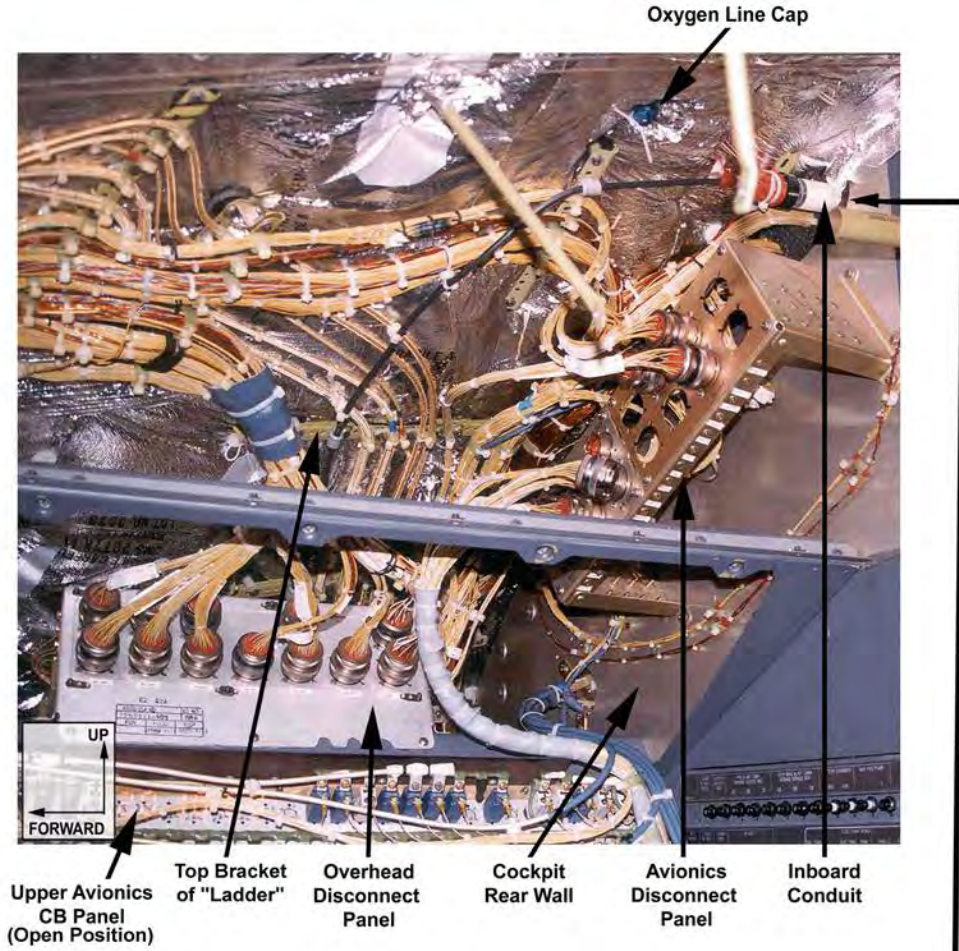
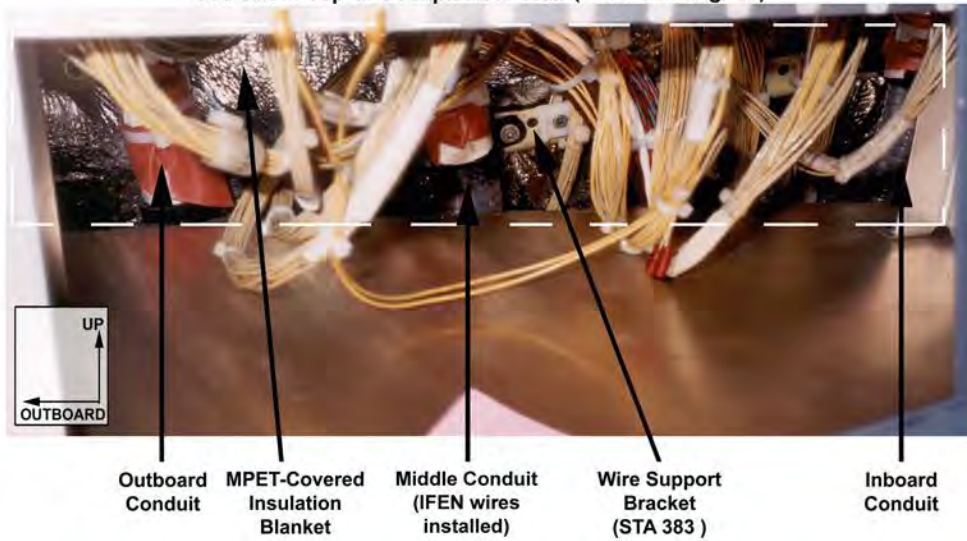
Figure 5: Cockpit attic area and cut-out above cockpit rear wall

Examination of other Swissair MD-11 aircraft in the Swissair fleet disclosed that openings existed in the smoke barriers, and in areas adjacent to the barrier. Some of these openings were located at conduit and wire run locations that pass through or above the cockpit rear wall. The top edge of the rear, right cockpit wall near STA 383 has a cut-out in it to permit the passage of wire bundles and conduits. (See Figures 4 and 5.)

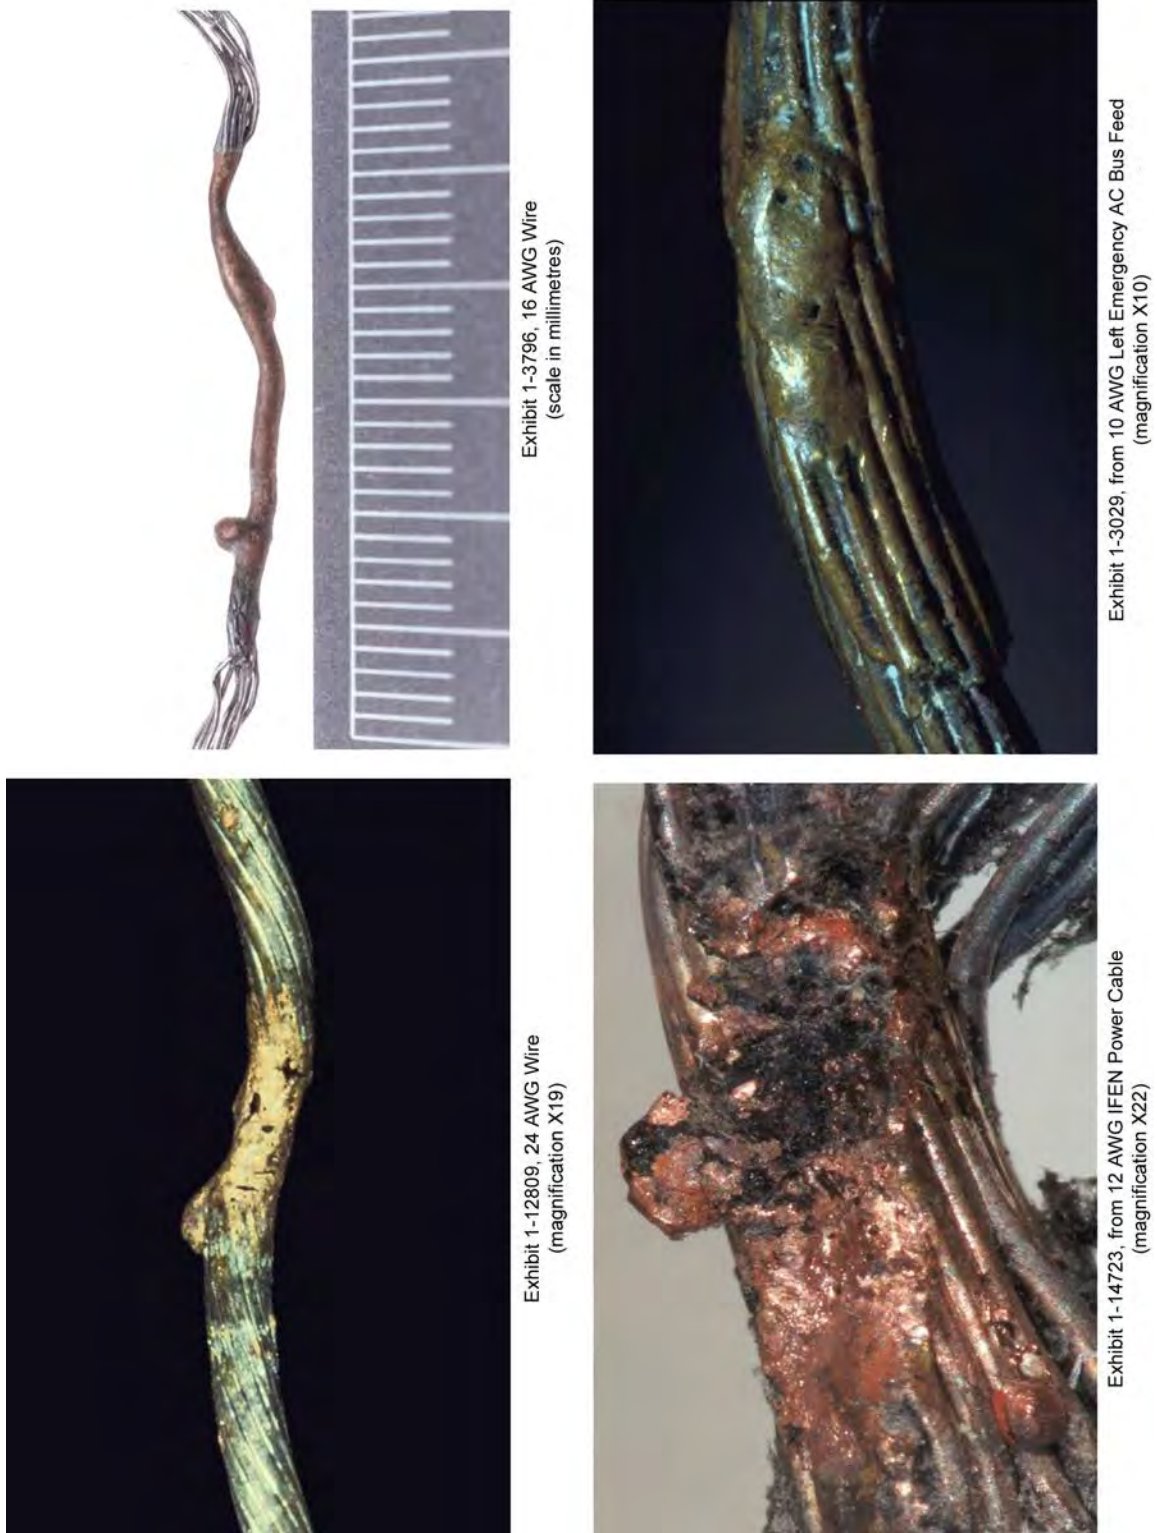
Figure 20: Wire segments with melted copper

All of the recovered wires were examined, primarily to identify any with signs of melted copper. As the fire did not reach temperatures high enough to melt copper,<sup>50</sup> any areas of melted copper would indicate that an electrical arcing<sup>51</sup> event had occurred.

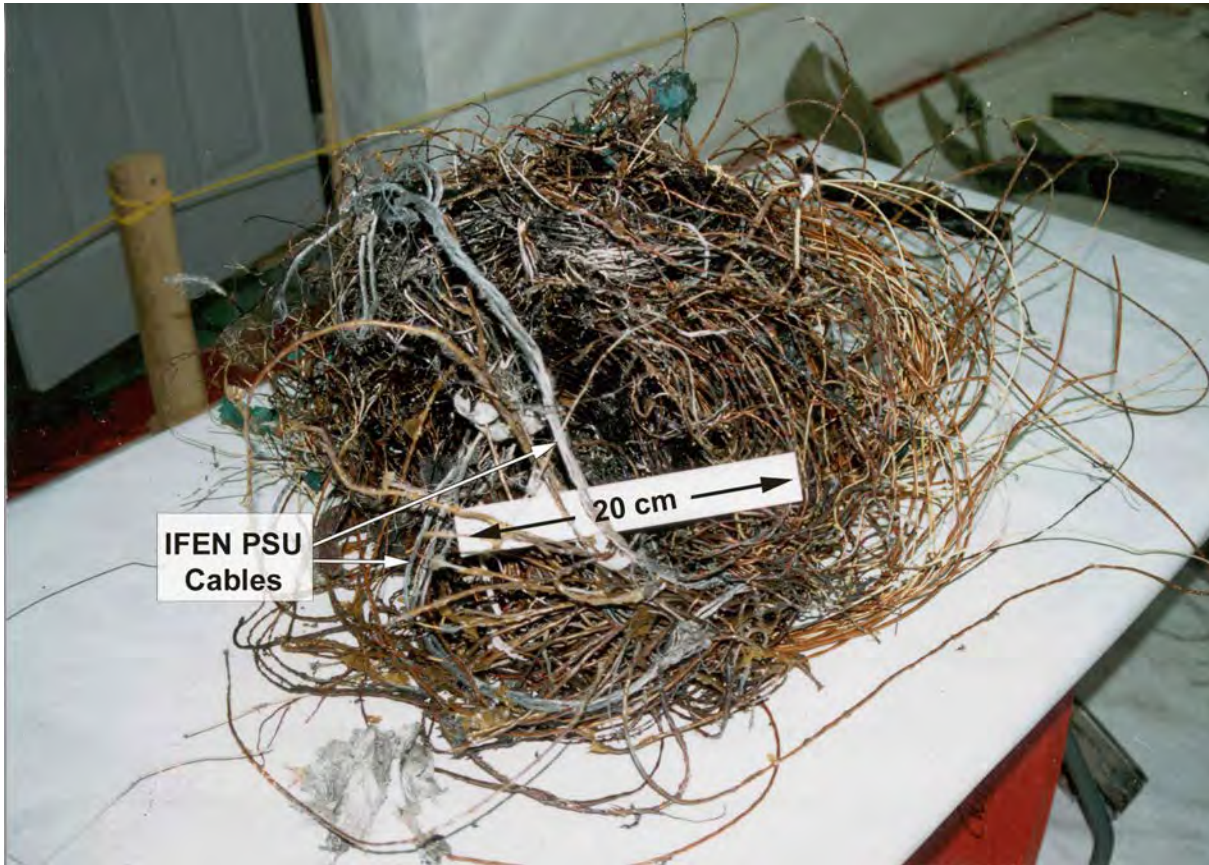
**Figure 21:** Exhibit 1-4372

Of the nine wire or cable segments with areas of melted copper that were recovered from Exhibit 1-4372, four were positively identified as being segments of the IFEN PSU cables (1-3790, 1-3791, 1-3792, and 1-3793) (see Figure 22). This identification was based on remnants of coloured ETFE insulation remaining attached to the wires. On each of these four segments, one end was heavily matted, or crushed together, and the opposite end was fractured and frayed. Exhibits 1-3790 and 1-3792 both had distinctive regions where the tin coating was missing from the wire strands on all three wires. Exhibits 1-3791 and 1-3793 did not have a similar region of missing tin.

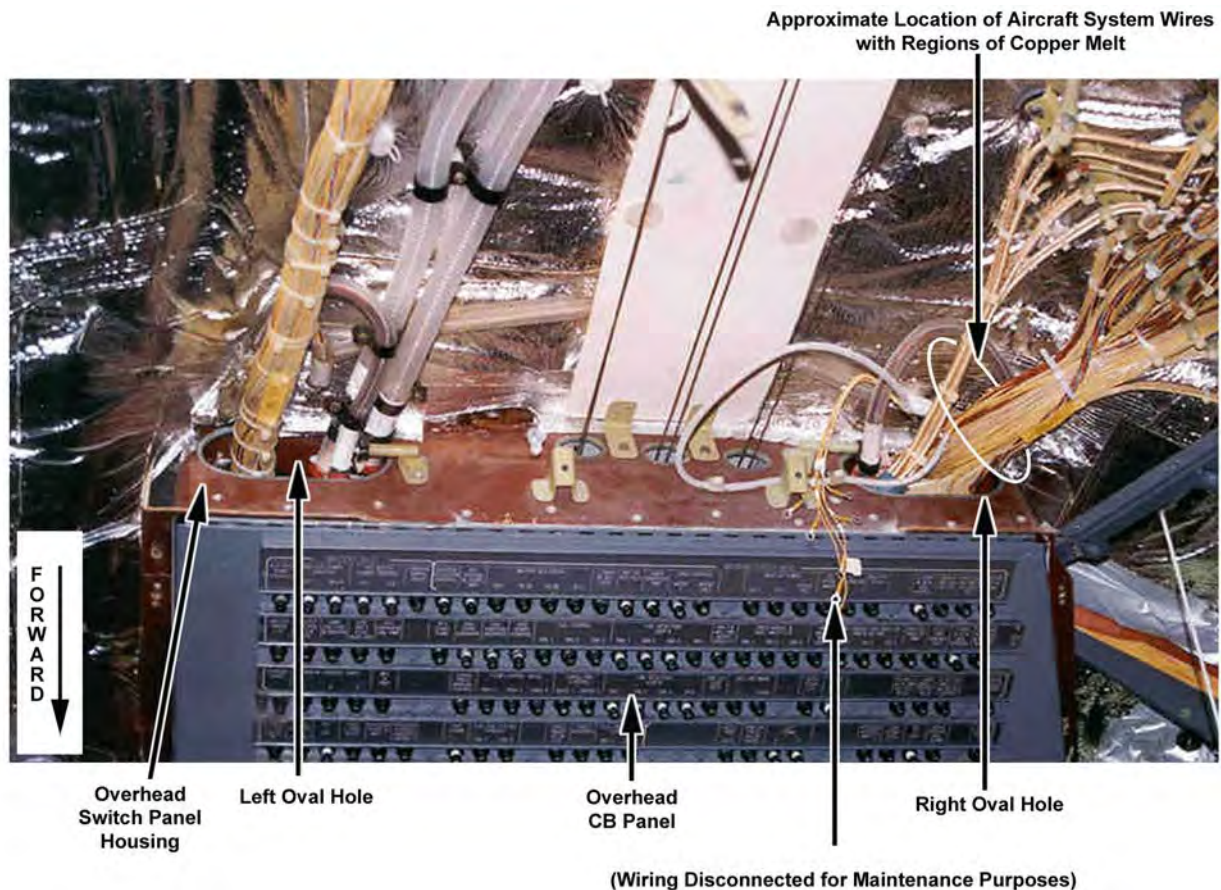
**Figure 23:** Location of identified aircraft wires with regions of copper melt

Exhibit 1-6976 consists of a segment of a 6 AWG nickel-coated, polyimide-insulated wire, approximately 102 cm (40 inches) long with the wire number B205-4-6 stamped on the insulation. This number identifies it as a segment of the left emergency DC bus feed wire. One end of the wire segment had two flag lugs attached that would have been connected to the left emergency DC bus bar located behind the overhead switch panel. The known location of the flag lug to bus bar connection allowed for this segment to be accurately located in the reconstruction mock-up. The end with the melted copper was located approximately 15 cm (6 inches) outside the right hole in the overhead CB panel housing. This placed it above the forward right side of the cockpit ceiling.

There was a 2-cm (0.8-inch) long section of resolidified copper located about 97 cm (38 inches) from the flag lugs. The nickel coating was missing from the conductor, for about 6 cm (2.4 inches) on either side of the melted area. The outer surface of the resolidified copper was smooth and did not exhibit any of the normal characteristics associated with an arcing event, such as surface porosity or irregular surface structure. Radiographs of this area showed it to be a solid mass, without voids. This was the only nickel-coated wire segment that exhibited melting of the nickel coating beyond the area of the resolidified copper. This melted copper was considered to have been the direct result of a welding operation during the manufacturing process of the wire.<sup>57</sup>

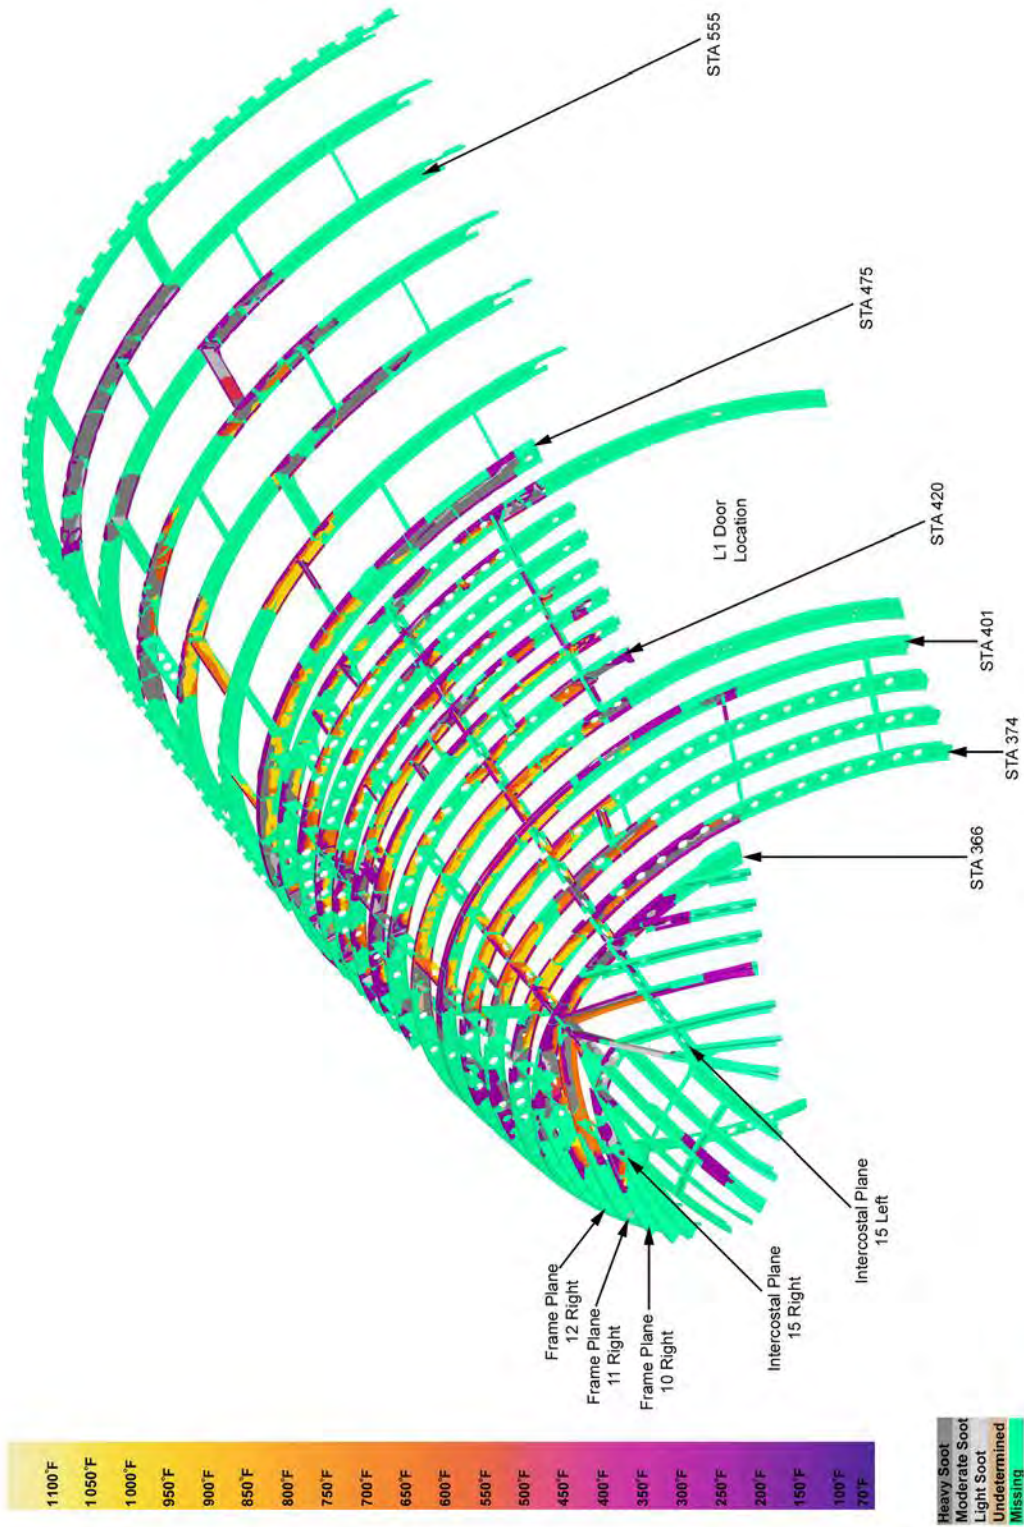
Figure 25: Heat damage – airframe structure

Damage to the riser duct assembly ranged from no heat damage to bare-metal heat damage. The vertical portion of this assembly had no heat damage. The first area of bare-metal damage to the riser duct assembly started at intercostal plane 15 right, where the lower surface had a region of bare-metal heat damage from  $X = -30$  inboard to the joint at  $X = -20$ . This was in the vicinity of the Galley 2 vent end cap. There was bare-metal damage from approximately STA 395 to STA 442 between  $X = 25$  and  $X = -10$ . A section of molded duct was installed in that area from STA 420 to STA 442 between  $X = 5$  and  $X = 25$ . No portions of this molded duct were identified in the wreckage.

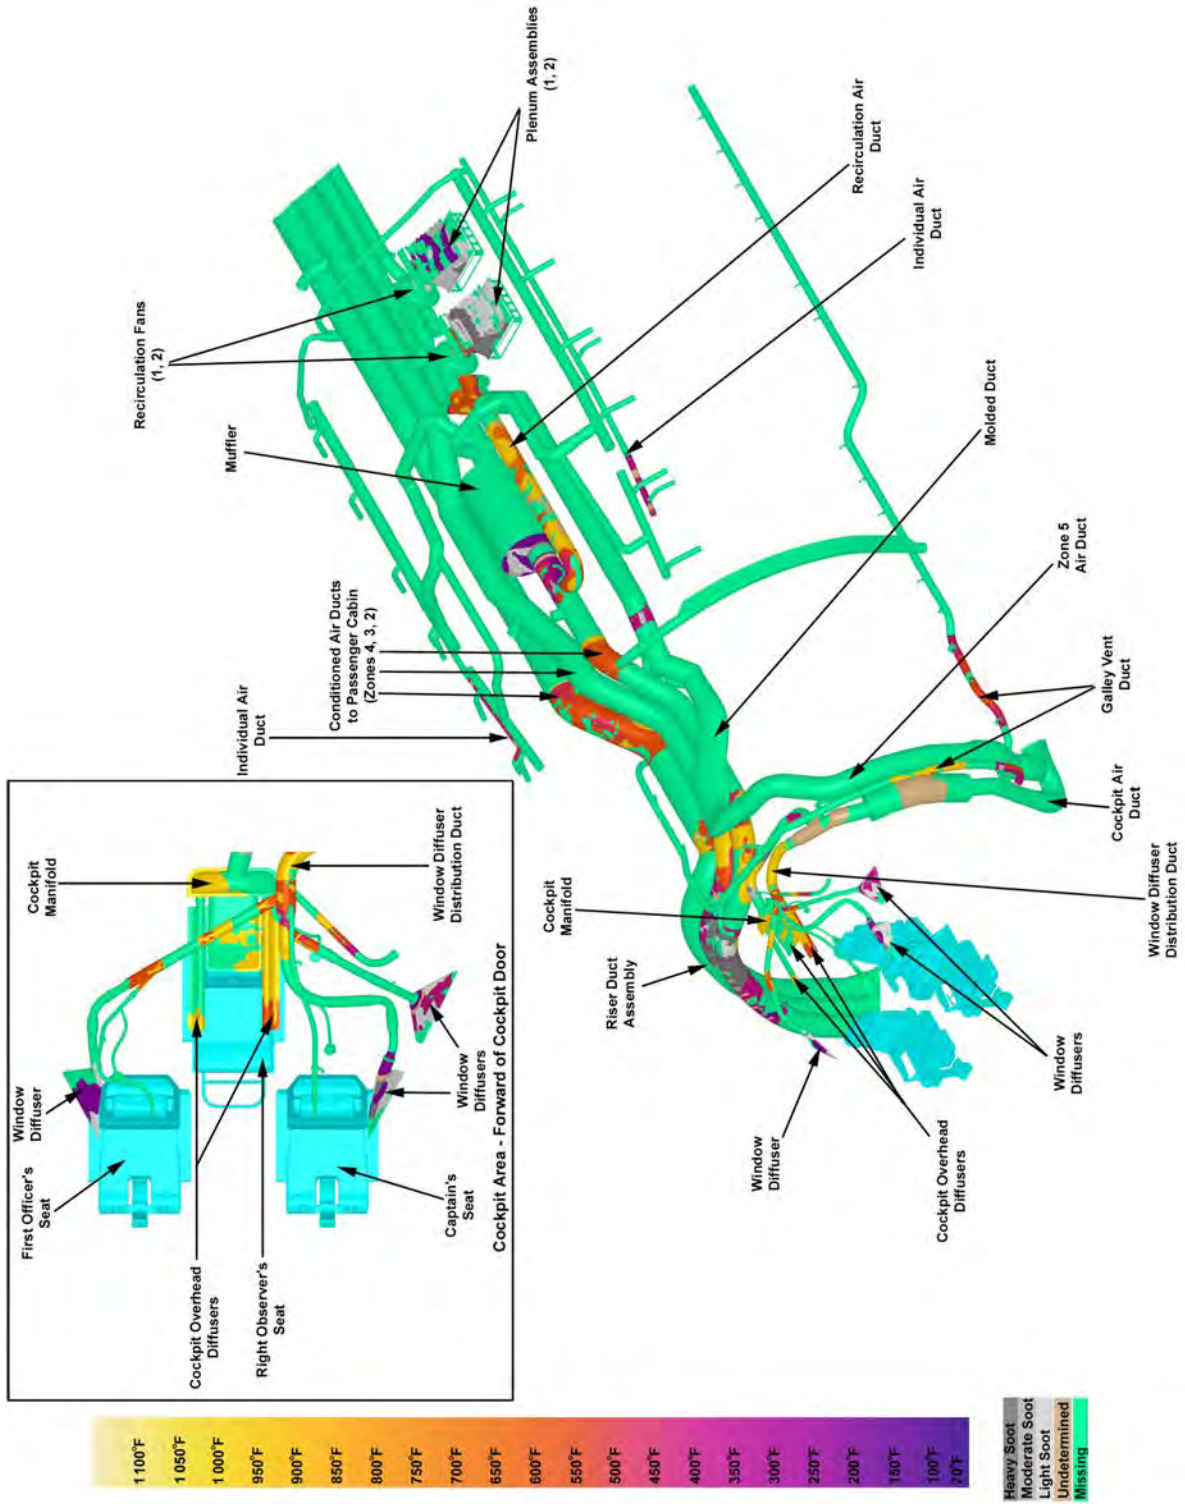
Figure 26: Heat damage – air distribution system

Between approximately STA 480 and STA 545, the main conditioned air ducts for zones 2, 3, and 4 transitioned from running near the top of the forward cabin drop-ceiling, upward to run near the crown of the aircraft. In this area there was bare-metal heat damage at places along the top of the ducts. The primer on the underside of these ducts was not damaged by heat. The recovered portions of two individual air ducts from approximately STA 555 to STA 595 at  $X=70$  and  $X=-70$  had areas of light to moderate soot accumulation.

Forward passenger cabin individual air was supplied by a fan and plenum assembly identical to a recirculation air fan and plenum assembly. The fan was located at STA 990 at  $X=-24$ . The plenum assembly was between  $X=-40$  and  $X=-65$ . The recovered portions of the plenum had no heat damage or soot accumulation. The individual air ducts were uninsulated and ran forward from STA 990 to a "Y" (split) at STA 750 at  $Z=91$ ,  $X=-21$ . One branch of the "Y" ran across the crown to the left side of the cabin at  $X=76$ , and the other ran to the right side at  $X=-76$ . The recovered portions of these ducts had moderate to heavy soot accumulations on the exterior, with no heat damage. The aftermost section of individual air duct that was identified was from STA 934 to STA 955 at  $X=-22$  and had light soot accumulation on the exterior.

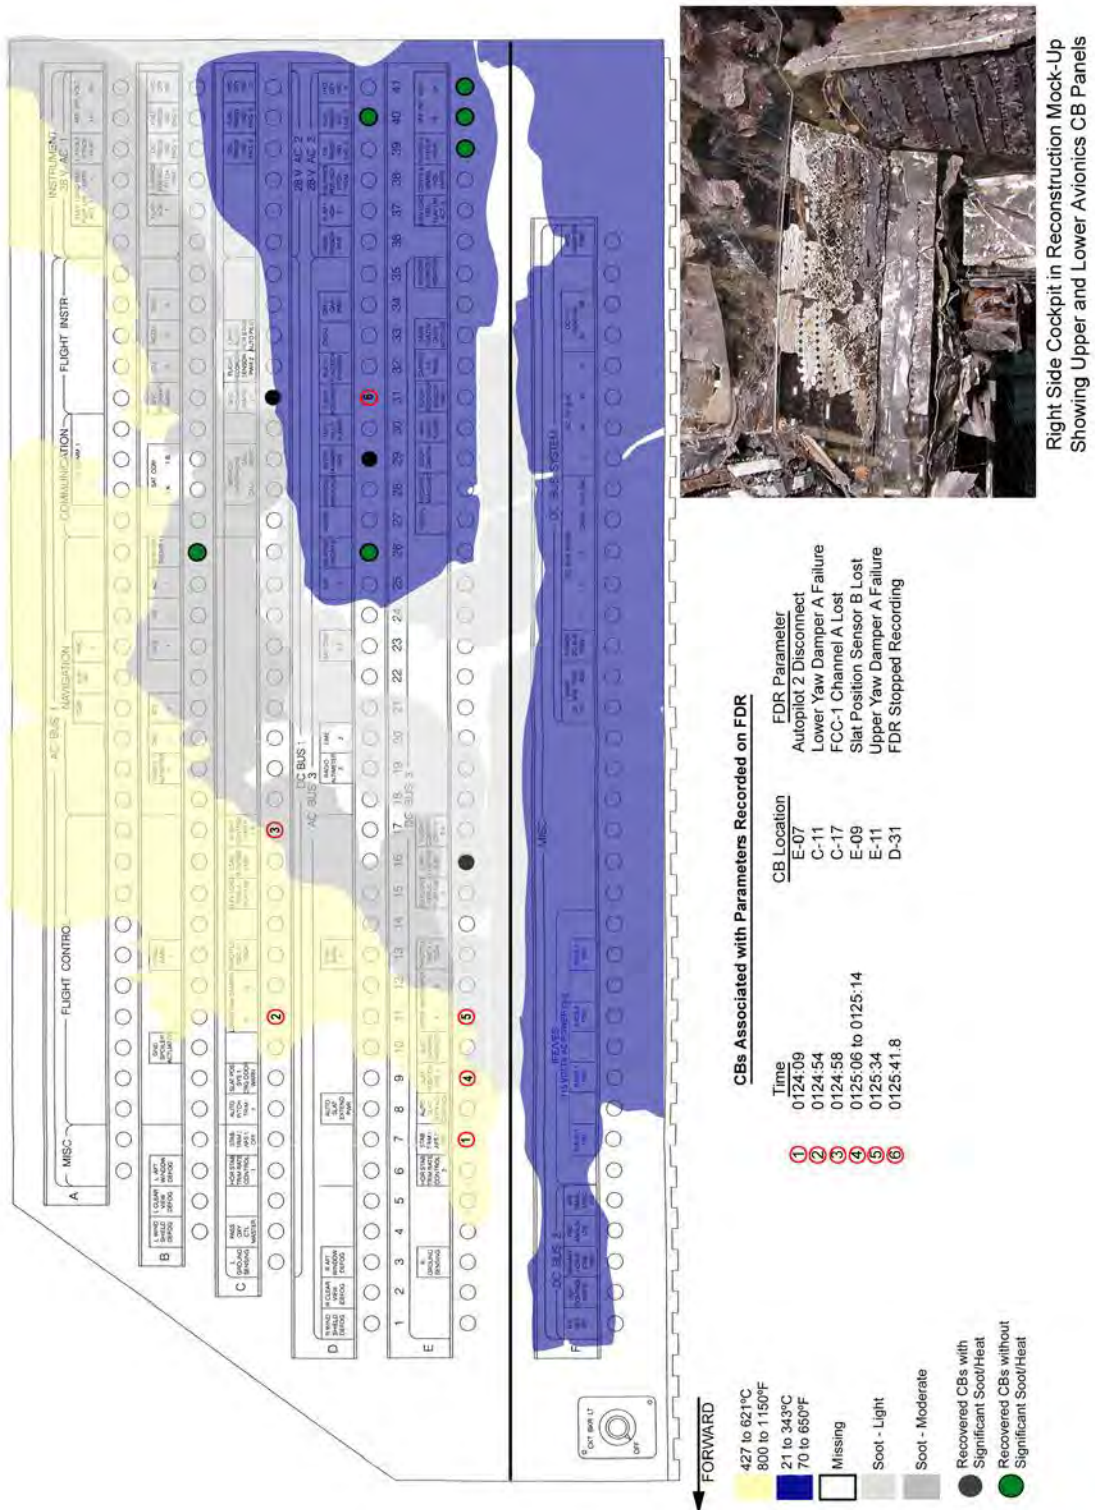
Figure 28: Heat damage – upper and lower avionics CB panels

side, particularly on those pieces near the forward end of the panel where the front side of the panel showed considerably more heat damage than the back side. Individual CBs showed soot on the white indicator ring; soot could only have been deposited if the CB had tripped and subsequently been exposed to combustion by-products. Details concerning the CBs on the avionics CB panel and wiring in the vicinity are included in separate sections of this report.

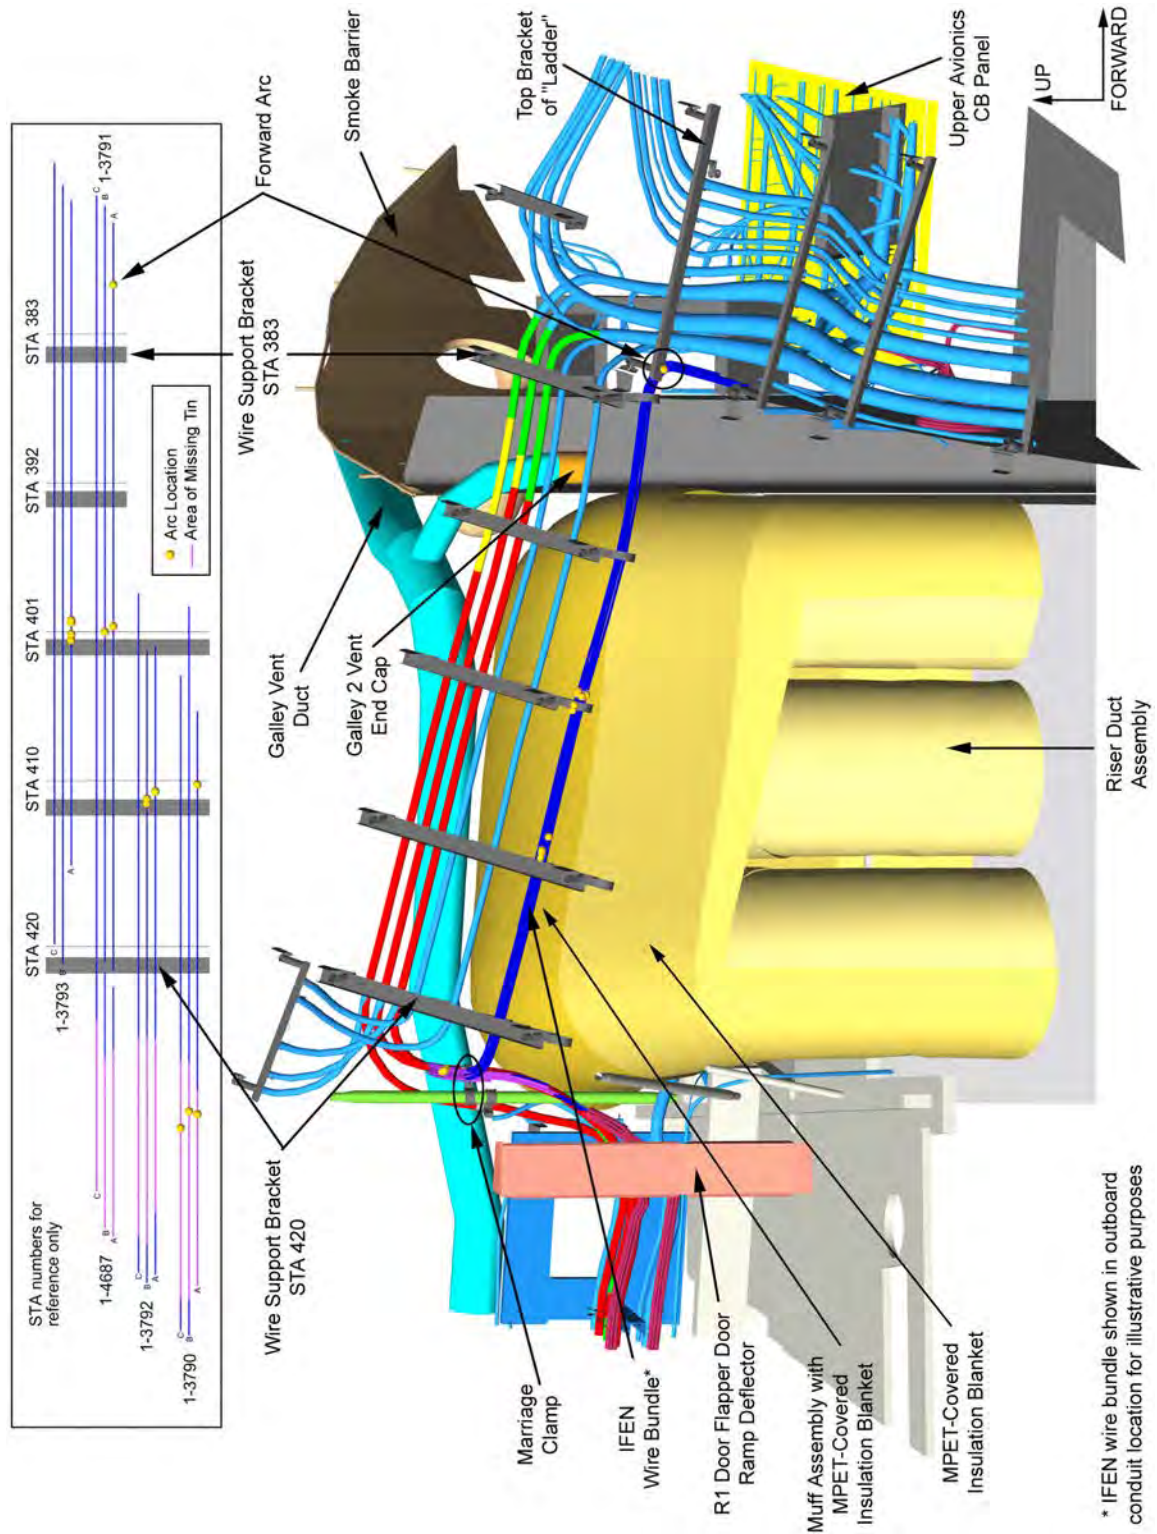
**Figure 30:** Position of recovered IFEN wires – outboard conduit

As indicated above, based on the layout of the cables and wires, it is possible to assess the direction of fire propagation based on the sequence of the arcing events. The aft arcs on exhibits 1-3790 and 1-3791 would most likely have tripped their associated CBs; therefore, the forward arcs must have occurred first, and not tripped their associated CBs. This strongly suggests that the fire was moving forward to aft.

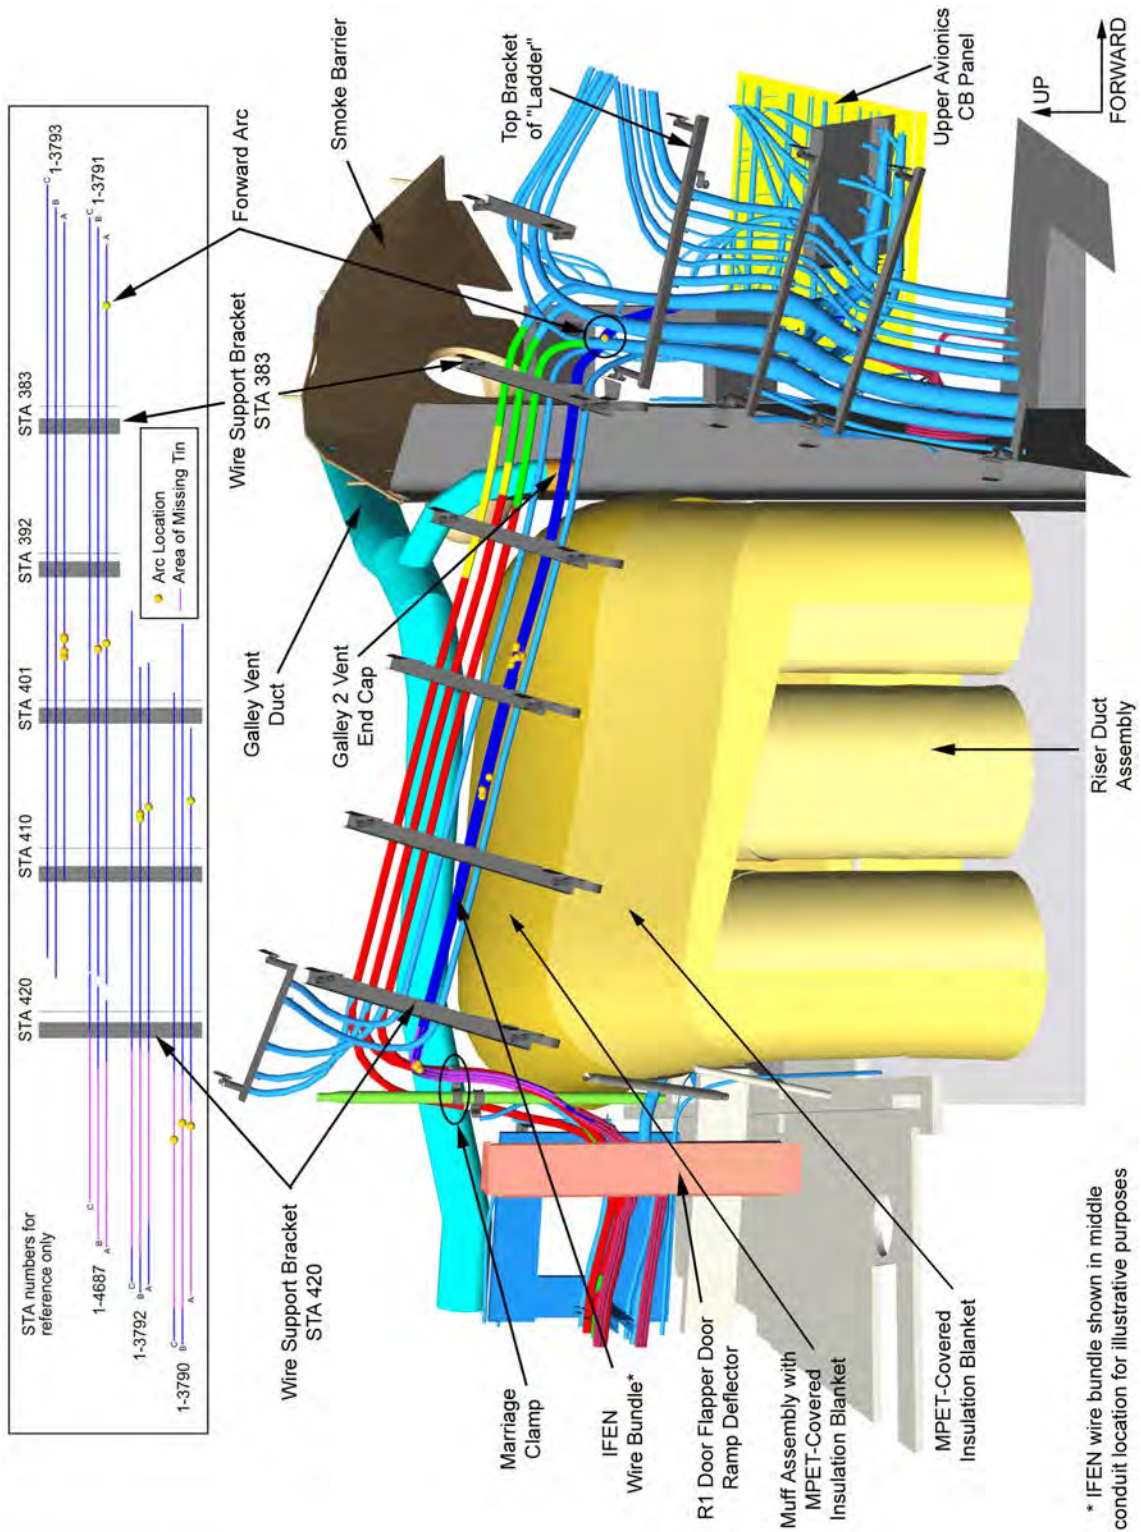
Figure 31: Position of recovered IFEN wires – middle conduit

The region of missing tin represented an area of higher heat. If this had been an earlier event, it is strongly suspected that all three cables would exhibit similar arcing events in the vicinity of 1-3790 outside the aft end of the conduit. With the cables and control wire laid out as described above, all of the regions of melted copper could be attributed to arcing events between phases on the same cable, between the cables and the control wire except for the arc event that took place at the forward end of 1-3791, or both. There was no matching arc damage on cable 1-3793 in this area. However, the continuation of exhibits 1-3790/1-3792 from approximately STA 401, along with the 16 AWG control wire forward, were not identified. Therefore, no determination could be made with respect to exactly what the single wire from 1-3791 had come in contact with at the forward end.
