AVIATION INVESTIGATION REPORT

A98P0164

LOSS OF SEPARATION

VICTORIA, BRITISH COLUMBIA

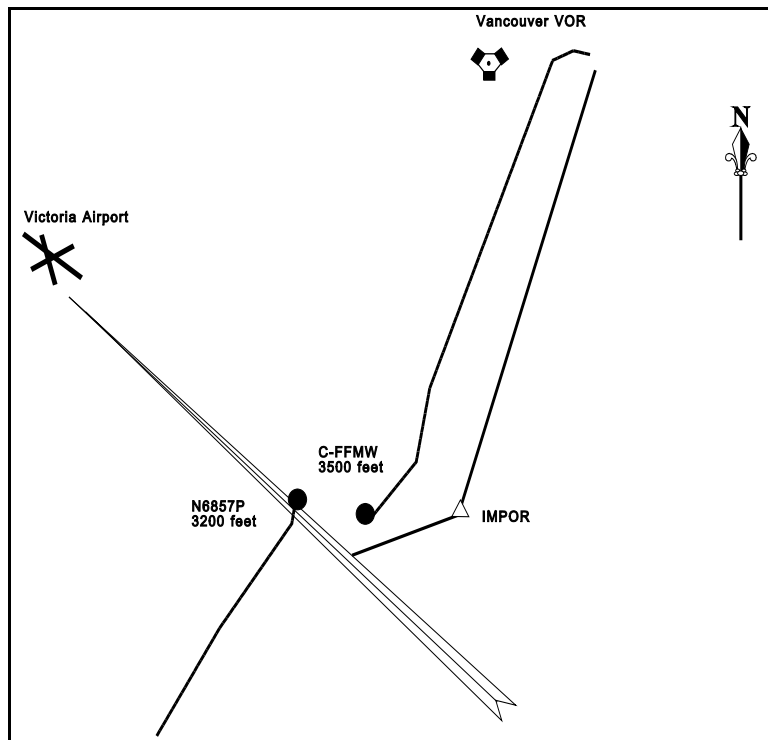
A review of the recorded radar information showed that the aircraft was not tracking the Vancouver VOR (very high frequency omnidirectional radio range) 157 degree radial toward the IMPOR intersection accurately, but was consistently west of track by as much as 2 nautical miles (nm). The trainee controller did not take any action to advise the aircraft of the observed deviation. This resulted in the aircraft turning inbound earlier than normal to intercept the localizer, which resulted in an unexpected decrease in spacing with the aircraft ahead. During a previous conversation, the on-the-job instructor (OJI) had cautioned the trainee about the possibility of C-FFMW turning in on a tighter track if no correction was initiated. The OJI did not intervene at this point.

1. The trainee did not correct the flight path of C-FFMW, which was consistently west of the Vancouver VOR 157 degree radial flying toward the IMPOR intersection, and the OJI did not intervene.
2. The OJI was unable to access the landline communications panel from his position at the adjacent console. This would have enabled him to communicate with other control agencies, such as the Victoria airport controller.

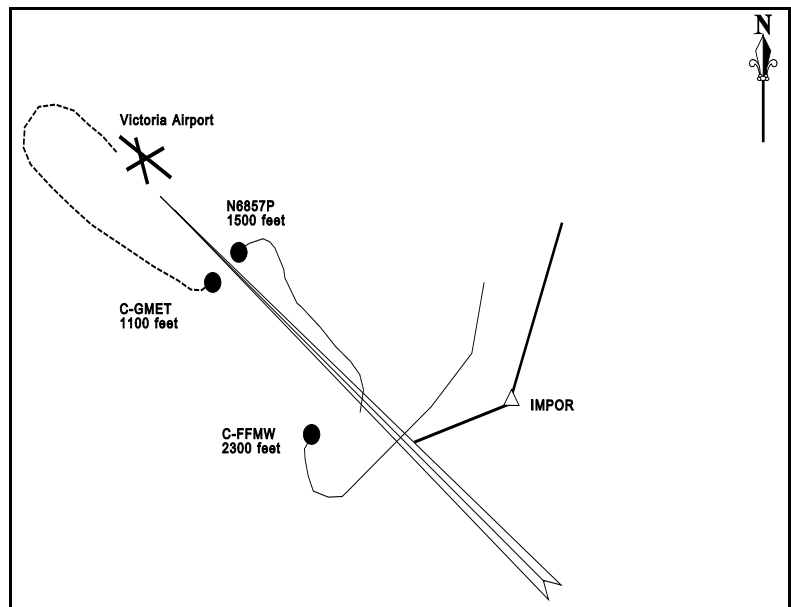
At 1047:37, the airport controller queried Victoria terminal on the hotline as to whether N6857P was definitely out of the approach sequence, but he received no response. Seven seconds later, having observed N6857P turning away from the approach course, he cleared C-GMET to turn onto base leg. Eight seconds later, upon seeing N6857P turning toward the approach course for runway 27, the airport controller again called Victoria terminal on the hotline and asked what they were going to do with N6857P. The trainee controller replied that N6857P was visual and was following the traffic ahead that was just crossing the threshold of runway 27. However, this traffic was another IFR aircraft on approach to runway 27 and not C-GMET in the circuit. Moments later, at 1048:04, N6857P checked in on the tower frequency. The airport controller immediately realized that there would be a conflict between the two aircraft and instructed C-GMET to turn directly toward the button of runway 27. When queried as to whether there was sufficient spacing behind C-GMET, the pilot of N6857P replied that an orbit was preferred to increase the spacing with the traffic ahead and that he had the traffic in sight. Both aircraft landed without further incident.
