AVIATION INVESTIGATION REPORT

A99A0100

RUNWAY OVERRUN

FOKKER F28 MK 1000 C-GTIZ

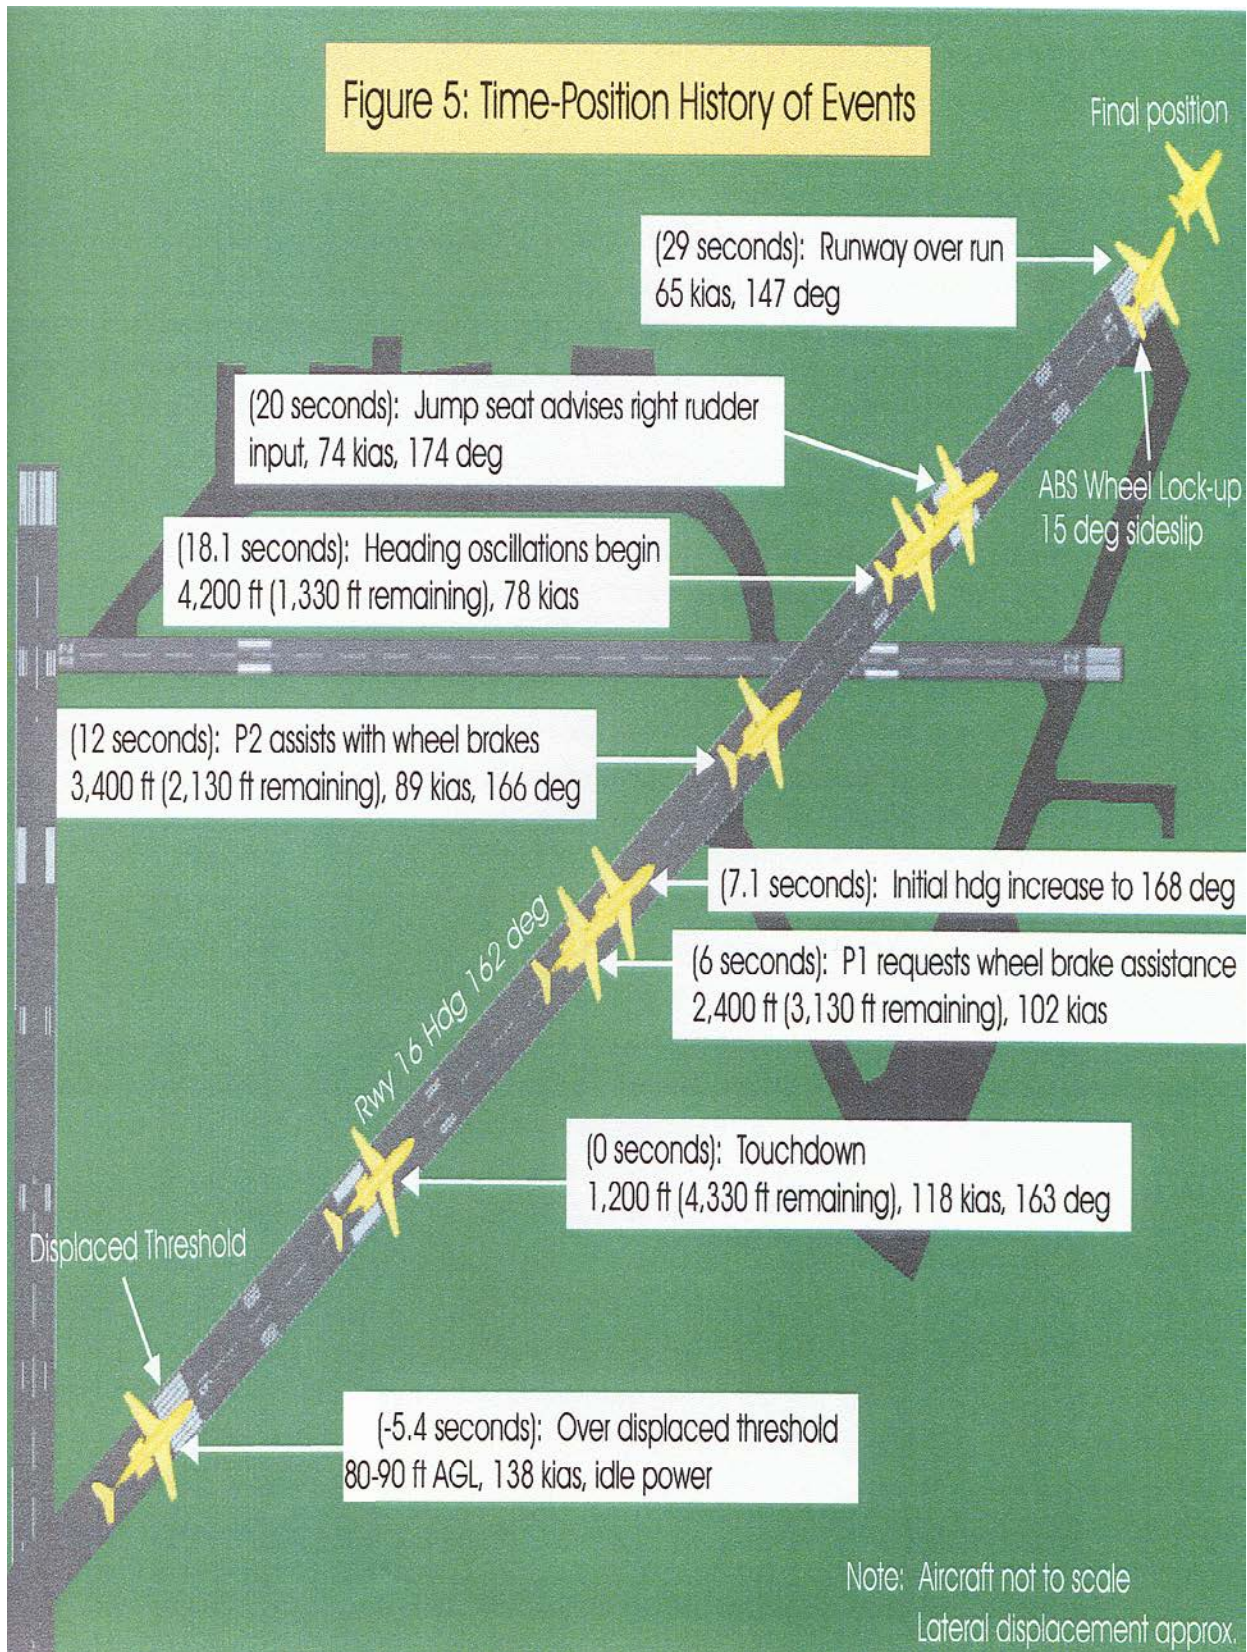
Appendix A—Schematic of Landing

As the main gear touched, the aircraft's heading gradually began to increase from 163°M , reaching 168°M seven seconds after touchdown. The nose gear touched two seconds after the main gear, and the captain applied the brakes. Six seconds after touchdown, the captain perceived that there was no braking action and urgently requested wheel-braking assistance from the co-pilot. The aircraft was now approximately 2400 feet beyond the displaced threshold and decelerating through 102 KIAS, on a heading of 168°M . The aircraft continued down the runway, near the centreline, with the nose 4° to 7° to the right of the runway heading. Maximum toe braking was applied continuously throughout the roll, and the crew reported applying the alternate braking system approximately 2900 feet from the runway end; however, there was no discernable braking effect from either brake system. The co-pilot confirmed toe braking application about 12 seconds after main-gear touchdown, 3400 feet from the displaced threshold (2130 feet from the runway end) at 89 KIAS. Approximately 1330 feet from the runway end, the first of two heading oscillations began. The aircraft's heading increased from 170°M to 178°M , then decreased to 147°M . The aircraft departed the end of the runway, slightly left of the centreline, on a heading of 147°M at 65 KIAS. (See Appendix A for a schematic of the landing.)
