AVIATION INVESTIGATION REPORT

A99Q0151

CONTROLLED FLIGHT INTO TERRAIN

RAYTHEON BEECH 1900D C-FLIH

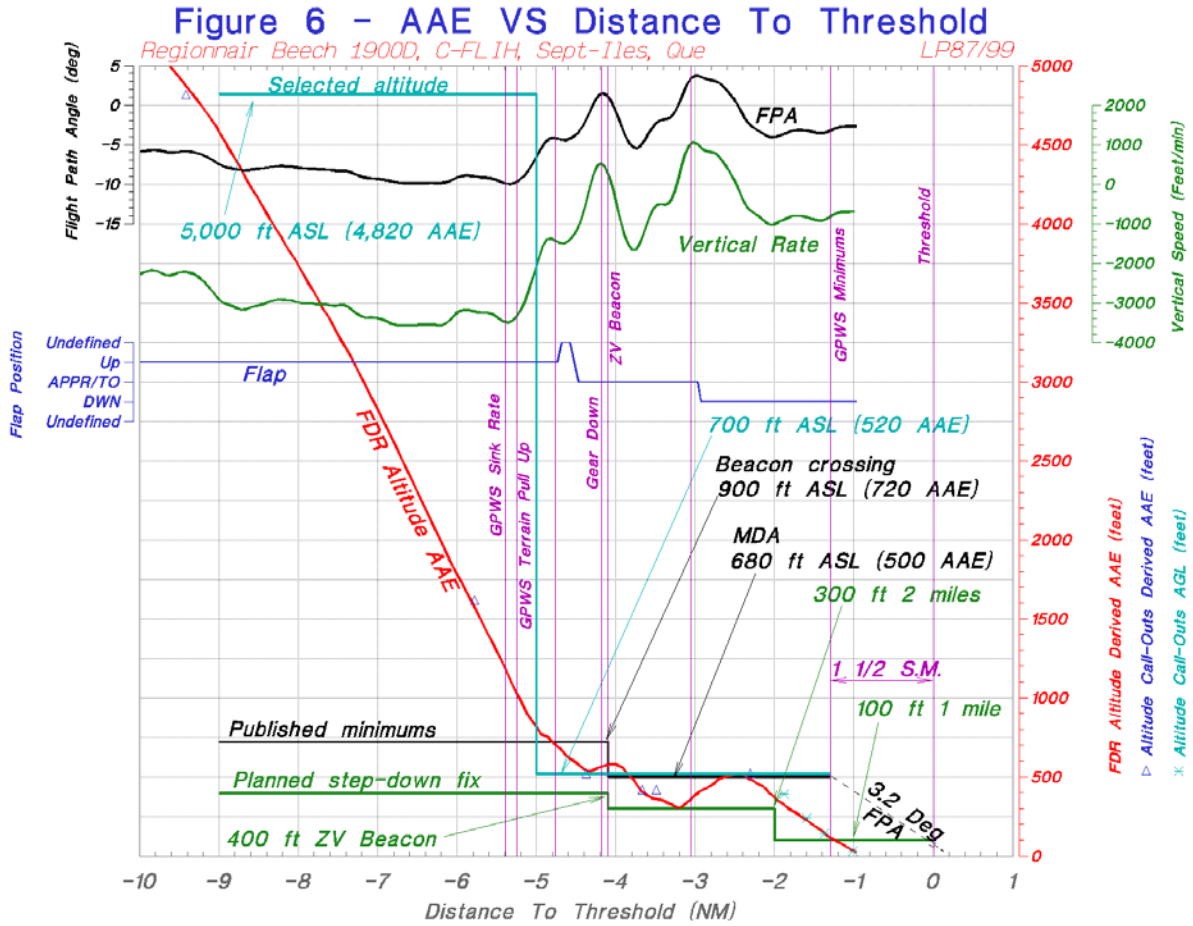
Appendix C—Flight Data Recorder Data

The descent from cruise flight into the aerodrome was started late, and the aircraft was high and fast during the approach phase to the NDB. From an altitude of 10 000 feet at 9 nm from the NDB, the rate of descent generally exceeded 3000 feet per minute (fpm). The aircraft crossed the beacon at 600 feet asl. For the last 30 seconds of flight and from approximately 3 nm from the threshold, the aircraft descended steadily at approximately 850 fpm, at 140 to 150 knots indicated airspeed, with full flaps extended. The captain coached the first officer throughout the descent and called out altitudes and distances. The ground proximity warning system (GPWS) "Minimums" activation sounded, consistent with the decision height (DH) selection of 100 feet, to which the captain responded with directions to continue a slow descent. The last call was at 30 feet, 1.2 seconds before impact.

During the descent into Sept-Îles from cruising altitude, the aircraft's flight profile was high and fast in relation to its range to the ZV NDB. The captain felt that a shuttle-type manoeuvre such as a 360° turn might provide for a more stabilized approach beyond the beacon and expressed his concern. The pilot flying replied that this should not cause a problem, and the captain allowed the flight to continue. At 1 nm from the NDB, the aircraft's rate of descent was still approximately 3000 fpm. The airspeed was 200 knots, and the flaps and the landing gear were up. The approach flap was selected as the aircraft arrived at the NDB, but the pilot flying had to raise the nose of the aircraft to slow down to the landing gear limiting speed. The aircraft's rate of descent between the NDB and 2.5 nm from the threshold varied between 1000 fpm and 1500 fpm, after which it stabilized at 850 fpm until impact. The indicated airspeed decreased from 200 knots at the NDB to approximately 137 knots at 2 nm from the threshold, then increased steadily to reach 153 knots at impact.
