MARINE INVESTIGATION REPORT

M00N0009

STRIKING OF ICE AND SUBSEQUENT SINKING

THE FISHING VESSEL "BCM ATLANTIC"

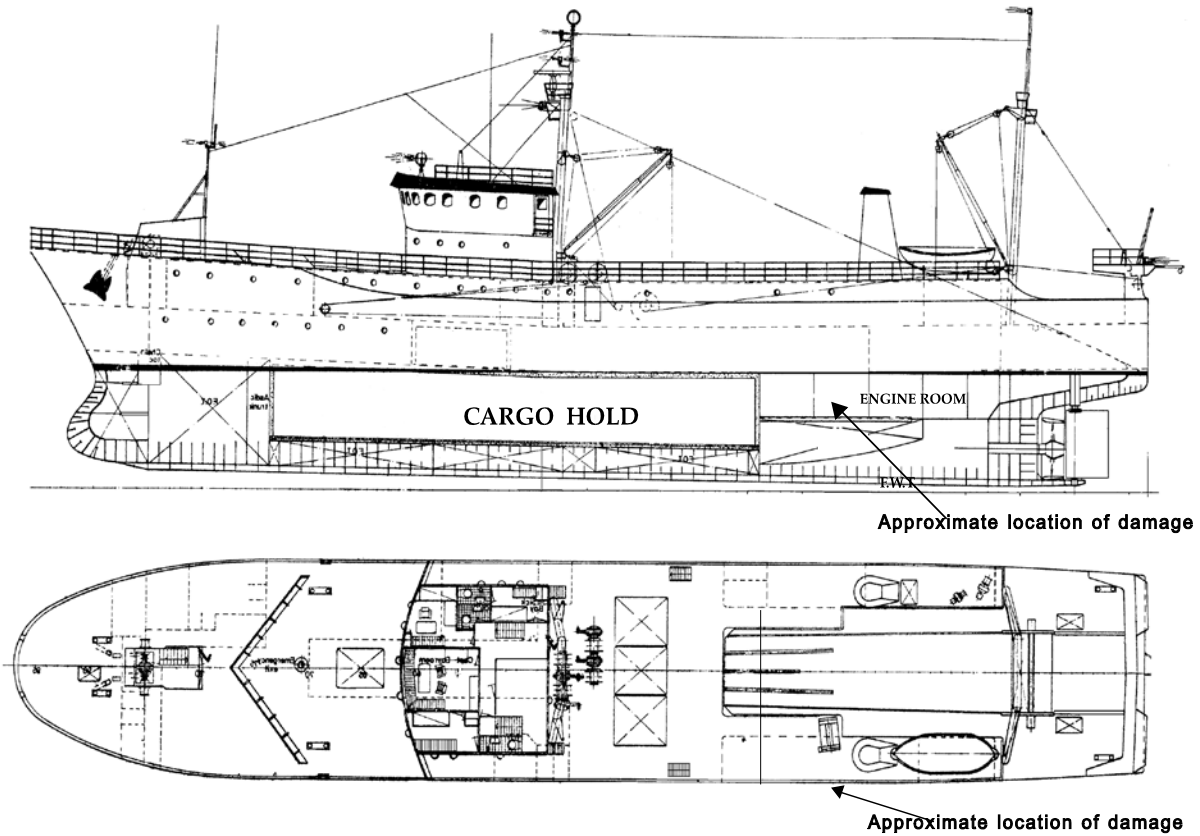
Appendix C - Location of Ice Damage

While shooting a trawl at night, on shrimp fishing grounds off Labrador, the “BCM ATLANTIC” struck a piece of ice. The vessel was holed in the shell plating on the port side in the vicinity of a common bulkhead between the engine-room and the cargo hold. As a consequence, the vessel flooded and then sank some four hours later. All personnel on board donned immersion suits and abandoned ship into three liferafts. Some three hours later, a rescue aircraft and a nearby fishing vessel located the rafts and all 26 people were recovered. No serious injuries or pollution resulted from this occurrence.

Within a minute of hearing the impact, the chief engineer ran down to the engine-room and saw water flooding through a hole on the port side of the hull near a common bulkhead between the engine-room and the cargo hold. The visible portion of the hole was estimated to have been about one metre high, running up to the top of the port-side fresh water tank (see Appendix C). However, it was not possible to determine the width of the hole, or if the damage extended forward of the bulkhead into the cargo hold, as the area was partly covered by the machinery installations. A deckhand, who was working in the cargo hold at the time, later reported having heard water enter the fish hold from an undetermined position at or near the port side aft end of the fish hold bulkhead. Bilge alarms activated in the engine-room as well as on the deck. The chief engineer immediately started two bilge pumps, which had a combined capacity of 1.6 m³ per minute. It was estimated that the engine-room was rapidly filling, at the rate of about one foot per minute.

- I. While swinging to starboard at six to seven knots, exposing the port side to ice contact, the vessel struck ice and was holed on the port side shell plating near the common bulkhead between the engine-room and the cargo hold.
- II. The speed required to shoot the trawl off the deck was considered sufficient to fracture the shell plating at the point of contact with the type of ice encountered.
- III. The impact with ice was noticed immediately and, within a minute, a hole in the engine-room was discovered.

- IV. The hole likely extended forward of the engine-room and breached the watertight integrity of the cargo hold.
- V. The total capacity of the engine-room bilge pumps was insufficient to cope with the water ingress.
- VI. The vessel stayed afloat for approximately four and a half hours after being holed; the vessel most likely sank because two of the largest compartments were flooded with sea water.
