MARINE INVESTIGATION REPORT

M05W0087

COLLISION

**BETWEEN THE FISHING VESSEL *SANDRA CAROL* AND
THE TUG *OCEAN WARRIOR* TOWING THE BARGES**

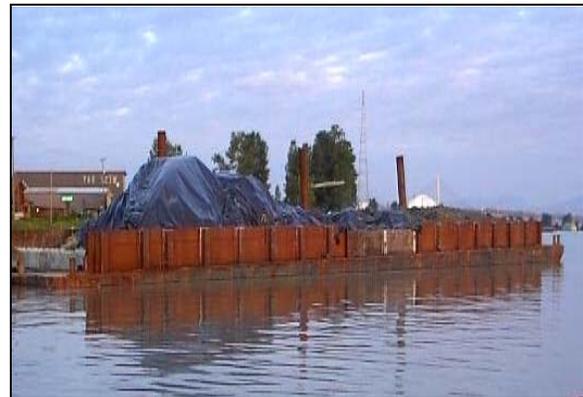
Barge 216 is a flush-decked steel barge used for hauling aggregate between ports on Canada's west coast. The hull is painted black, and the 1.2 m steel box walls are composed of unpainted steel plate (see Photo 1).

Photo 1. *Barge 216* fully loaded with soil as it was at the time of the accident. The bow is at left.

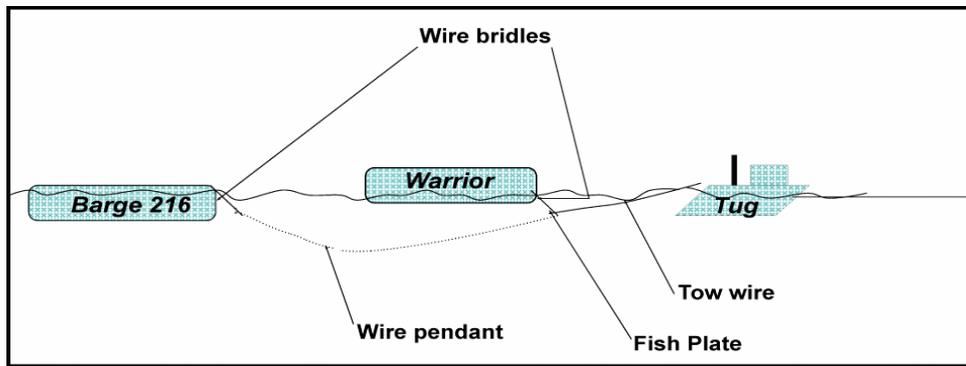
The tug *Ocean Warrior* departed Victoria Harbour with a crew of four at about 1515 the same day, towing the empty aggregate barge *Warrior* approximately 61 m astern and the barge *Barge 216* fully loaded with approximately 2300 tons of contaminated soil approximately 45 m astern of the *Warrior*. (For towing arrangement see Figure 1.)

Figure 1. Towing arrangement for the tug *Ocean Warrior* and barges *Warrior* and *Barge 216*

At 2246, the *Sandra Carol*, in a position with James Point on North Pender Island bearing 065° True (T) at nine cables, continued on its preset course and passed between the stern of the *Warrior* and the bow of the loaded *Barge 216*. The forefoot of the wood fishing vessel struck the wire pennant near the bridle of *Barge 216*. The vessel's hull planks broke, seawater quickly flooded the hull, and the vessel became swamped. The freeboard of the fully loaded *Barge 216* was about the same height as the main deck of the *Sandra Carol*, and the owner/operator was able to step without injury onto the foredeck of *Barge 216*.
