MARINE INVESTIGATION REPORT

M05W0110

SINKING

FISHING VESSEL *MORNING SUNRISE*
OFF SAVARY ISLAND,
NORTHERN GEORGIA STRAIT, BRITISH COLUMBIA
29 JUNE 2005

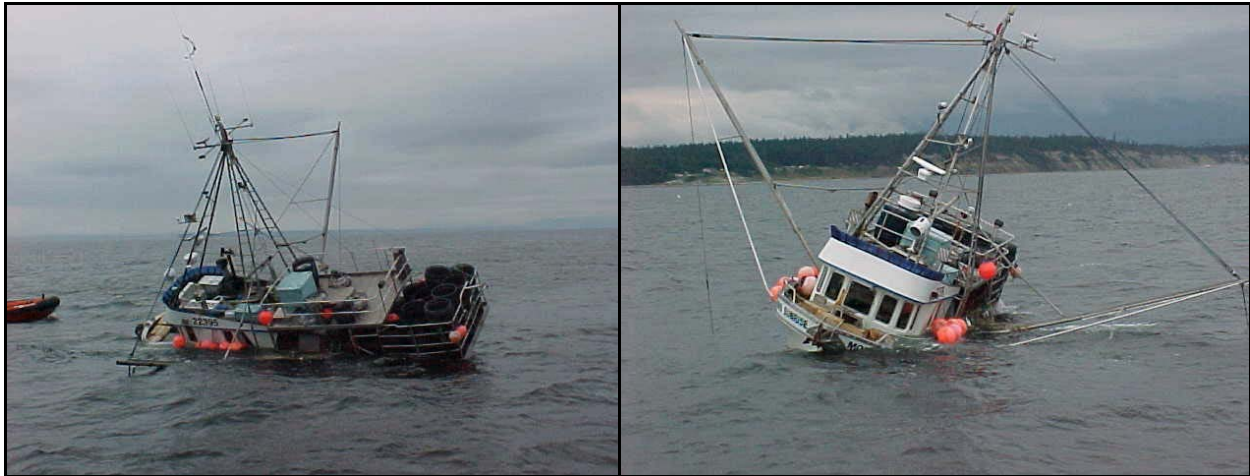
Photo 1. The *Morning Sunrise* during capsizing

The master changed over to manual steering and, in an effort to right the vessel, increased engine revolutions and placed the helm hard-a-starboard. The vessel momentarily returned to the upright, then heeled to starboard, assuming a list of approximately 40° to starboard. The master then increased the revolutions further and placed the helm hard-a-port. This resulted in the vessel assuming a heavy port list again, until it eventually rolled over on its beam ends and

gradually settled deeper into the water. At 1612, the skipper broadcast a Mayday message on VHF channel 16, giving the vessel's Loran C coordinates. He then ordered the crew to don their immersion suits; all crew members then abandoned the vessel into the launched liferaft.

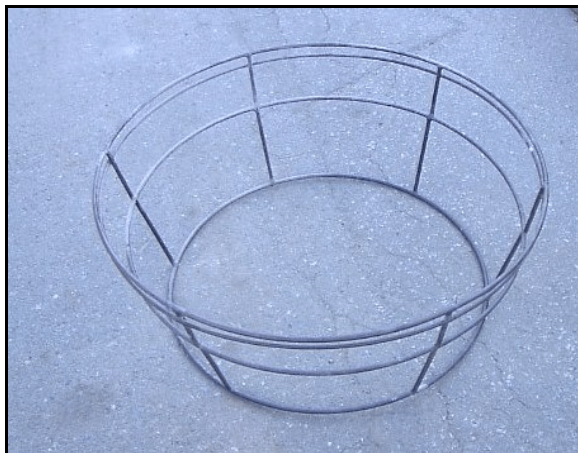
Also in 1995, in order to deter fishers from jury-rigging their prawn traps to maximize their catch, DFO set upper limits for trap volume and mesh size. Since these limits did not take into consideration trap weights, licence holders opted to make the traps more robust by progressively increasing the trap weights from 2 kg to 5 kg. This enabled the traps to withstand the weight of the catch, and the licence holders to better their catch size.

Photo 2. Shell of trap before cordage is added

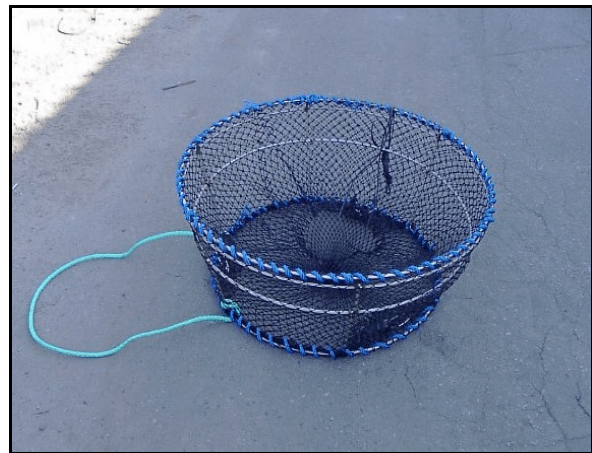
Photo 3. Fishing prawn trap

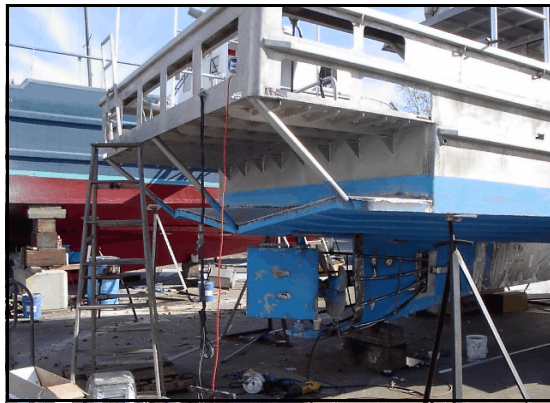
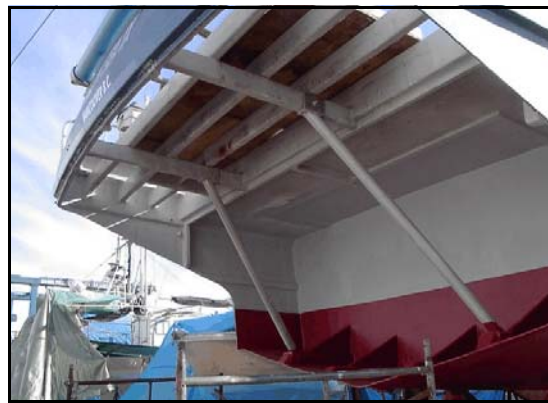
Photo 4. Examples of platform deck extension to accommodate extra traps

The Stacked Licence policy permits vessel owners to carry 500 prawn traps on board. To facilitate this, an aluminum platform deck extension weighing about 181 kg was added to the after end of the *Morning Sunrise*. This extension was not included in the vessel's length overall. Around the same time, a similar aluminum platform, extending approximately 2.75 m aft from the top deck of the housework, was constructed. This added a further weight of about 227 kg to the vessel. The 408 kg weight of the added structures was above the vessel's centre of gravity. These modifications were carried out by a local welding shop without consulting a naval architect or TC.

The DFO length restriction, in conjunction with the Stacked Licence policy, encourages the addition of platform extensions. This not only increases the trap stowage area, but it also allows the carriage of 200 extra traps, at a greater height above the vessel's centre of gravity, adversely affecting a vessel's transverse stability. Other modifications to comply with DFO length restrictions include

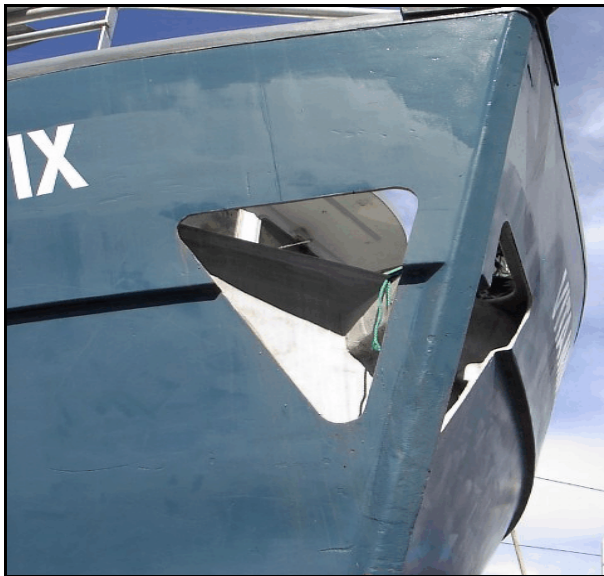
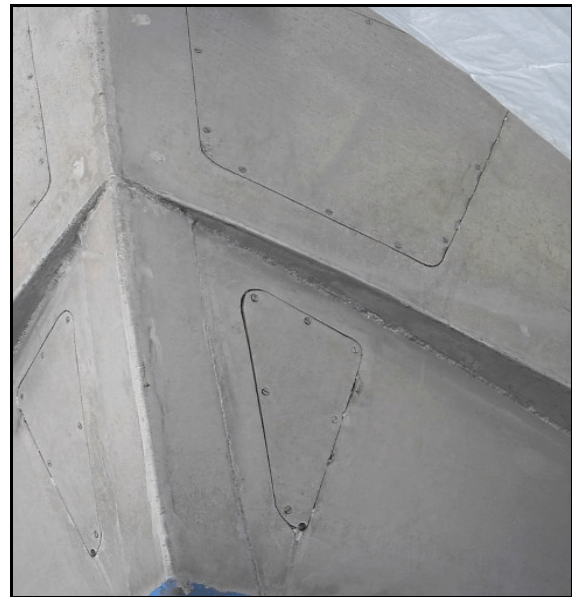
- opening end compartments to the sea, which can compromise the watertight integrity of the space;
- moving away from conventional design concepts and introducing features such as increasing the width and above-water areas to meet operational needs, which may adversely affect the vessel's transverse and dynamic stability.

Photo 5. Examples of vessels' overall length being reduced by opening the end compartment to the sea. This can compromise the watertight integrity of those vessels. These modifications are done to meet the DFO length restrictions. **Note:** Openings made in the bow section of the vessel on the photo to the left. Drain holes at the bottom of the triangular plate on the photo to the right.
